Blackout 2011 – Volume I

Events Leading Up to the Outage

This course is based on an April 2012 report by the Federal Energy Regulatory Commission and the North American Electric Reliability Corporation titled, Arizona – Southern California Outage on September 8, 2011. The Report has been edited for brevity and clarity for this course.

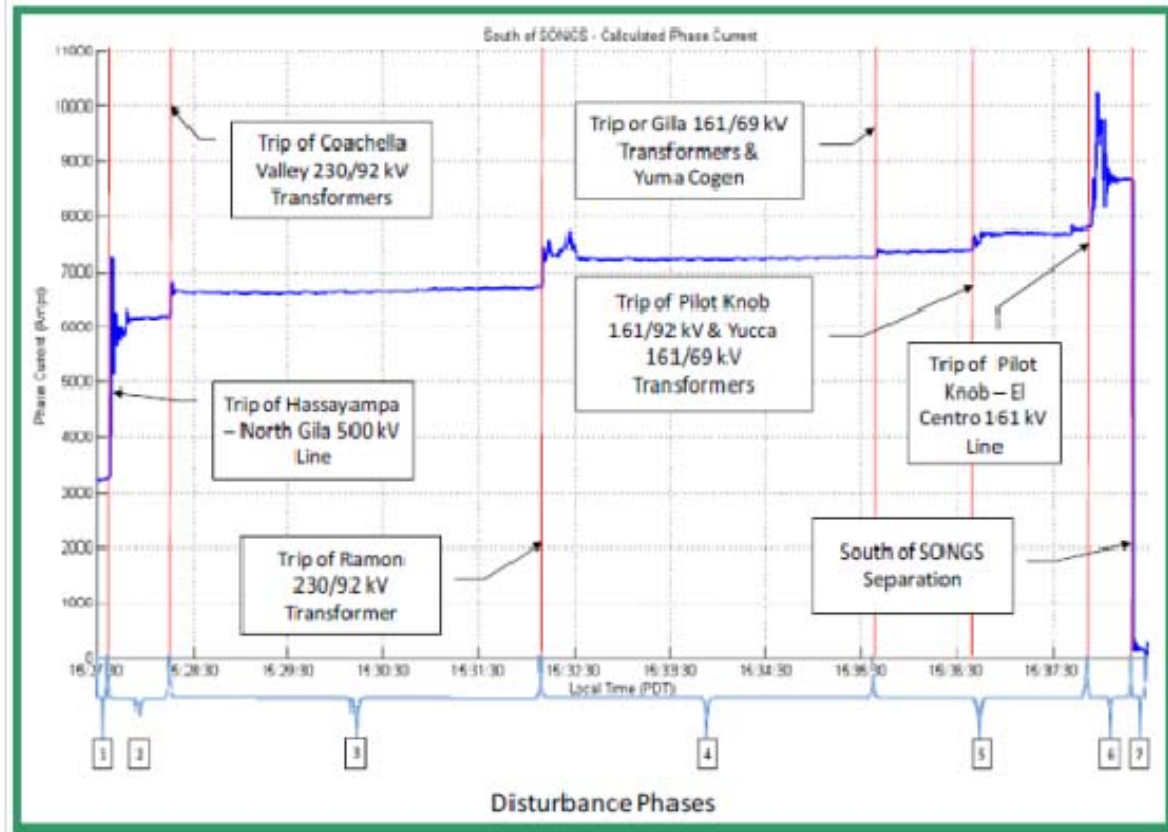
Figure 4

Figure 5 shows all seven phases of the disturbance. The seven phases of the disturbance were,

1. Pre-disturbance conditions,
2. Trip of Hassayampa-North Gila 500 kV Line,
3. Trip of the Coachella Valley 230/92 kV transformer and voltage depression,
4. Trip of Ramon 230/92 kV Transformer and collapse of IID's Northern 92 kV system,
5. Yuma load pocket separates from IID and WALC,
6. High-speed cascade, Operation of the SONGS separation scheme and islanding of San Diego, IID, CFE, and Yuma, and
7. Collapse of the San Diego/CFE/YUMA island.

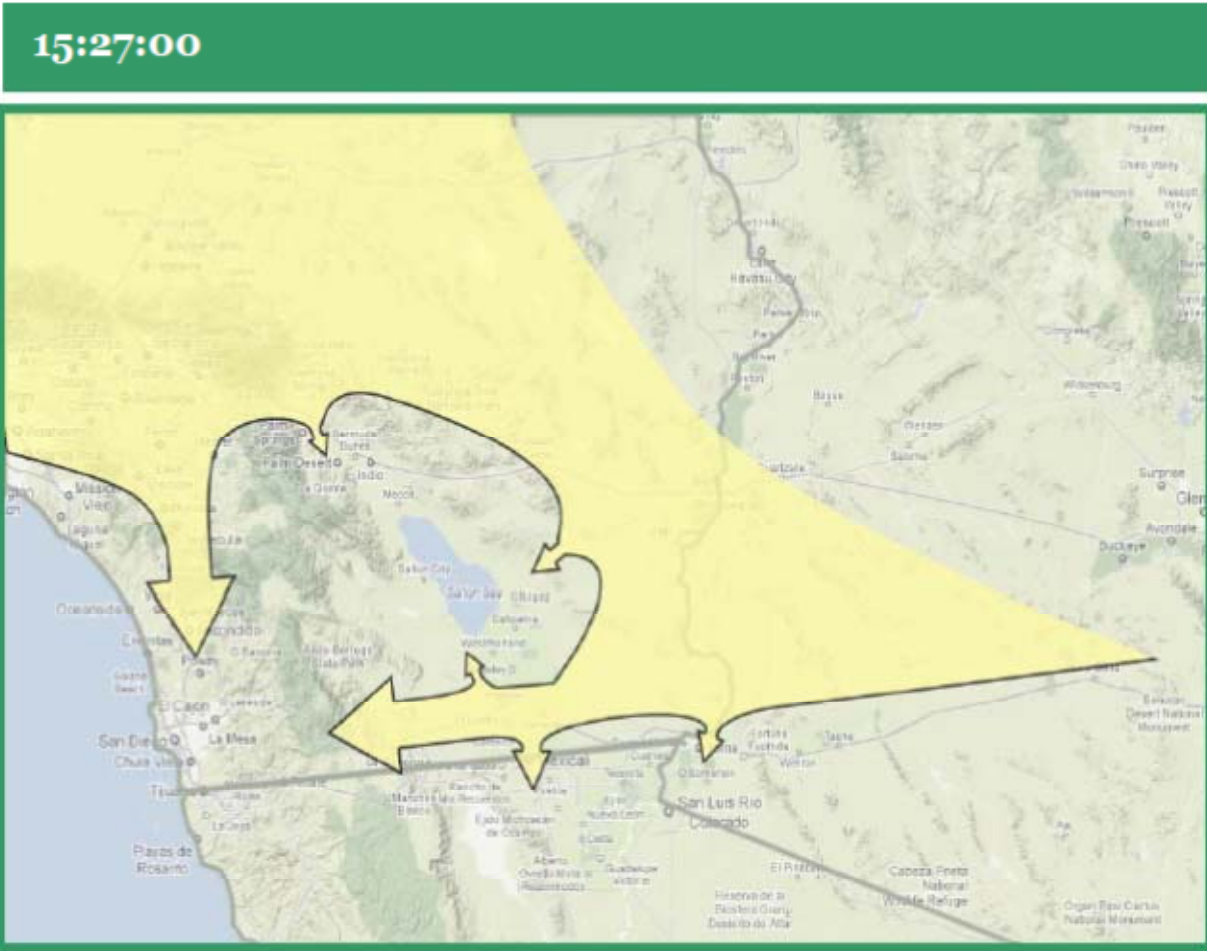
Figure 5 shows load flows during Phase I.

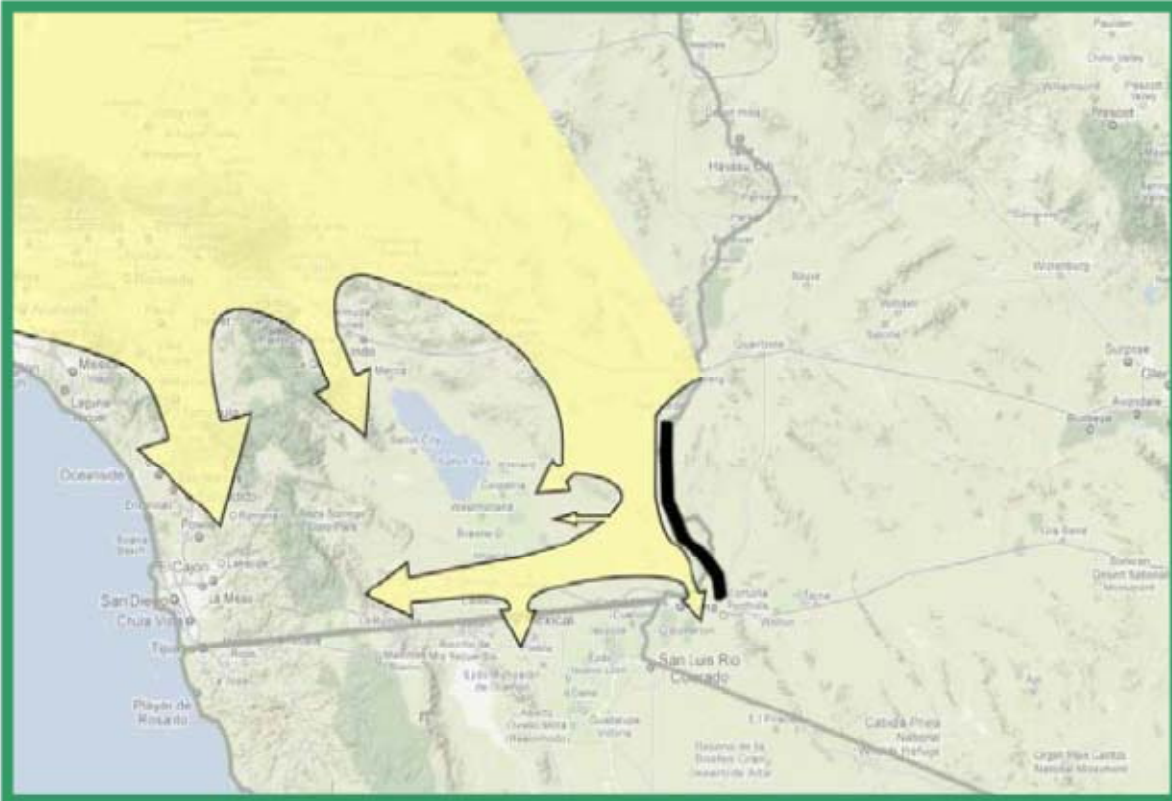
Figure 6 shows load flows during Phase 2.

15:27:40

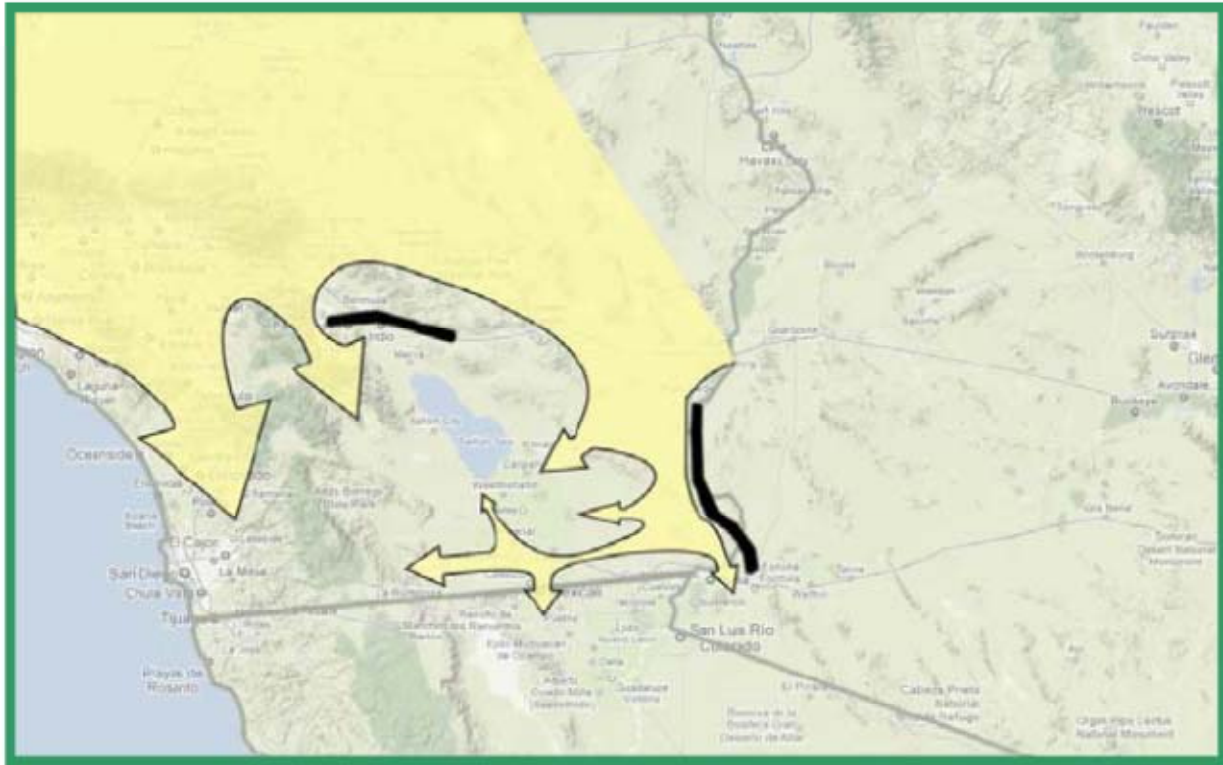
Figure 7 shows the load flows during Phase 3.

15:28:18

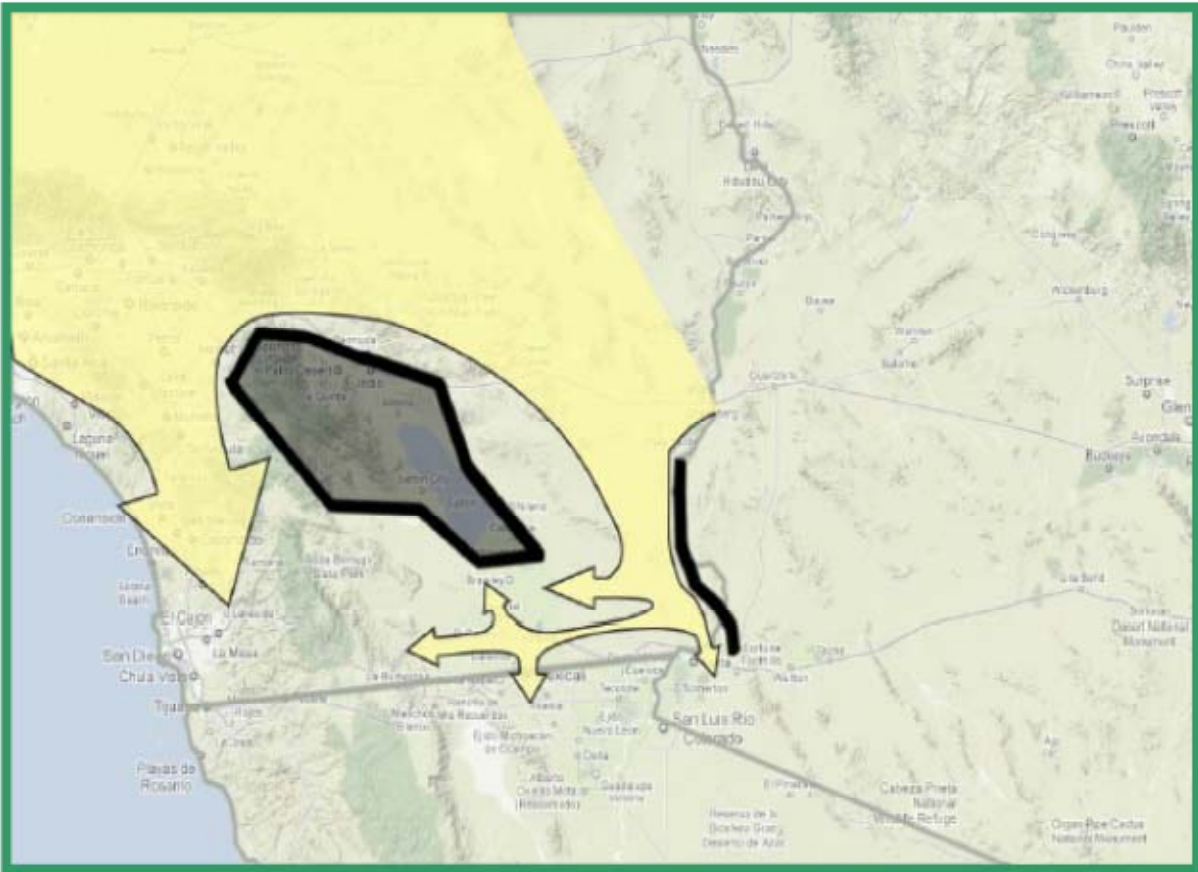
Figure 8 shows the load flows during Phase 4.

Time: 15:32:35

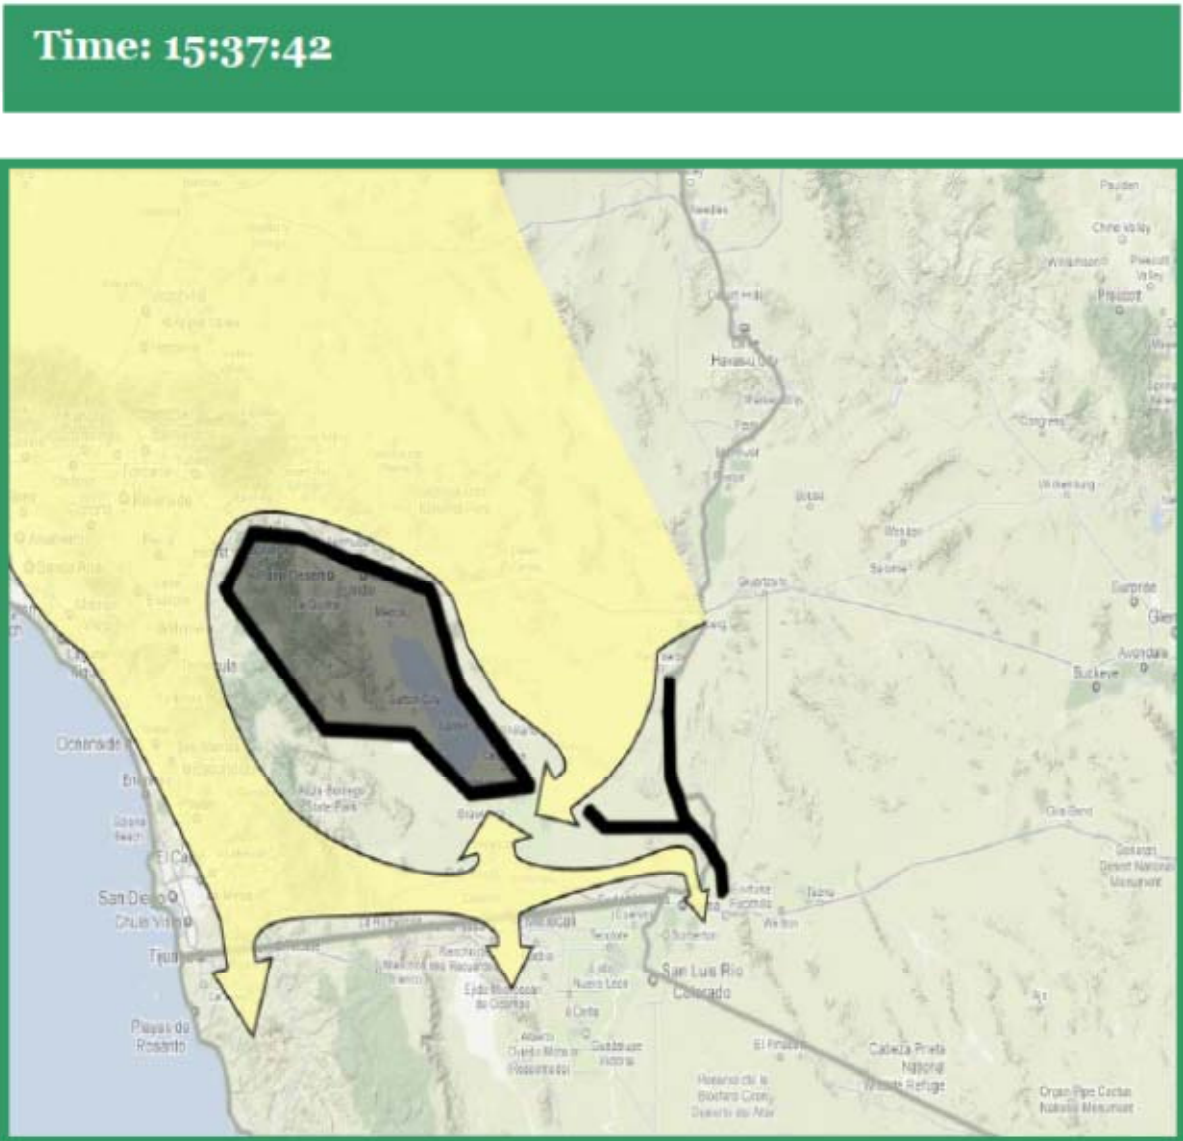
Figure 9 shows the load flows during Phase 5.

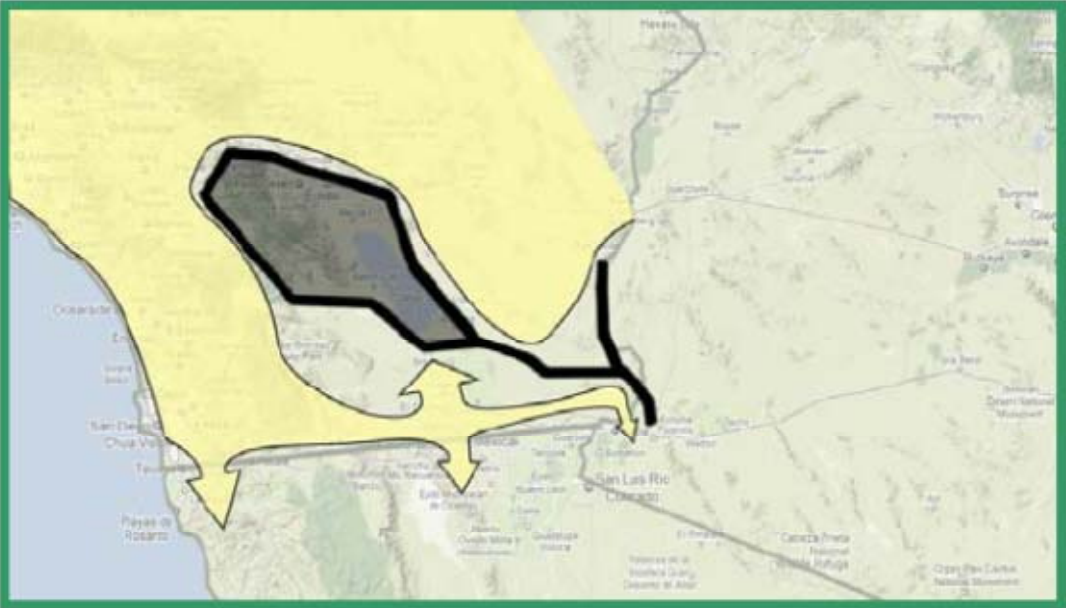
Figure 10

Time: 15:37:55.110

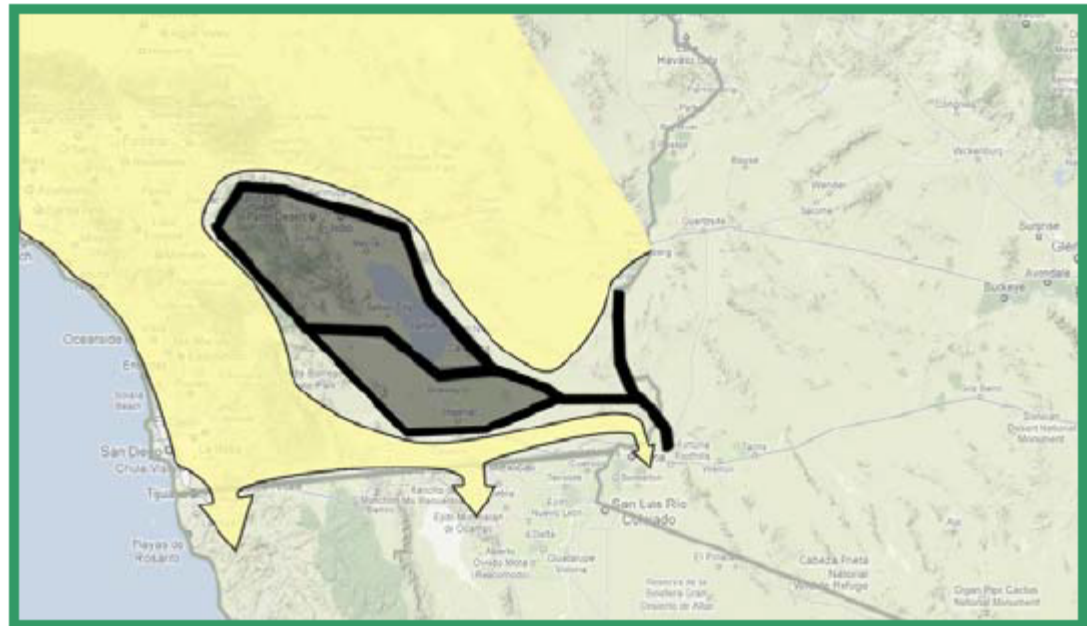
Figure 11

Time: 15:38:02.4

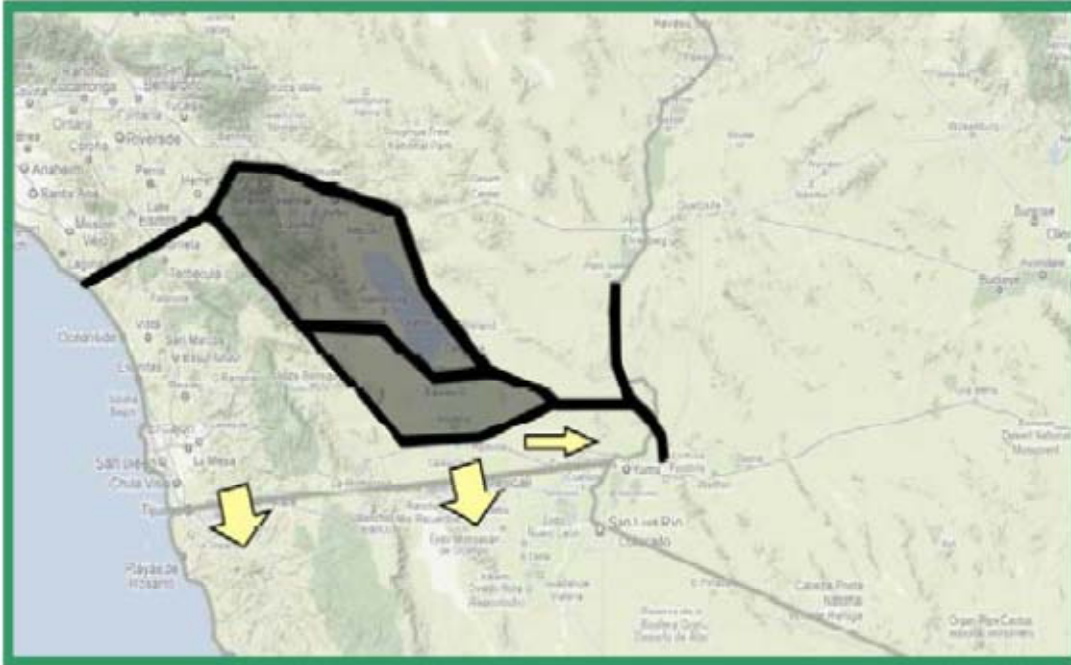
Figure 12

Time: 15:38:21.2

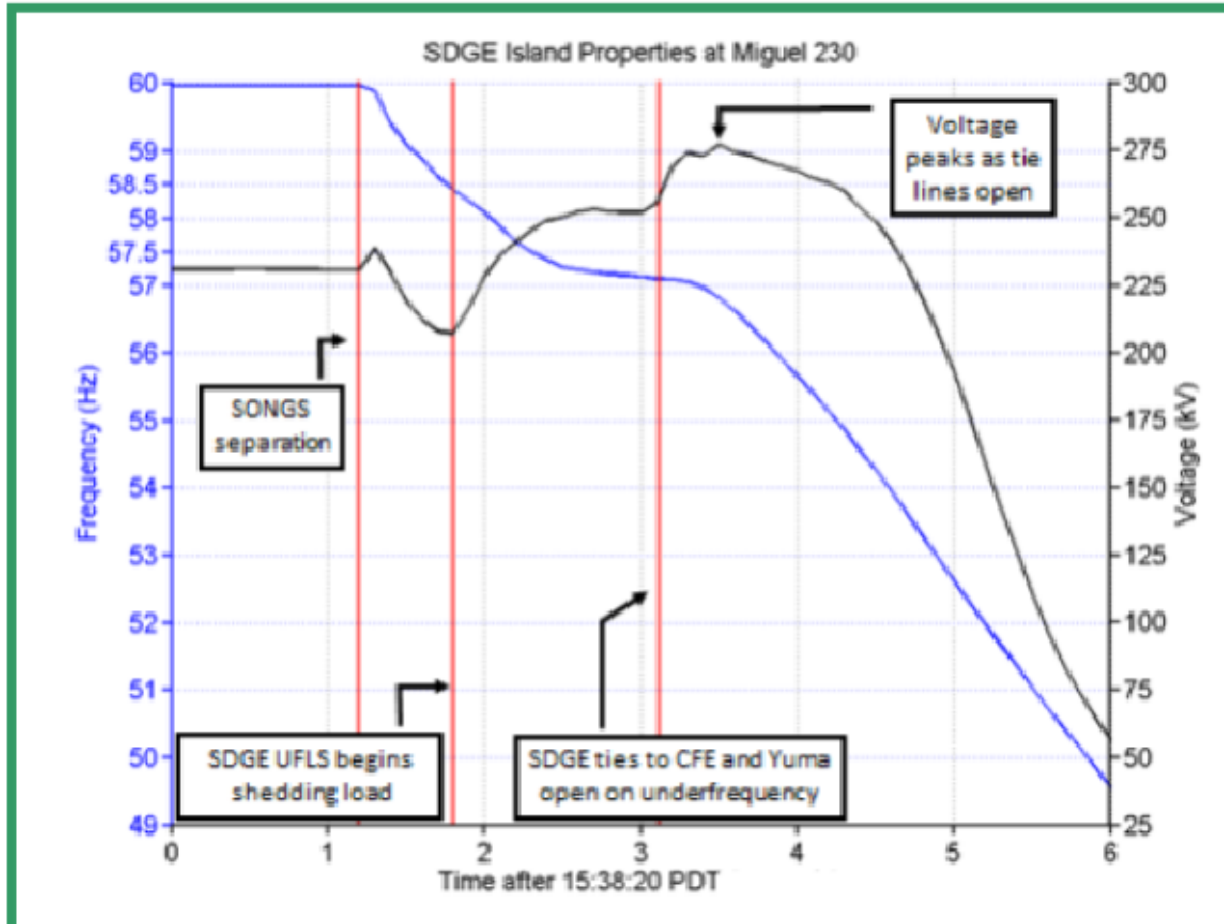
Figure 13

Frequency, Voltage in the SDG&E/Yuma/CFE Island

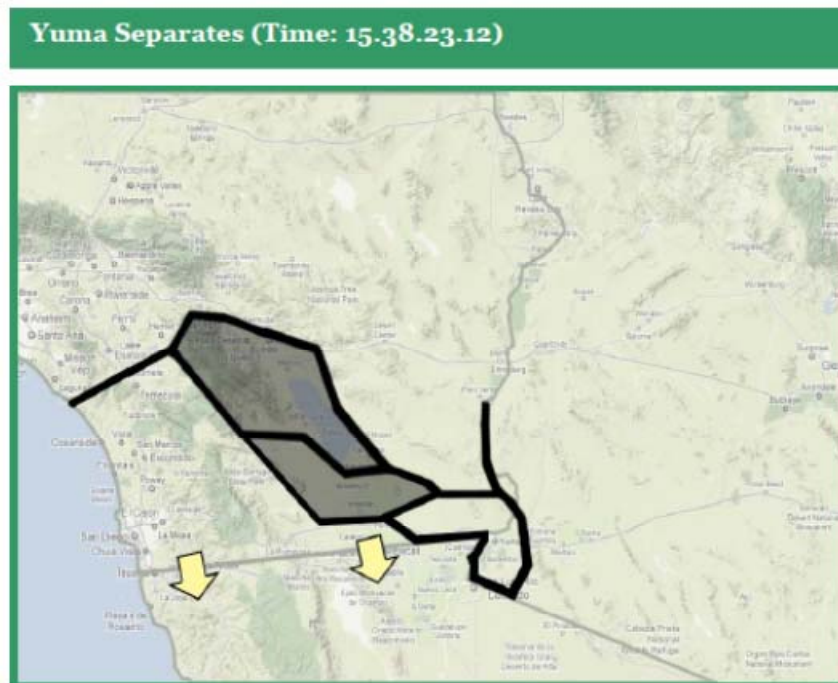
Figure 14

By 15:38:38, the SDG&E, CFE and Yuma islands had all collapsed, leaving approximately 2.7 million customers without power. Figure 14, 15, and 16 show the conditions during this phase.

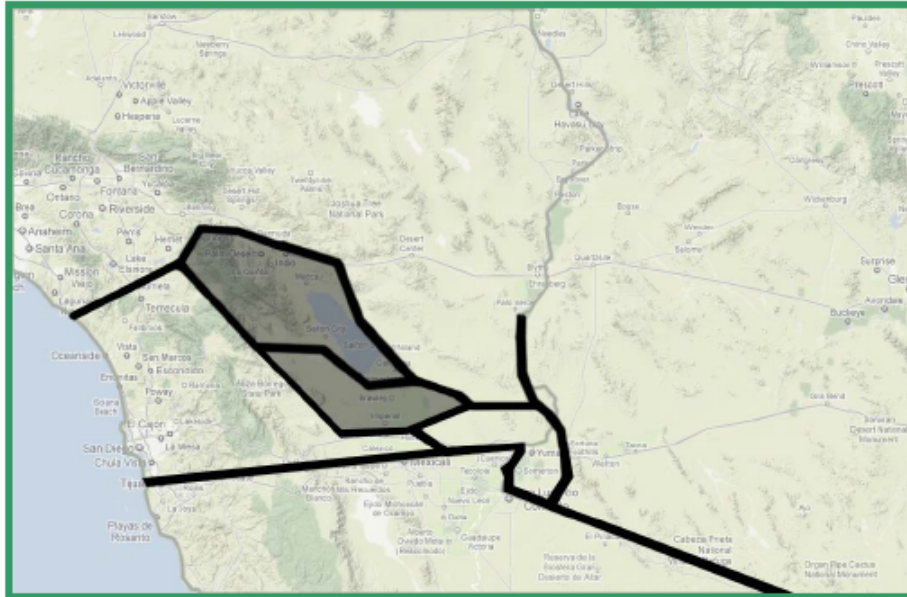
Figure 15

CFE Separates (Time: 15:38.23.13)

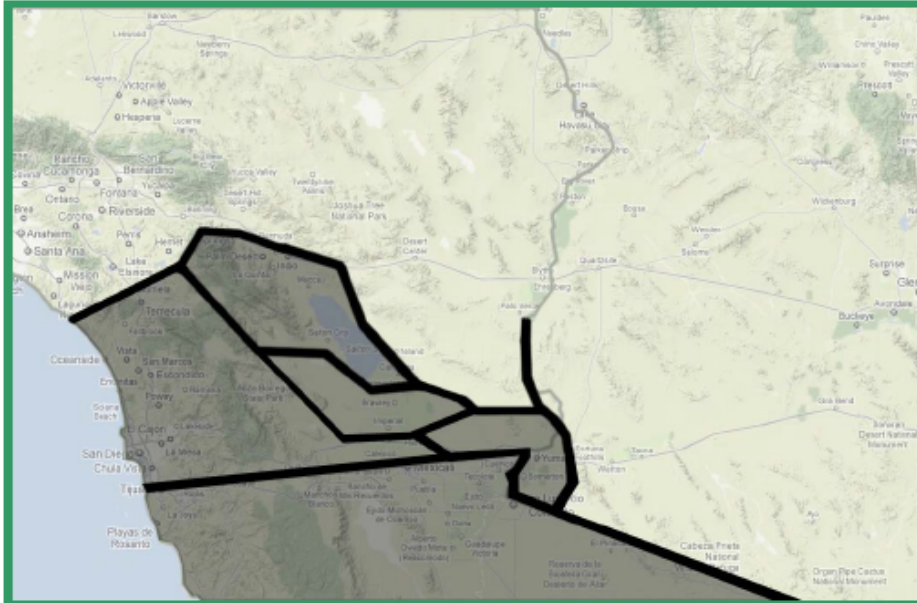
Figure 16

SDG&E, CFE, and Yuma Blackout (by 15:38.30)
