PDHonline Course G363 (4 PDH)

OSHA Fatal Facts: Fatalities Caused by Improper Work Practices

Instructor: Mark P. Rossow, Ph.D, PE Retired

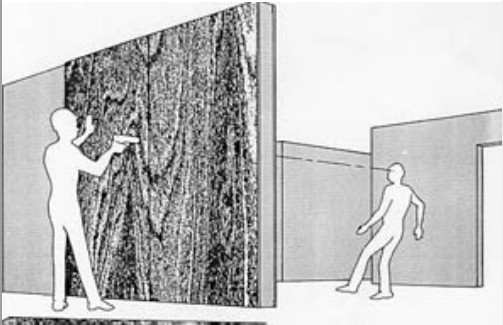
ACCIDENT SUMMARY No. 2

Accident Type:	Struck by Nail

A carpenter apprentice was killed when he was struck in the head by a nail that was fired from a powder actuated tool. The tool operator, while attempting to anchor a plywood form in preparation for pouring a concrete wall, fired the gun causing the nail to pass through the hollow wall. The nail travelled some twenty-seven feet before striking the victim. The tool operator had never received training in the proper use of the tool, and none of the employees in the area were wearing personal protective equipment.

1. Institute a program for frequent and regular inspections of the job site, materials, and equipment by a competent person(s) (1926.20(b)(2)).
2. Require employees exposed to the potential hazards associated with flying nails to use appropriate personal protective equipment. (1926.100(a) and 1926.102(a)(1)).
3. Train employees using powder actuated tools in the safe operation of the particular tool (1926.302(e)(2)).
4. Train employees operating powder actuated tools to avoid firing into easily penetrated materials (1926.302(e)(8)).

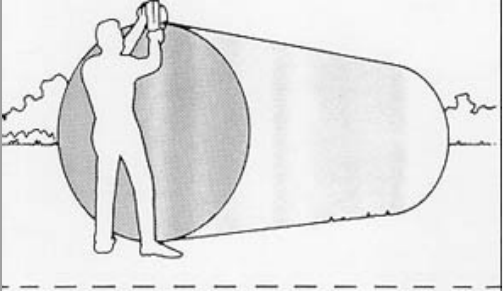
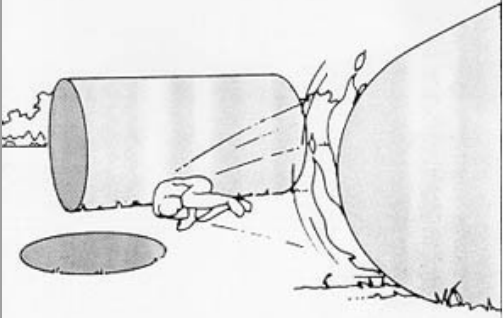
ACCIDENT SUMMARY No. 3

Accident Type:	Explosion

1. Train employees to recognize and avoid unsafe conditions when working with tanks that have previously contained flammable liquids (29 CFR 1926.21(b)(2)).

2. Follow recommended procedures set forth in American Petroleum Institute (API) Bulletin 1604, "Recommended Practice for Abandonment or Removal of Used Underground Service Station Tanks".
3. Test atmosphere in tank prior to work or cutting.
4. Establish guidelines for gas-freeing.

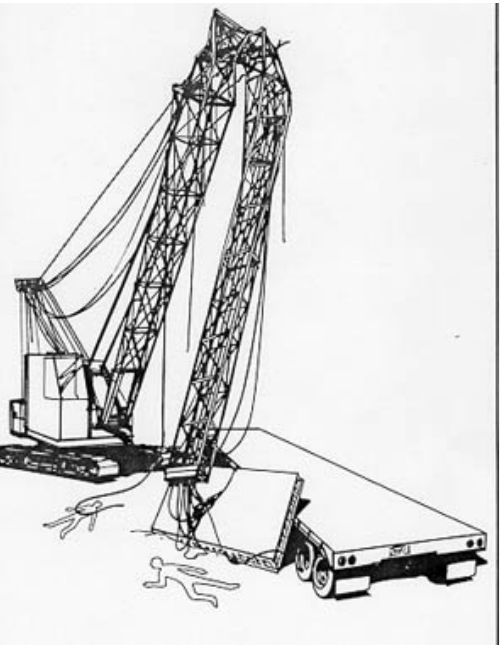
ACCIDENT SUMMARY No. 4

Accident Type:	Struck by Collapsing Crane Boom

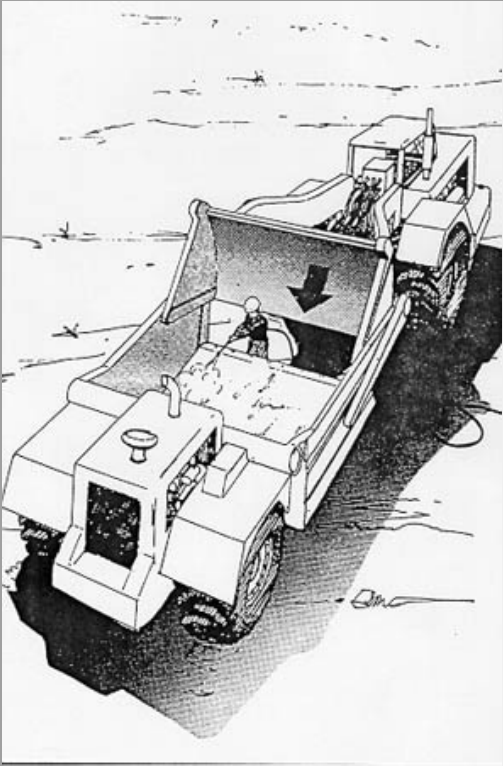
ACCIDENT SUMMARY No. 5

Accident Type:	Caught in or Between

1. Employer shall instruct each employee to recognize and avoid unsafe conditions applicable to his work environment (1926.21(b)(2)).
2. Bulldozer and scraper blades and similar equipment shall either be fully lowered or blocked when being repaired or not in use.

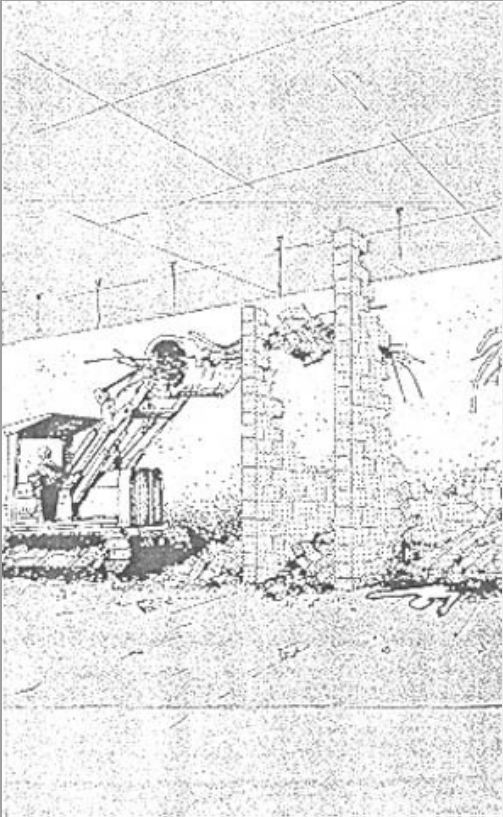
ACCIDENT SUMMARY No. 7

Accident Type:	Crushed by Falling Wall

A front end loader was being used to remove a piece of pipe and conduit near two 13 foot high nonload bearing cement block walls. The front end loader, equipped with a "clam" attachment, was pulling on pipe and conduit which ran through the upper part of the cement block walls. Pulling on the piping caused the wall to collapse, crushing and killing a laborer who was working within five feet of the base.

2. While demolition is underway, a competent person must continually inspect the operations as the work progresses to detect an hazards caused by the weakening of walls or other deterioration of materials (29 CFR 1926.859(g)).
3. In addition to these precautions, danger signs should be posted where an immediate hazard exists.

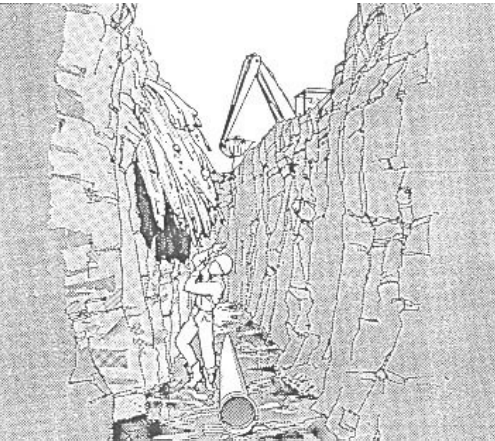
ACCIDENT SUMMARY No. 9

Accident Type:	Trench Cave-in

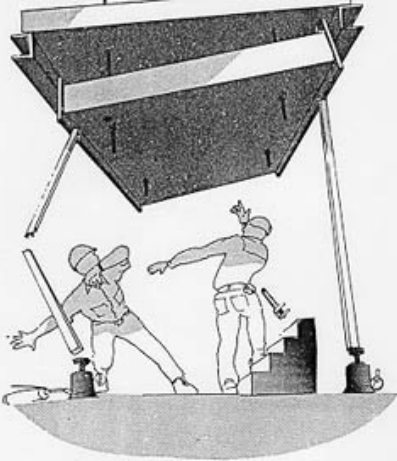
ACCIDENT SUMMARY No. 10

Accident Type:	Crushed by Falling Machinery

2. Train employees in the proper inspection techniques for hydraulic jacks and the procedures to be used during the installation of the equipment (1926.21(b)(2)).
3. Crib or block the load after raising to secure it against movement (1910.244(a)(2)(iii)).
4. Inspect hydraulic jacks at least every 6 months for deteriorated lines, leaks, mushroomed heads, etc. (1910.244(a)(2)(vi)(a)).
5. Inspect rigging equipment prior to each shift use (1926.251 (a)(1)).

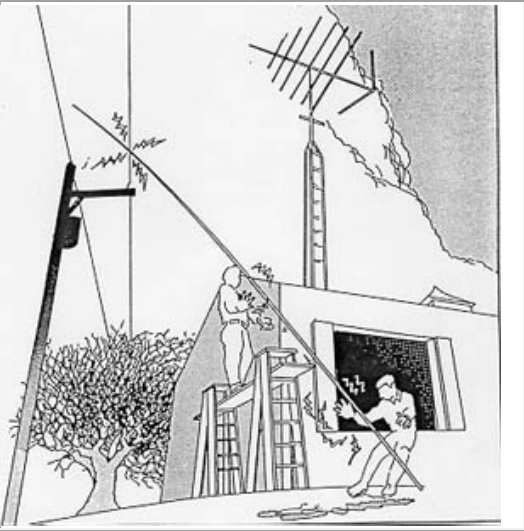
ACCIDENT SUMMARY No. 11

Accident Type:	Electrocution
Weather Conditions:	Wet Ground
Type of Operation:	Remodeling
Size of Work Crew:	2
Collective Bargaining	No
Competent Safety Monitor on Site:	Yes
Safety and Health Program in Effect:	No
Was the Worksite Inspected Regularly:	Yes
Training and Education Provided:	No
Employee Job Title:	Carpenter
Age & Sex:	33-Male
Experience at this Type of Work:	30 Days
Time on Project:	3 Days

Two employees were installing aluminum siding on a farmhouse when it became necessary to remove a 36-foot high metal pole CB antenna. One employee stood on a metal pick board between two ladders and unfastened the antenna at the top of the house. The other employee, who was standing on the ground, took the antenna to lay it down in the yard. The antenna made electrical contact with a 7200-volt power transmission line 30 feet 10 inches from the house and 23 feet 9 inches above the ground. The employee handling the antenna received a fatal shock and the other employee a minor shock.

1. Note the presence of power lines and be extremely cautious when working near them. Train employees to recognize and avoid electrical hazards (29CFR 1926.21(b)(2)).
2. Do not permit employees to work near any part of an electrical power circuit which might be contacted in the course of the work. Guard all electrical power circuits against accidental contact by insulating the circuit or deenergizing it or by other effective means that would protect the employee (29CFR 1926.400(C)(1)).

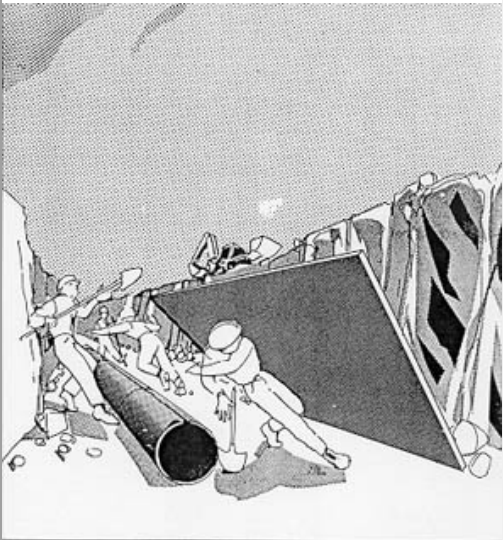
ACCIDENT SUMMARY No. 13

Accident Type:	Collapse of Shoring

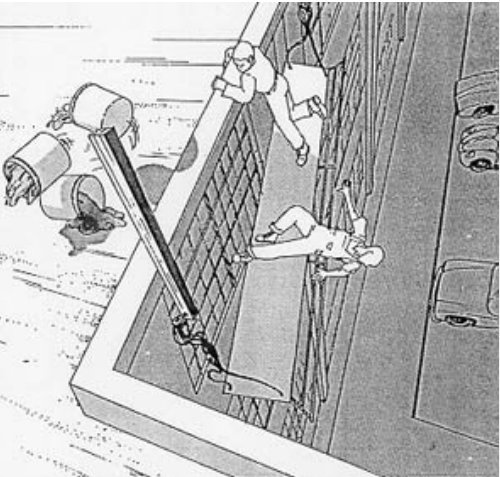
ACCIDENT SUMMARY No. 14

Accident Type:	Fall, Different Level

Two employees were painting the exterior of a three-story building when one of the two outriggers on their two-point suspension scaffold failed. One painter safely climbed back onto the roof while the other fell approximately 35 feet to his death. The outriggers were inadequately counterweighted with three 5-gallon buckets containing sand and were not secured to a structurally sound portion of the building. Neither painter was wearing an approved safety belt and lanyard attached to an independent lifeline.

1. Develop and maintain a safety and health program to provide guidance for safe operations (29 CFR 1926.20(b)(1)).
2. Institute, a program for frequent and regular inspections of the job site, as well as materials and equipment by a competent person(s) (29 CFR 1926.20(b)(2)).
3. Instruct each employee on how to recognize and avoid unsafe conditions which apply to the work and work areas (29 CFR 1926.21(b)(2)).
4. Construct scaffolds and their components so that they can support at least four times the maximum intended load (29 CFR 1926.451(a)(7)).

5. Install outrigger tiebacks of $\frac{3}{4}$ inch rope, or equivalent, to a structurally sound portion of the building to provide a secondary means of anchorage (29 CFR 1926.451(i)(4)).
6. Require employees to wear approved safety belt and lanyard equipment attached to an independent lifeline that is attached to a substantial structural member (29 CFR 1926.451(i)(8)).

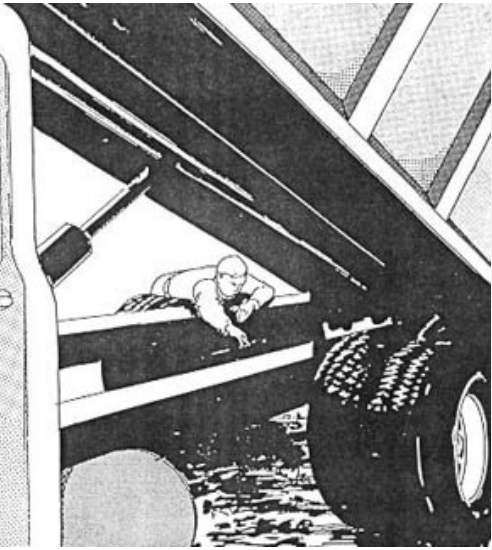
ACCIDENT SUMMARY No. 15

Accident Type:	Crushed by Dump Truck Body

Employees must be instructed to recognize and avoid unsafe conditions associated with their work (29 CFR 1926.21 (b)(2)).

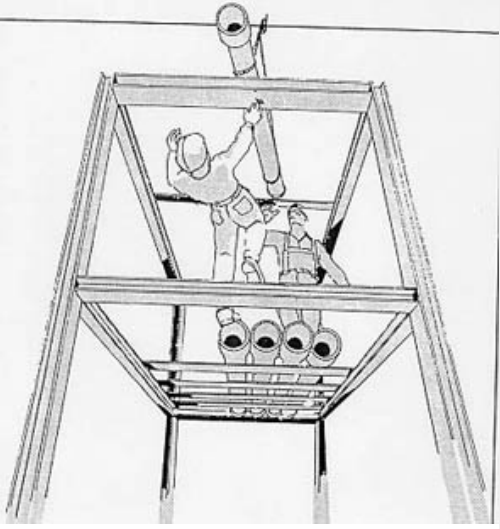
ACCIDENT SUMMARY No. 16

Accident Type:	Fall from Elevation

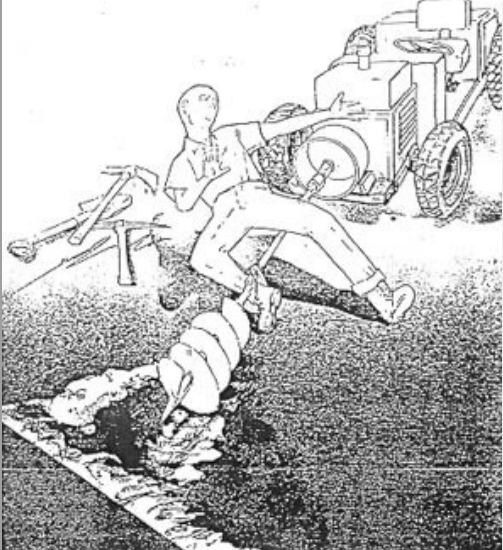
ACCIDENT SUMMARY No. 18

Accident Type:	Caught by Rotating Part

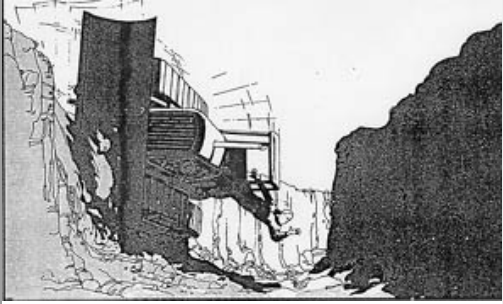
ACCIDENT SUMMARY No. 19

Accident Type:	Crushing

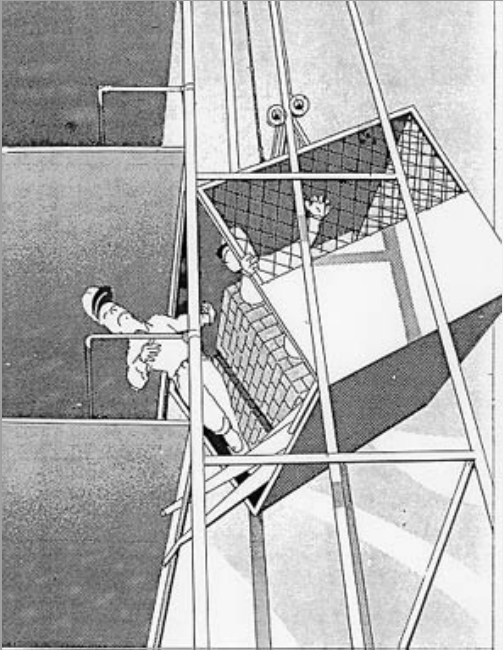
ACCIDENT SUMMARY No. 20

Accident Type:	Fall from Elevation

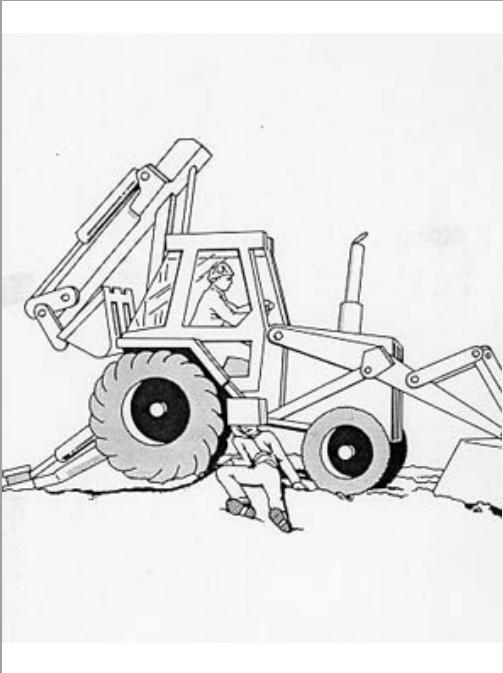
ACCIDENT SUMMARY No. 34

Accident Type:	Caught in Machinery

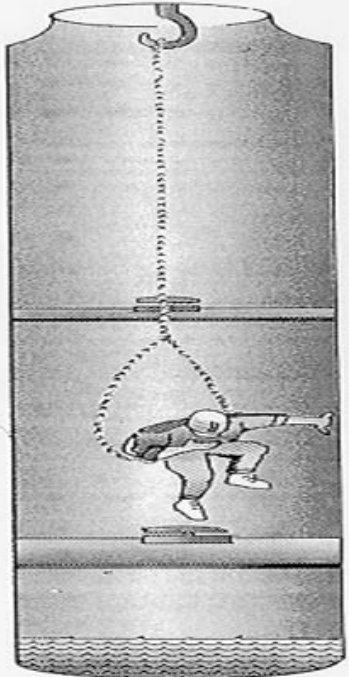
ACCIDENT SUMMARY No. 39

Accident Type:	Asphyxiation

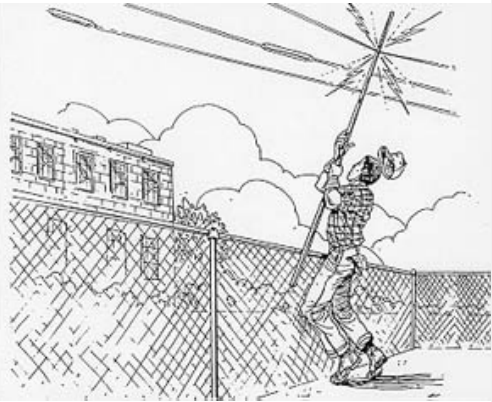
ACCIDENT SUMMARY No. 40

Accident Type:	Electrocution

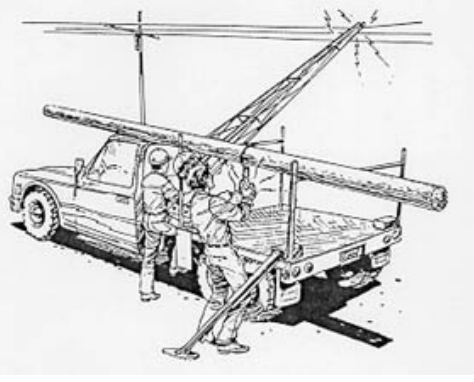
ACCIDENT SUMMARY No. 44

Accident Type:	Electrocution

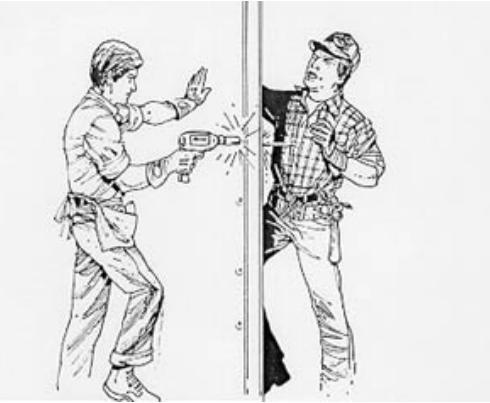
ACCIDENT SUMMARY No. 48

Accident Type:	Struck by Nail

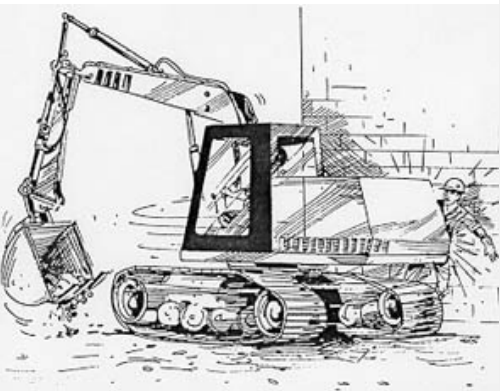
ACCIDENT SUMMARY No. 50

Accident Type:	Caught between Backhoe Superstructure and Concrete Wall

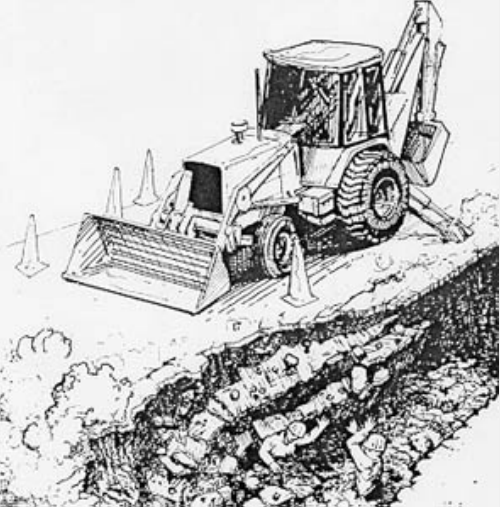
ACCIDENT SUMMARY No. 55

Accident Type:	Trench Cave-in

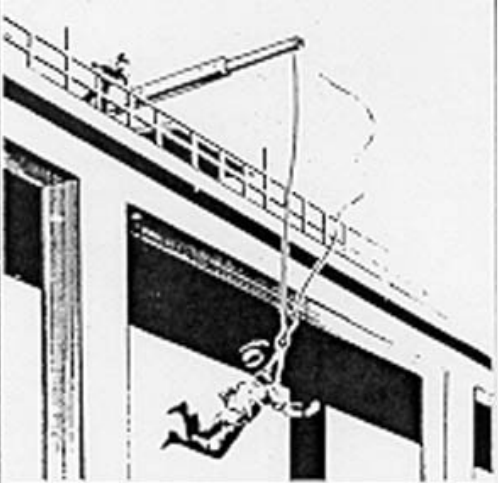
ACCIDENT SUMMARY No. 58

Accident Type:	Fall and Drowning

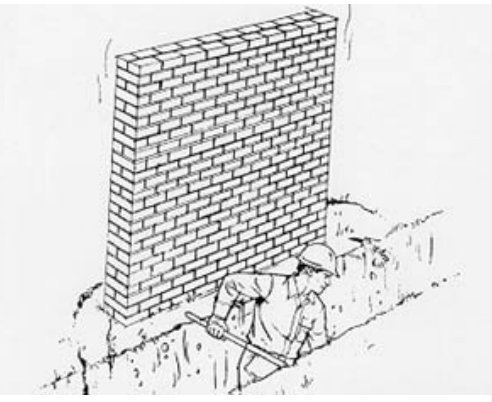
ACCIDENT SUMMARY No. 59

Accident Type:	Struck by Falling Wall

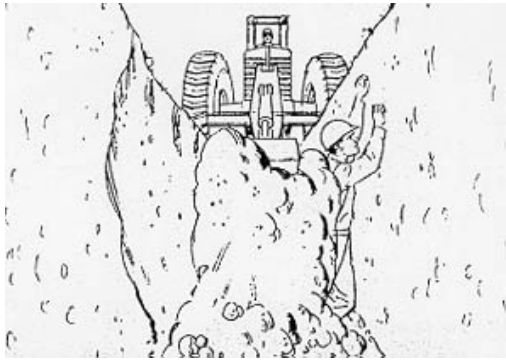
ACCIDENT SUMMARY No. 61

Accident Type:	Trench Collapse

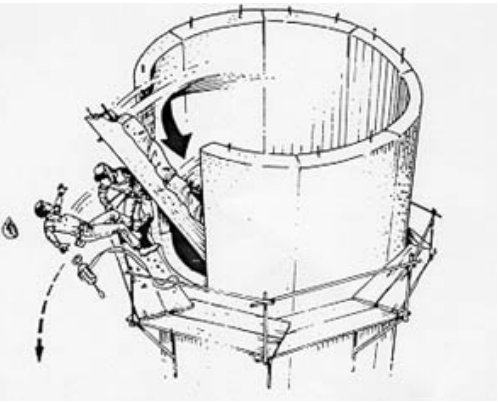
ACCIDENT SUMMARY No. 64

Accident Type:	Fall

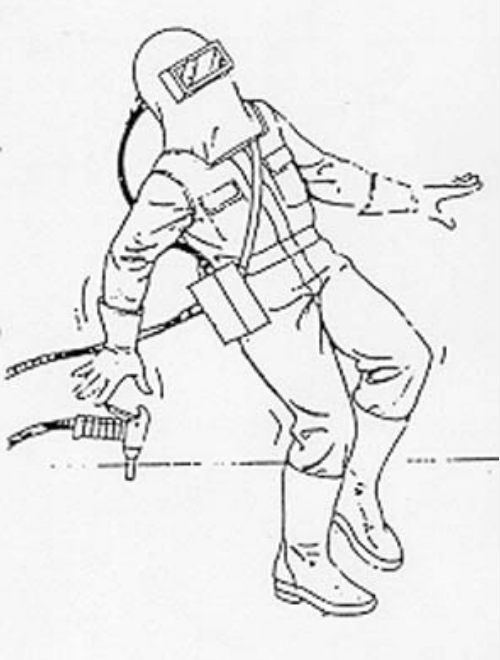
ACCIDENT SUMMARY No. 67

Accident Type:	Asphyxiation

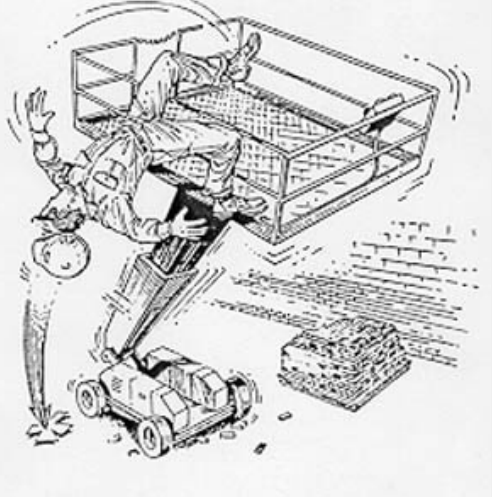
ACCIDENT SUMMARY No. 68

Accident Type:	Fall (Thrown from)

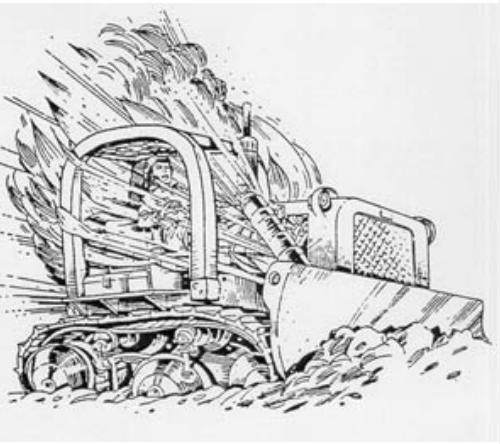
ACCIDENT SUMMARY No. 69

Accident Type:	Death due to burns
