## **Basics on Forensic Engineering - Part II**

**PRELIMINARY REPORT**

**SLIP & FALL**

TAKEN PLACE AT  
11465 Fort Caroline Lakes Drive North  
Jacksonville, Florida 32225

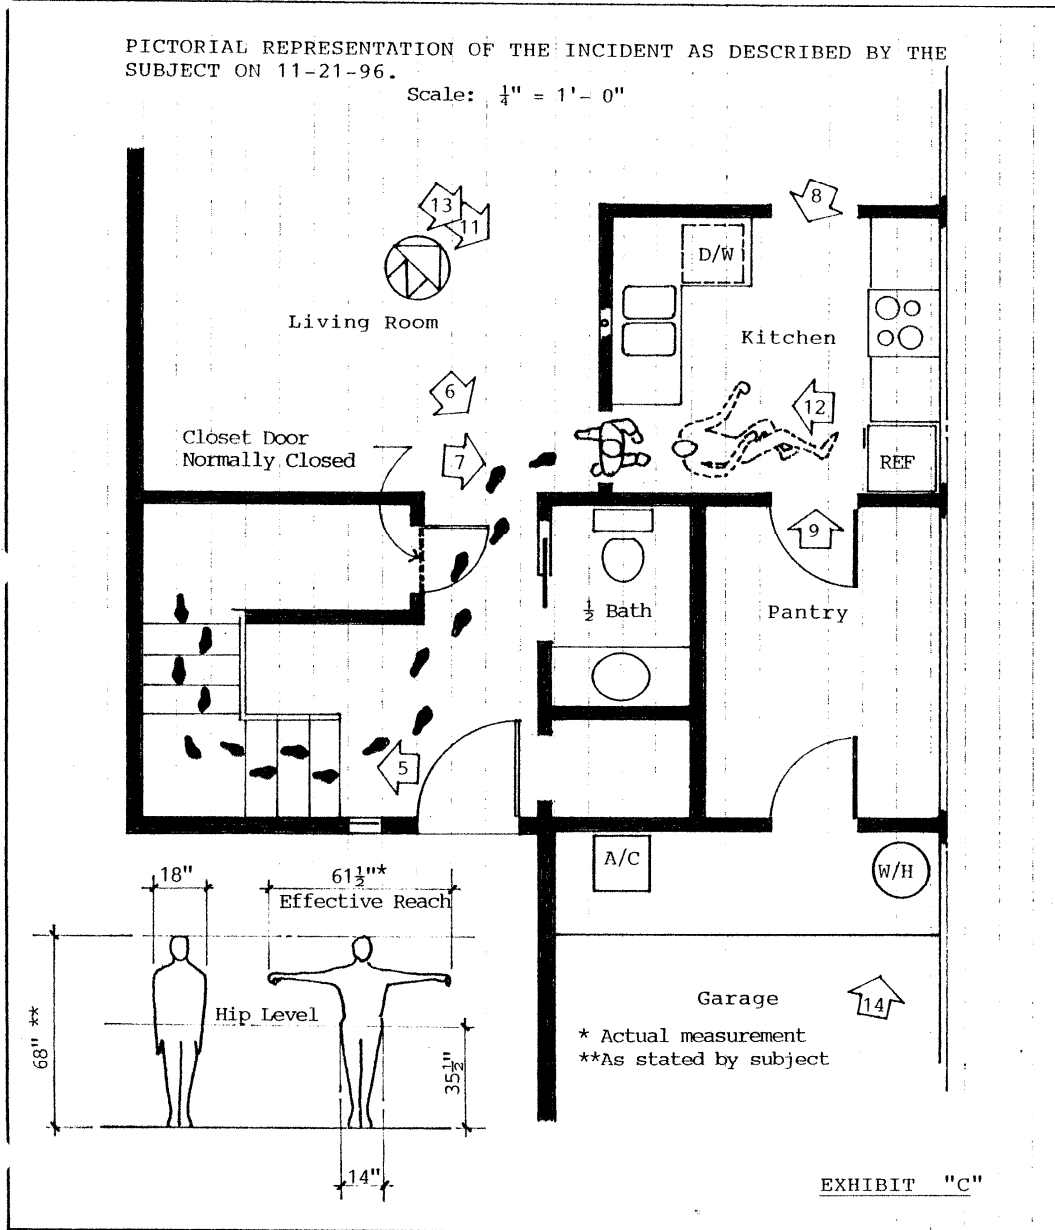
PICTORIAL REPRESENTATION OF THE INCIDENT AS DESCRIBED BY THE SUBJECT ON 11-21-96.

4.7 Exhibit C depicts the path allegedly followed by the tenant on his way to the kitchen and unto the fall site. Interestingly enough and in spite of the tenant's effective arm spread of 61½ inches shown on the same exhibit, he fell within a narrow space of 30 inches between the wall and the countertop (Exhibit D).

Verbally he indicated that "he heard noises coming from the kitchen area and he came downstairs to investigate". At the same time he marked down his footsteps along the stairway and into the kitchen. His markings have been redrawn and reproduced on the enclosed Exhibit C, as the subscriber's interpretation of his version.

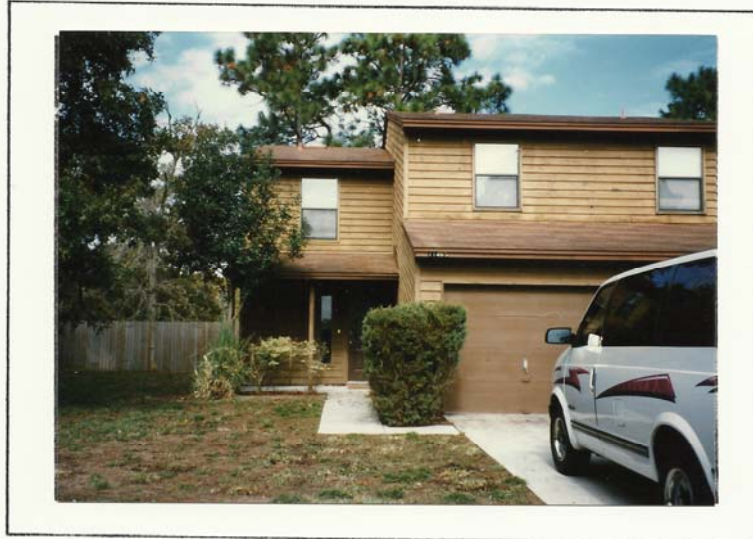
PICTURE No. 1

framed structure built in 1985 (Picture #1), with a living room, dining room, kitchen, pantry, half bath and garage on the ground floor (see Exhibit A), and three bedrooms and two bathrooms on the second floor (Exhibit B).

Subject Description: Front view of townhouse at 11465 Ft. Caroline  
Lakes Drive North, Jacksonville.

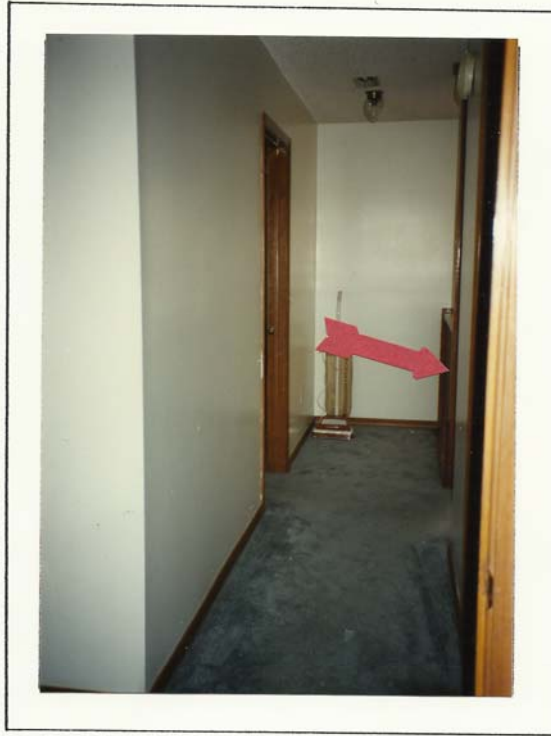
PICTURE No. 2

4.5 Following the Claimant's statements, the alleged path prior to the fall was then examined. Pictures #2 through #5 depict the stairway which led the tenant to the downstairs area. Picture #6 shows the opening passed by the tenant on his way into the kitchen area.

Subject Description: Second floor hallway. Arrow indicates location of stairway leading down to ground floor.

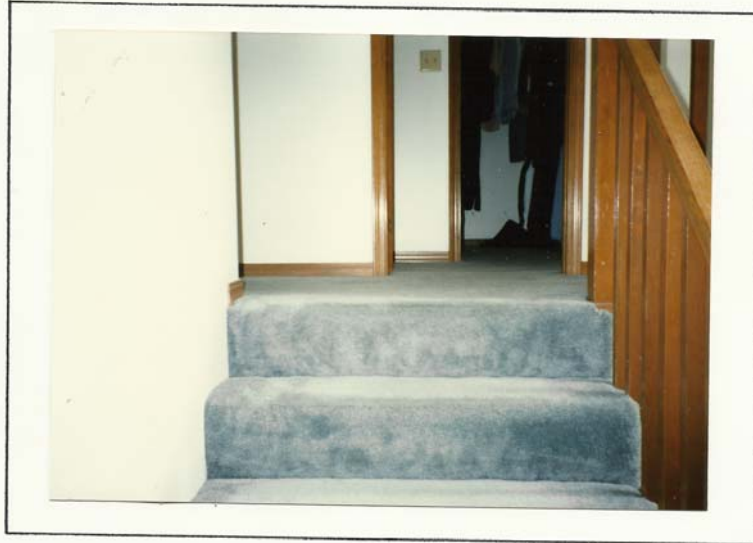
PICTURE No. 3

Subject Description: Upper flight of stairway.

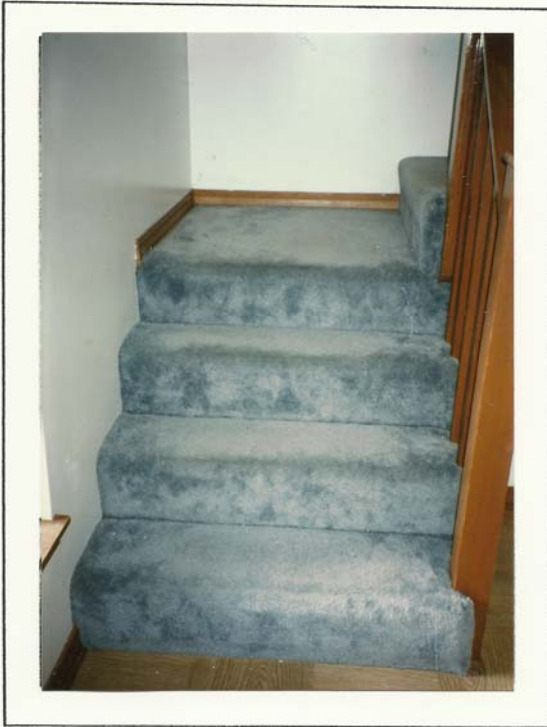
PICTURE No. 5

Subject Description: Stairway lower flight.

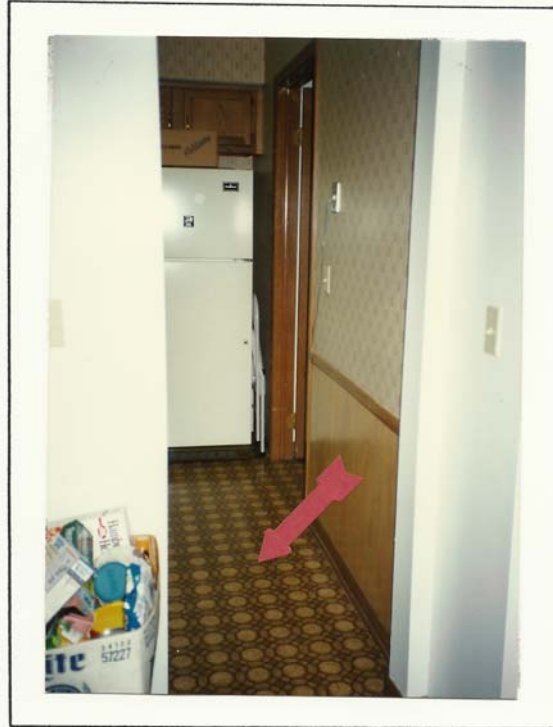
PICTURE No. 7

4.6 Pictures #7 and #8 show the location of the alleged slip and fall as described by the tenant on his interview as transcribed on Appendix I.

Subject Description: View of kitchen from the living room. Arrow indicates location of alleged fall.

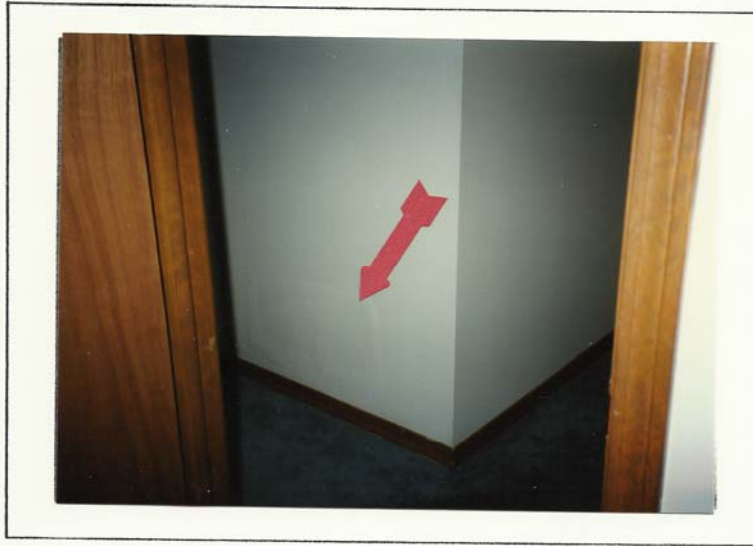
PICTURE No. 10

4.8 Picture #10 shows the location where the plumber, or more appropriately Seminole Plumbing Company, cut through the wall to locate and repair a section of a leaking pipe. Field collected evidence indicated that the water supply and distribution system was installed using copper pipes. Such material although successfully used in many areas of the country, in Jacksonville and South Georgia it is known to fail at the joints. A request filed with the utilities company came to verify such a condition which is clearly indicated on their statement letter dated November 16, 1996 which has been enclosed herein as Exhibit E.

Subject Description: Second floor hallway. Arrow indicates location of plumbing repairs.

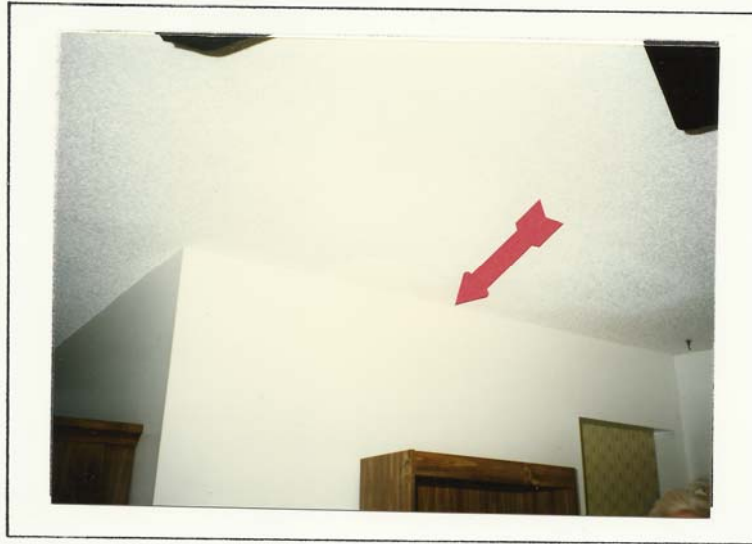
PICTURE No. 11

4.9 Areas around and in the immediate proximity of the plumbing wall (where the plumbing stack was allegedly located) were carefully examined for water damage or water stains, none was found. Both, ceilings (Pictures #11 and #12) and floor (Pictures #6 and #13) showed no evidence of water damage

Subject Description: Ceiling condition in the vicinity of the plumbing wall. An arrow indicates approximate location of the plumbing stack.

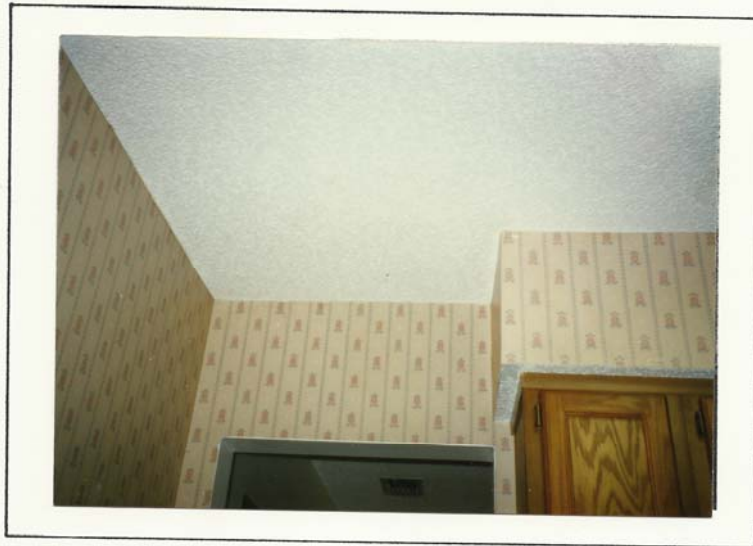
PICTURE No. 12

Subject Description: Condition of kitchen ceiling above location of alleged fall.

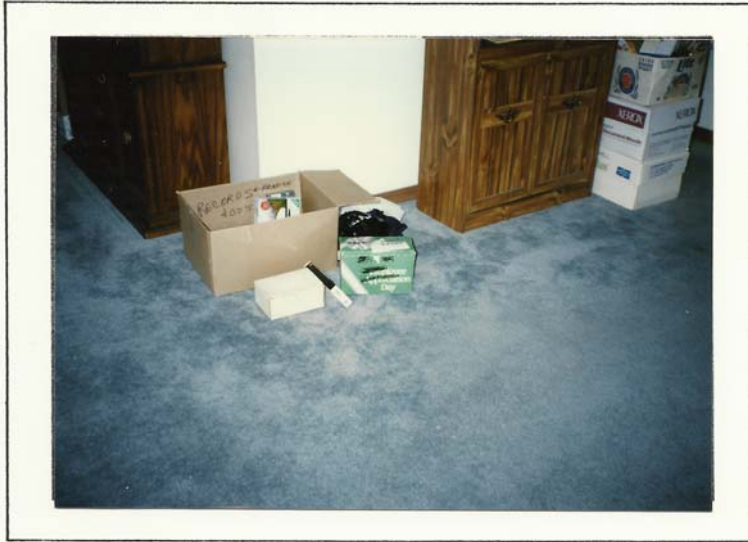
PICTURE No. 13

Subject Description: Condition of carpeting in the adjacent areas to the plumbing wall.

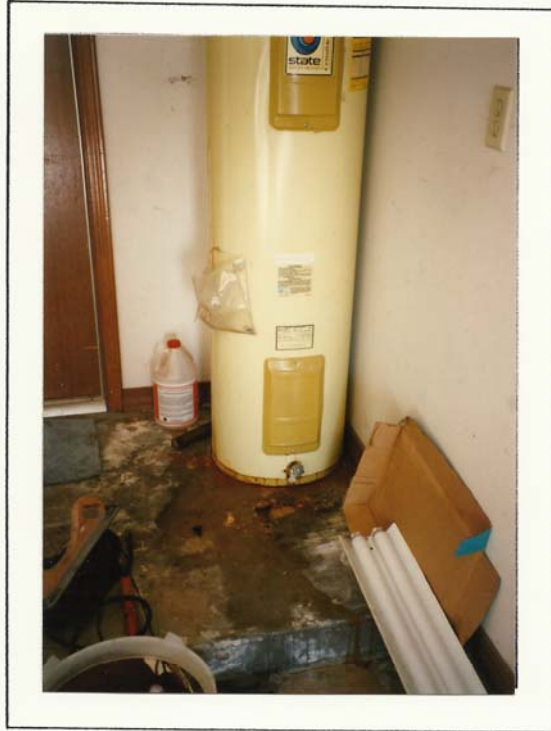
PICTURE No. 14

4.3 During this first visit a few photographs were taken in the kitchen area (Pictures #8 and #9) and the garage area where the water heater was located (Picture #14). Profuse water stains were observed coming out of the water heater indicating a leaky unit. As determined later during our investigation, the broken water heater was a prior event and unrelated to the current incident.

Subject Description: View of water heater.
