**PDHonline Course R133 (2 PDH)**

# **Ethical Issues from the Kansas City Hyatt Hotel Collapse**

*Instructor: J. Paul Guyer, P.E., R.A., Fellow ASCE, Fellow AEI*

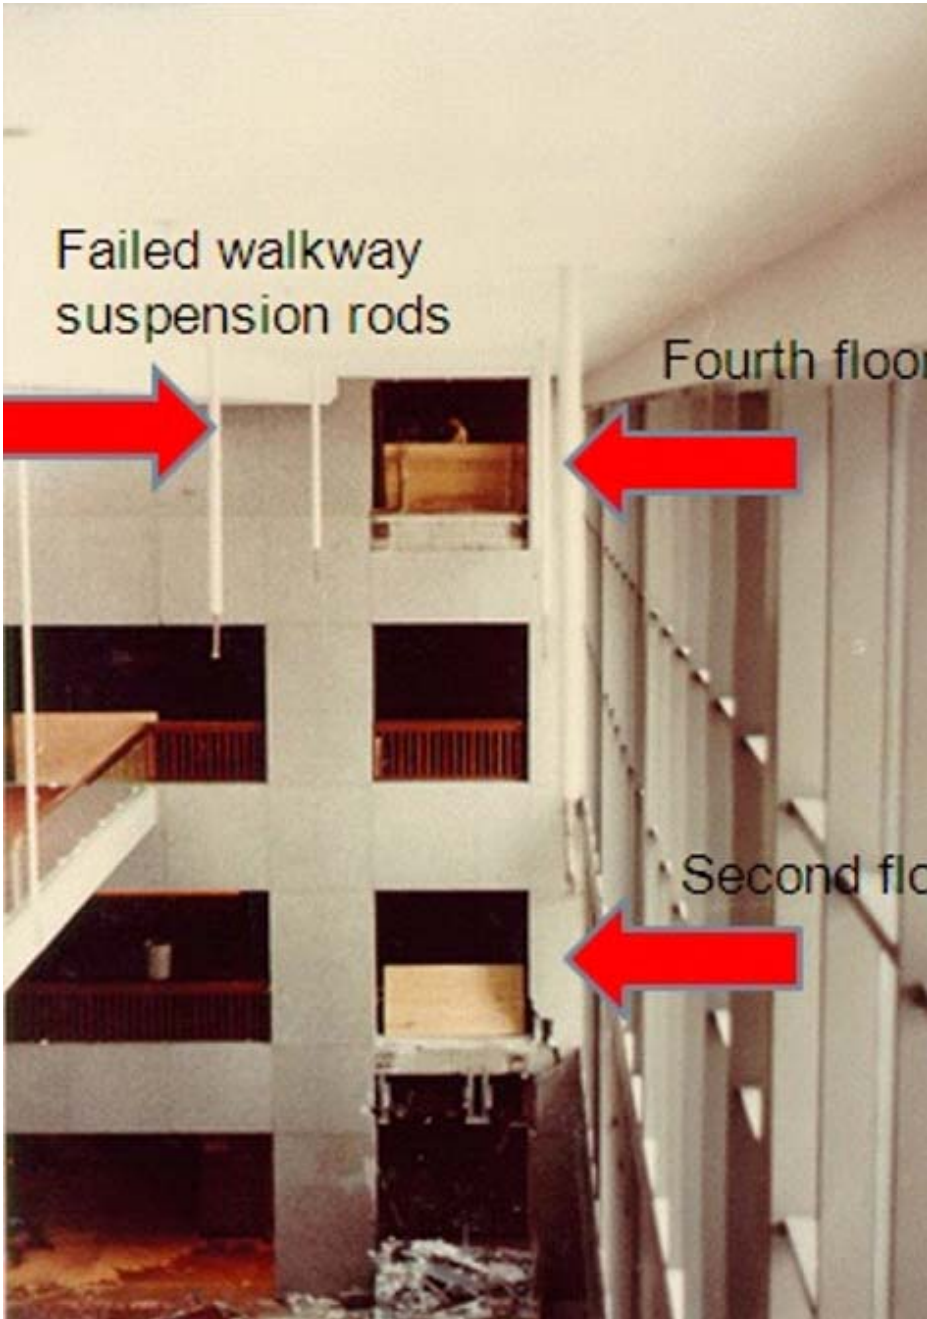
The fourth floor walkway failed, collapsed onto the second floor walkway, both crashed to the lobby floor, and 114 people were killed and 200 injured.

Figure 9  
Collapsed Walkways at 2<sup>nd</sup> and 4<sup>th</sup> Floors

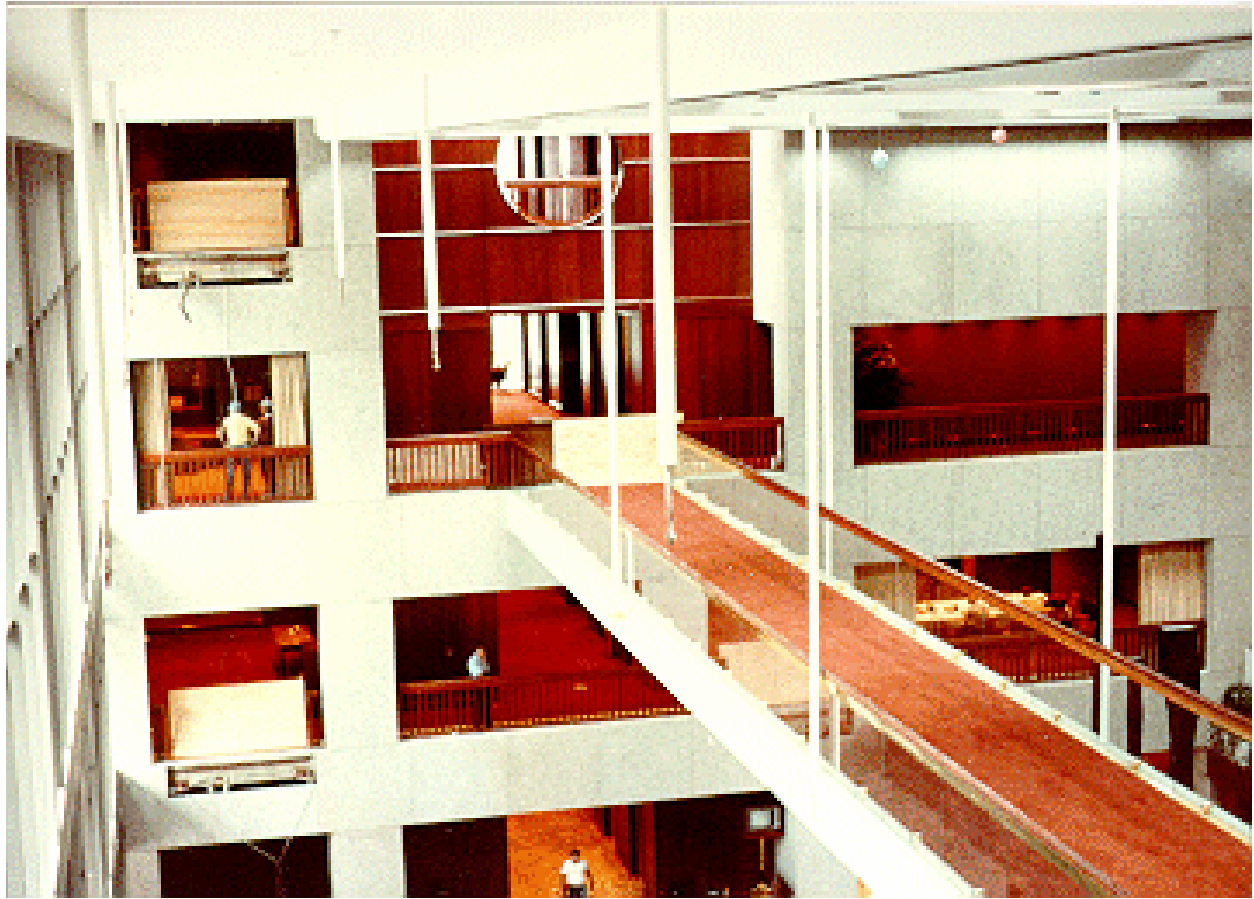
The third walkway, at the third floor, was offset from the other two and was not involved in the failure.

Figure 10  
Surviving 3<sup>rd</sup> Floor Walkway

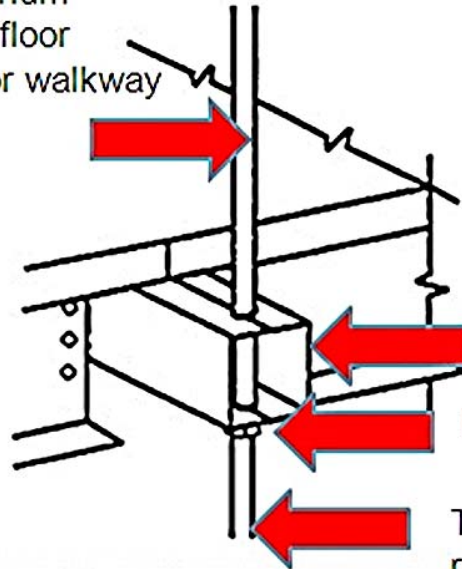
Figure 13  
The Structural Engineer's Original Design

**First**, the Gillum design required continuous suspension rods approximately 40-feet long. Havens determined these would be unacceptably expensive to procure and install.

**Second**, the suspension rods would have to be threaded for approximately 30-feet of their length in order to install the nut on the rod that supported the fourth floor walkway. This was determined by Havens to be unacceptably expensive to fabricate and install.

1-1/4" continuous suspension rod from 4<sup>th</sup> floor atrium ceiling, through 4<sup>th</sup> floor walkway, to 2<sup>nd</sup> floor walkway

4<sup>th</sup> floor walkway deck structure (connection similar at 2<sup>nd</sup> floor walkway)

Box beam fabricated of two 8x8.5 MC channels welded toe-to-toe

Box beam rests on nut

Threading of rod required from 2<sup>nd</sup> to 4<sup>th</sup> floor walkways

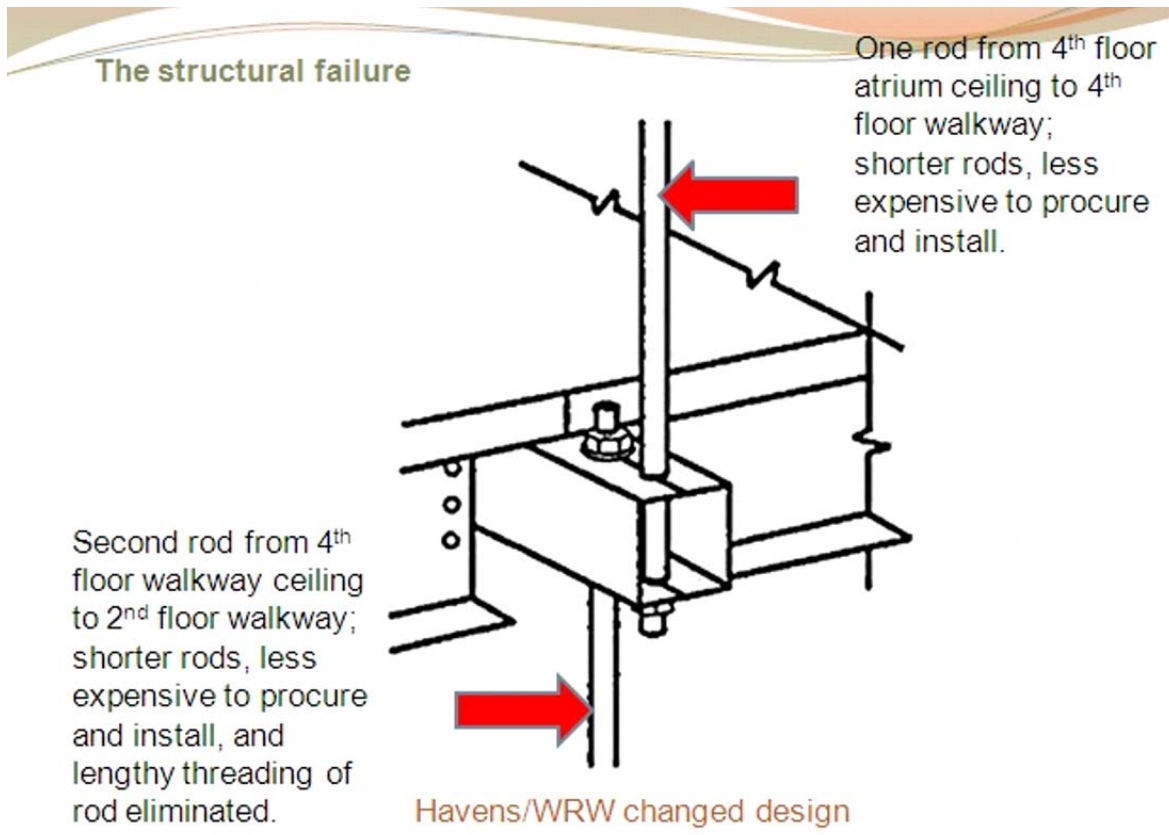
The cause of the failure was a change made by the steel detailer (WRW, a sub-contractor to Havens, which in turn was a sub-contractor to Eldridge) to the suspension rods design shown on the structural engineer Gillum's drawings.

Figure 14  
The change made by the Steel Fabricator-Erector/Detailer

- **the design change which led to the failure at the box beam-nut-suspension rod connection**

THE NBS specifically concluded that “Under the original hanger rod arrangement (continuous rod) the box beam-hanger rod connections as shown on the contract drawings *would have had the capacity to resist the loads estimated to have been acting at the time of collapse.*”

**6.1.1** Havens/WRW had properly designed the changed detail

**6.1.2** The improperly changed detail had been noted and corrected by Gillum

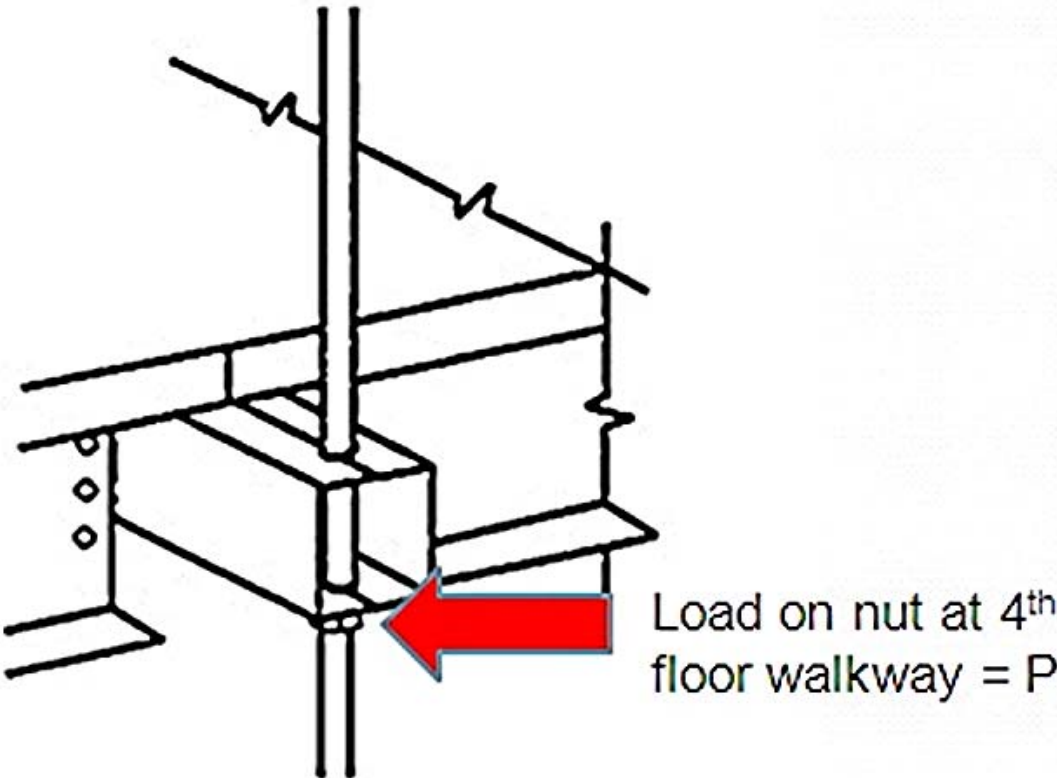
Figure 15  
The Structural Engineer's Original Design

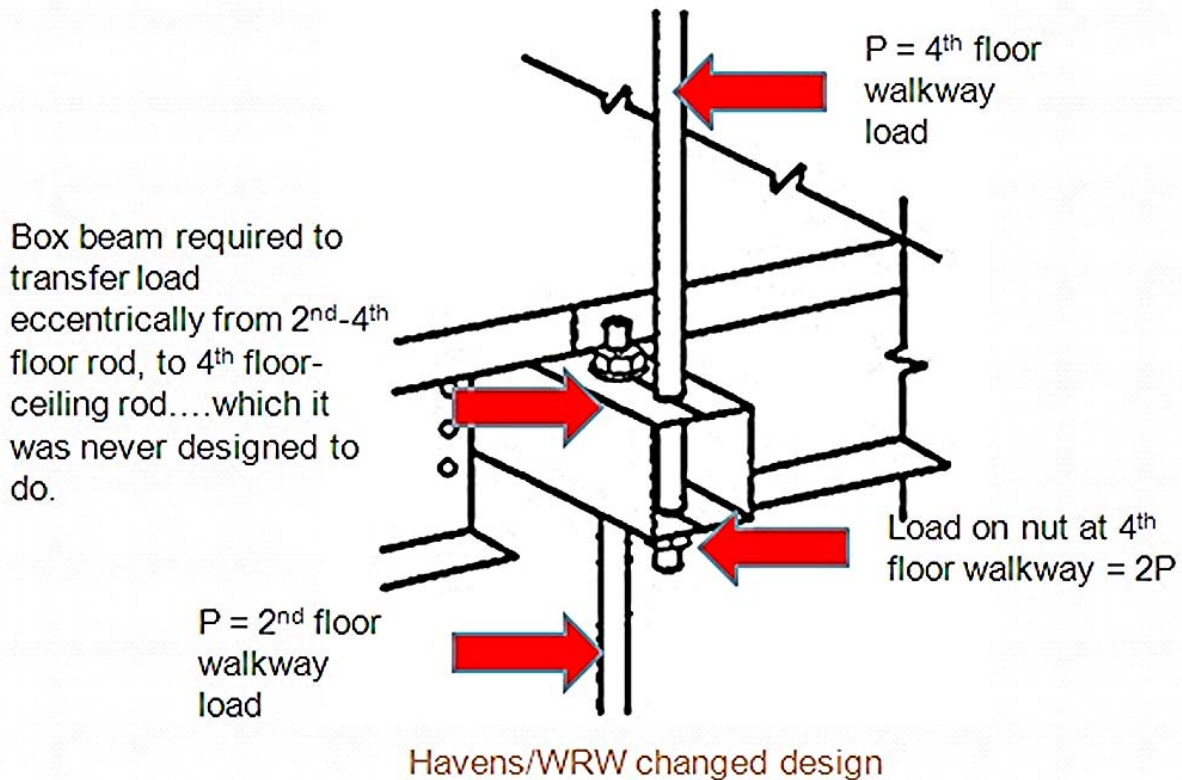
Figure 16  
The change made by the Steel Fabricator-Erector/Detailer
