Ethical Issues from the Kansas City Hyatt Hotel Collapse (Video Course)

ETHICAL ISSUES FROM THE KANSAS CITY HYATT HOTEL COLLAPSE

In July 1981 the most disastrous structural engineering failure in U.S. history took place in Kansas City. Two interior walkways in the lobby atrium collapsed at the recently constructed Hyatt Regency Hotel in Kansas City, with a resulting loss of 114 lives and injuries to 200 others. This is the story of that tragic event.

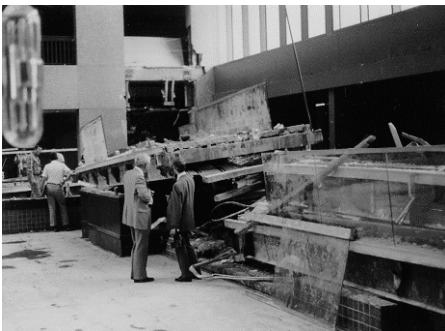
□ Here is what the incident scene looked like....

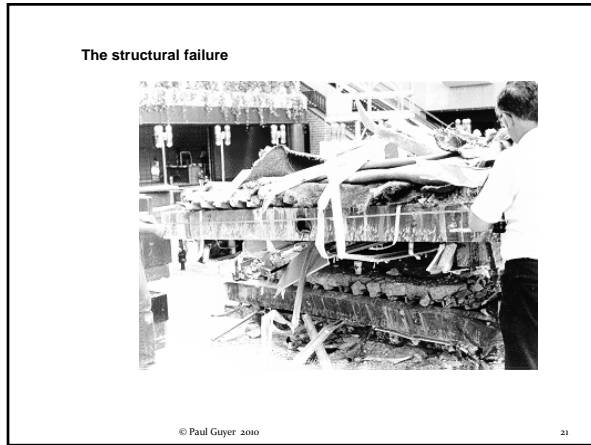
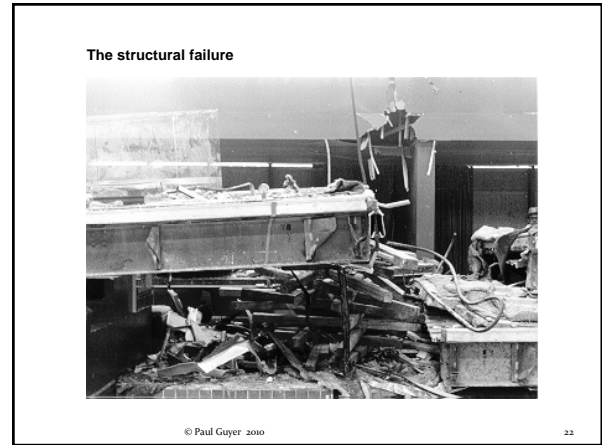
- ❑ What went wrong?
- ❑ One theory suggested at an early stage was that the people dancing on the fourth floor walkway induced harmonic vibrations that reached critical amplitude that resulted in failure. This theory was disregarded when evidence of a different cause became apparent.
- ❑ The cause of the failure was a change made by the steel detailer (WRW, a sub-contractor to Havens, which in turn was a sub-contractor to Eldridge) to the suspension rods design shown on the structural engineer Gillum's drawings.
- ❑ Why did WRW, at Haven's instigation, make this change? Because of two *constructability* issues....

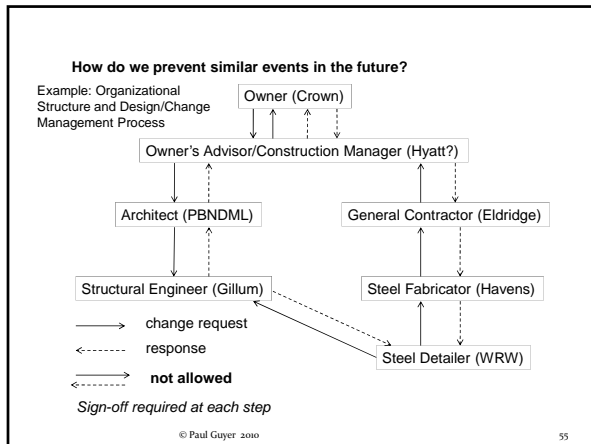
- ❑ The cause of this tragedy was an ineffective change management system. To prevent this type of tragedy in the future, three things are needed:
 - **A clearly defined organizational structure**
 - **Clearly defined and enforced process procedures**
 - **Independent constructability review**
- ❑ **Organizational Structure and Procedures:** Here is what the design and construction organizational structure and decision-making process should look like....

- Is this structure/procedure inefficient? No. Here is why...
 - It forces as many "sets of eyes" as possible to look at contract documents (drawings, specifications, changes)
 - Although team members have different levels of expertise, all have *some level* of expertise, and therefore can potentially spot errors and questionable actions
 - The requirement for "sign-off" at each level forces team members to *take things seriously* and accept some level of responsibility
 - The owner's participation in this process is essential *because only the owner has budget authority*
 - There are well accepted methodologies where time is critical to issue directives with post-facto sign offs
