Engineering Ethics Case Study: The Taum Sauk Reservoir Failure

Taum Sauk Upper Dam Breach FERC No. P-2277

Technical Reasons for the Breach
of December 14, 2005

FERC Independent Panel of Consultants (IPOC)

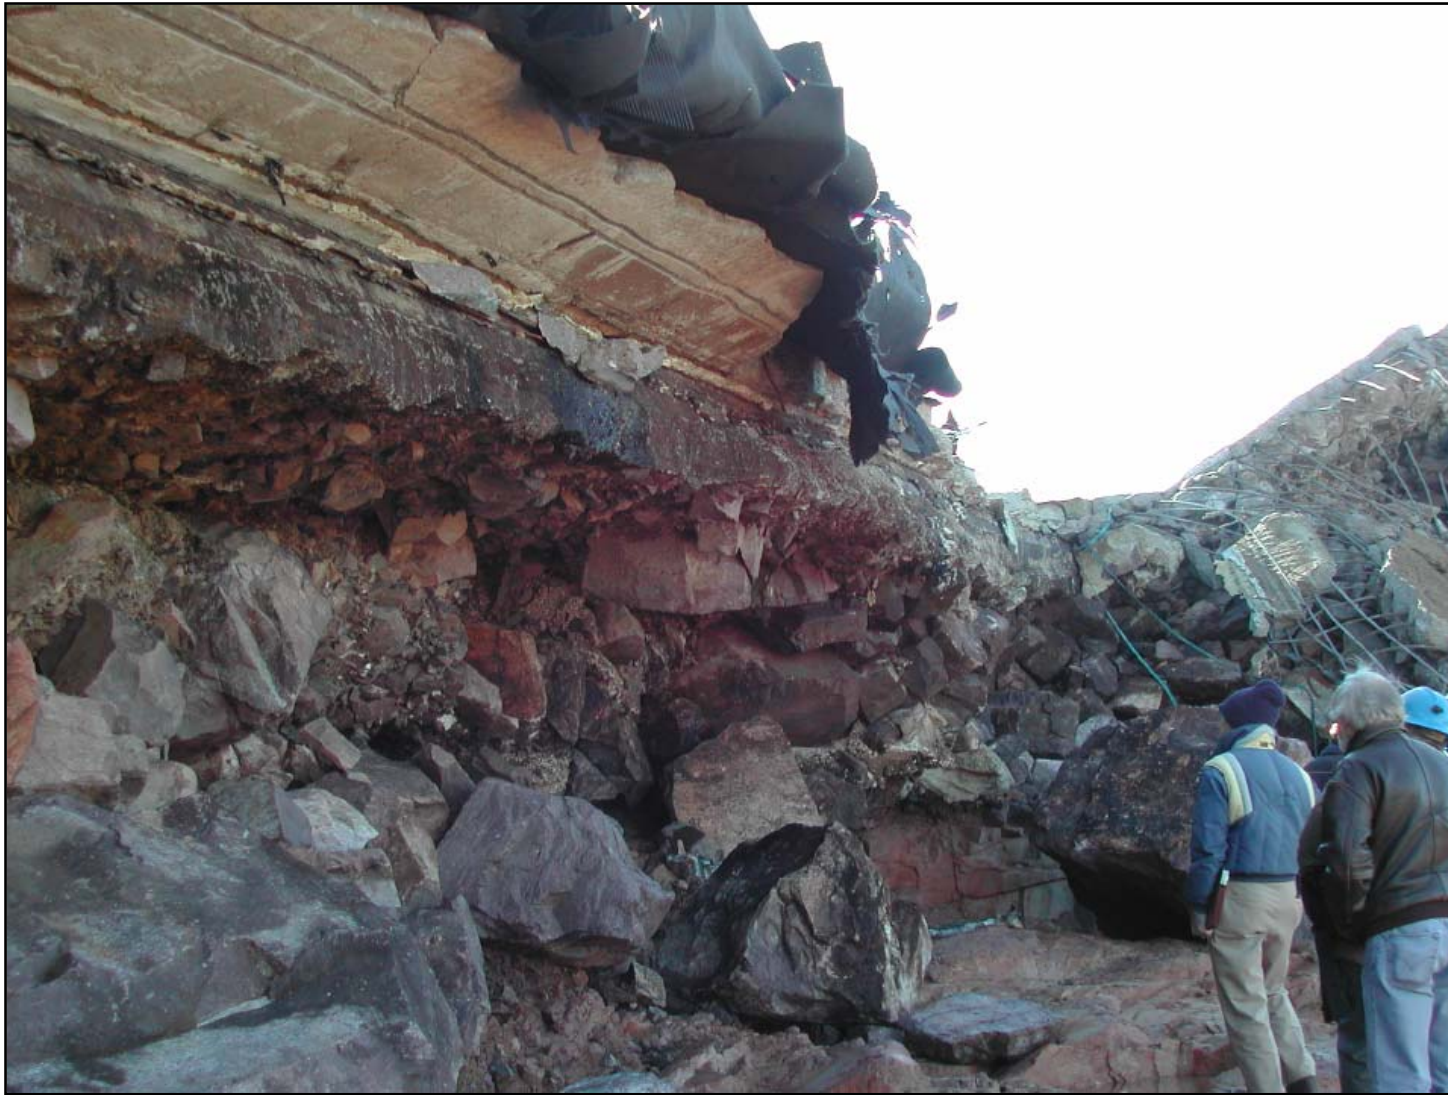
Figure 6-7

Figures 6-6, 6-7, and 6-8 show three views of the area under the base of the bottom of the face slab and plinth. The most glaring issue revealed by Figure 6-6 for example is that it appears that the plinth was not taken down to the rhyolite bedrock shown at the bottom of the photo. This is not considered good practice today and it was not good practice in 1963. Figures 6-7 and 6-8 show similar construction along the plinth area. This observation makes it consistent to rationalize the blow outs and holes that had to be repaired upstream of Panels 90-95 in 1963 and 1964. It definitely appears from these inspections that the plinth was not extended to bedrock for this dam, at least in the breach area.

Rockfill between top of rock and base of plinth,
note reddish grout in rockfill beneath the plinth

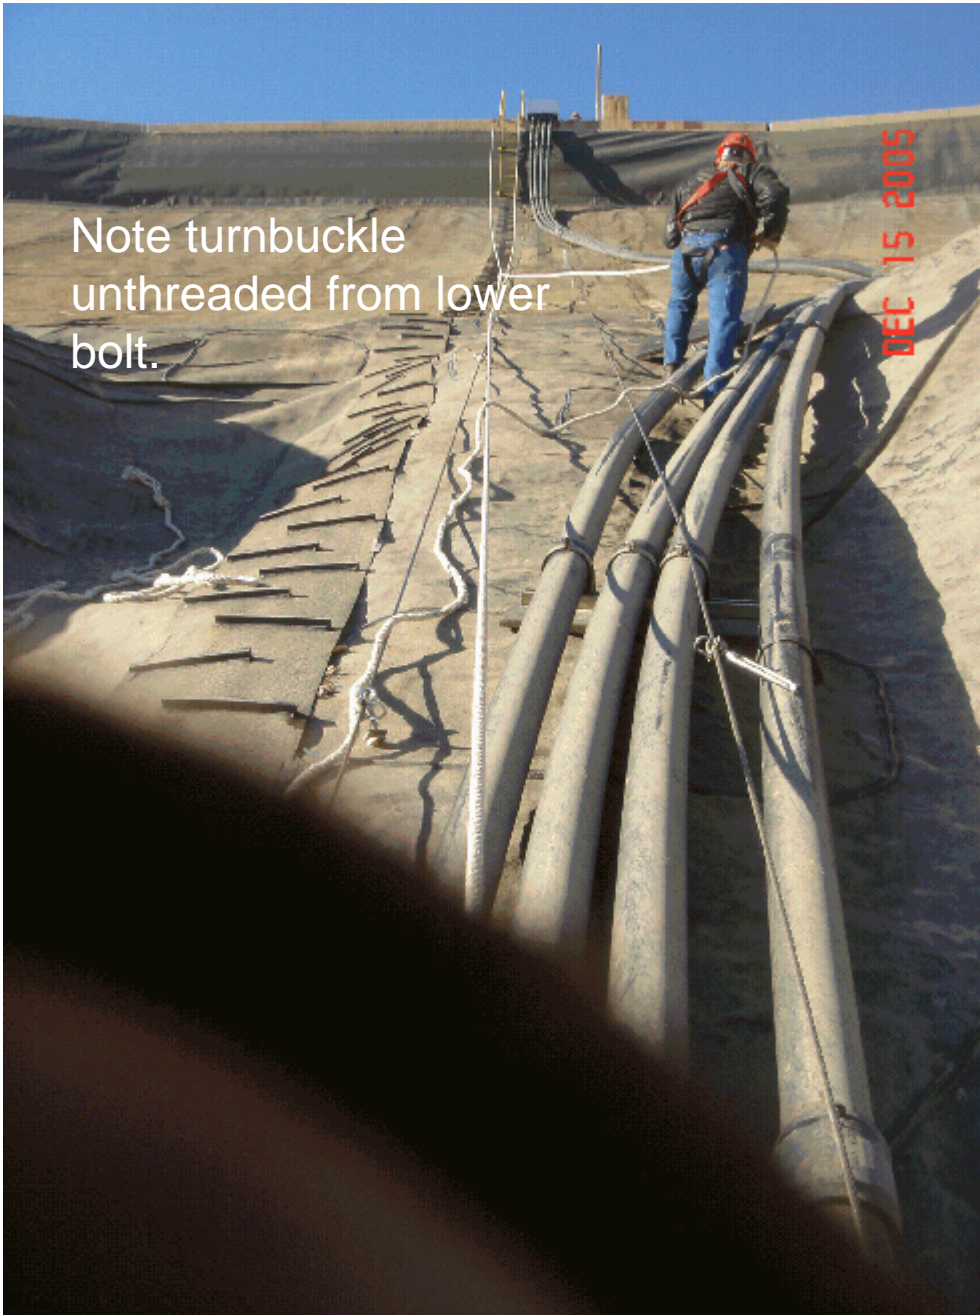
Figure 7-3

Note turnbuckle
unthreaded from lower
bolt.

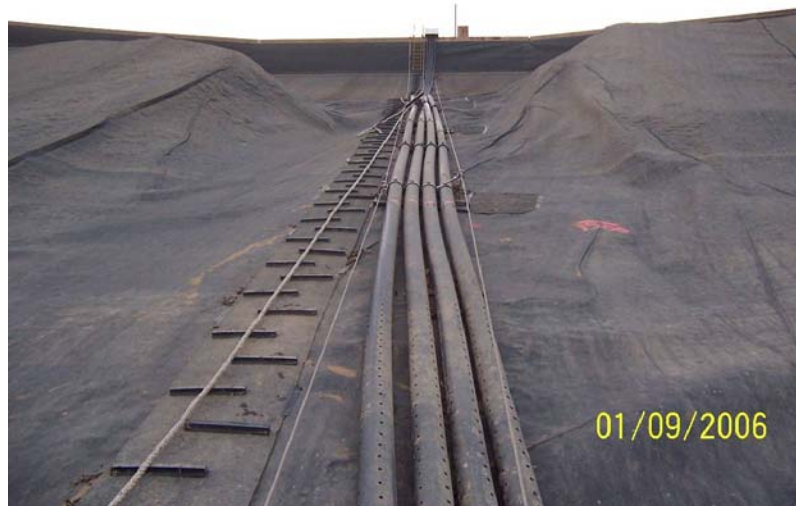
Figure 7-5

Note, straightening of protective pipes between dates of above photos.

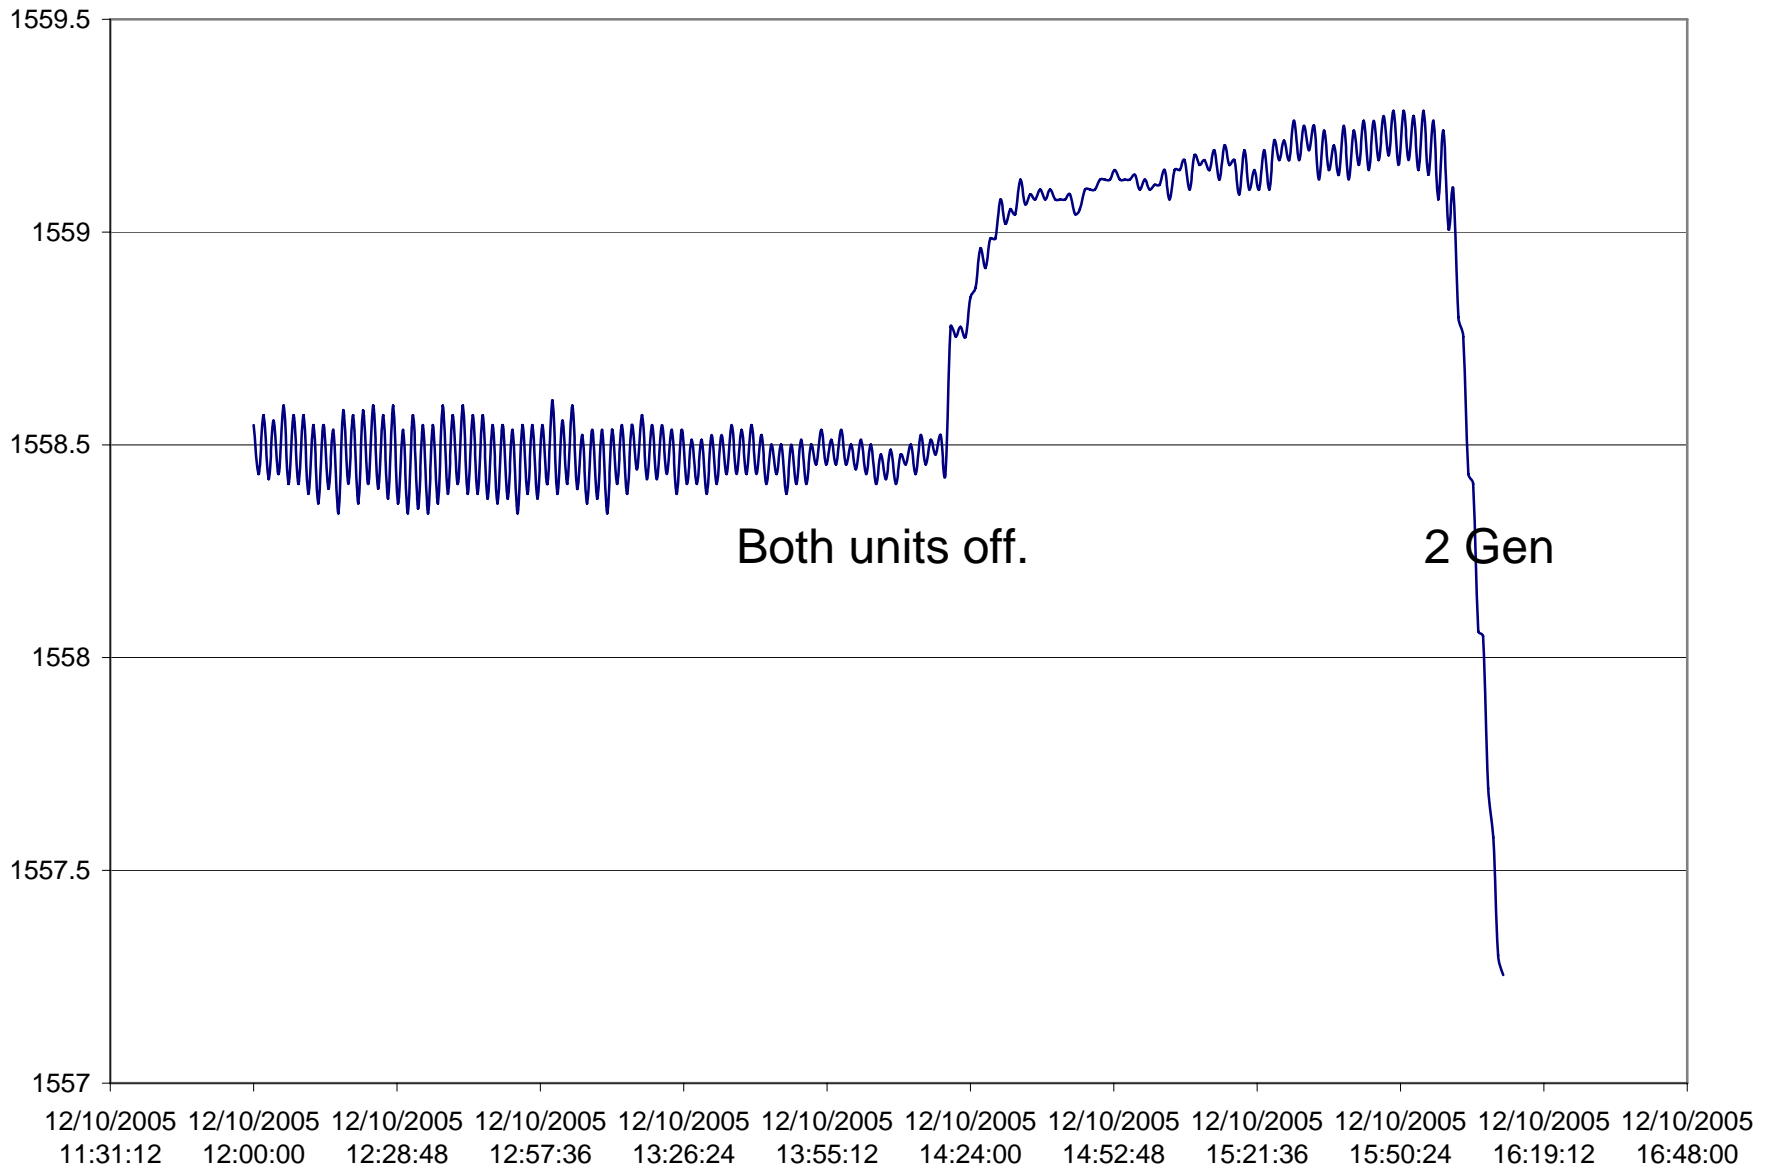
Figure 7-23 shows an interesting pattern of water level readings for December 10, 2005 with both units off followed by both units generating. We don't know if these level fluctuations are due to transducer movement or other causes. The left portion of the plot seems to be damping out until the disturbance around 14:24. The subsequent fluctuations appear to be building in amplitude until the two generators began operation.

Erratic level indications on Dec. 10th.

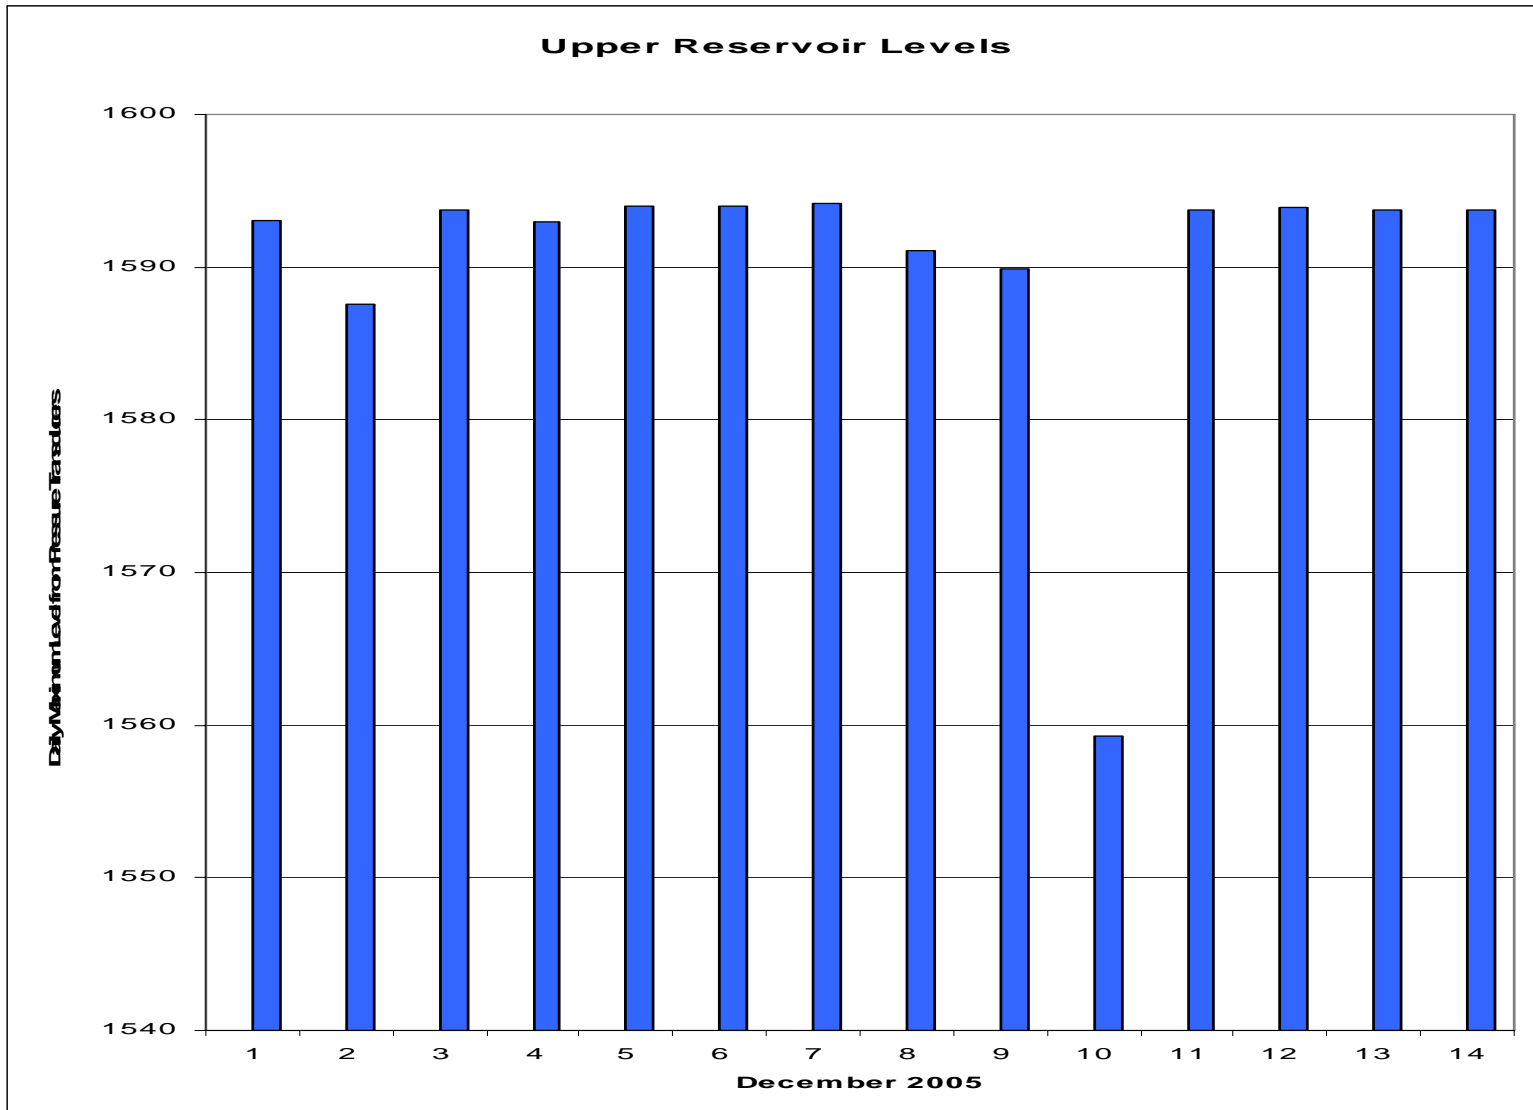
Figure 7-27 is a plot of maximum daily water level indications for December 2005. The plot shows that level indications as high as that shown for December 14, 2005 were achieved on many earlier days. Since reservoir failure did not occur on those dates, it suggests that the level reading offset described above for December 13, 2005 is primarily responsible for the failure to shut down the last pump. As noted above, that offset resulted in the actual water level being at least two feet higher than the pressure transducers indicated.

Daily maximum indicated levels.

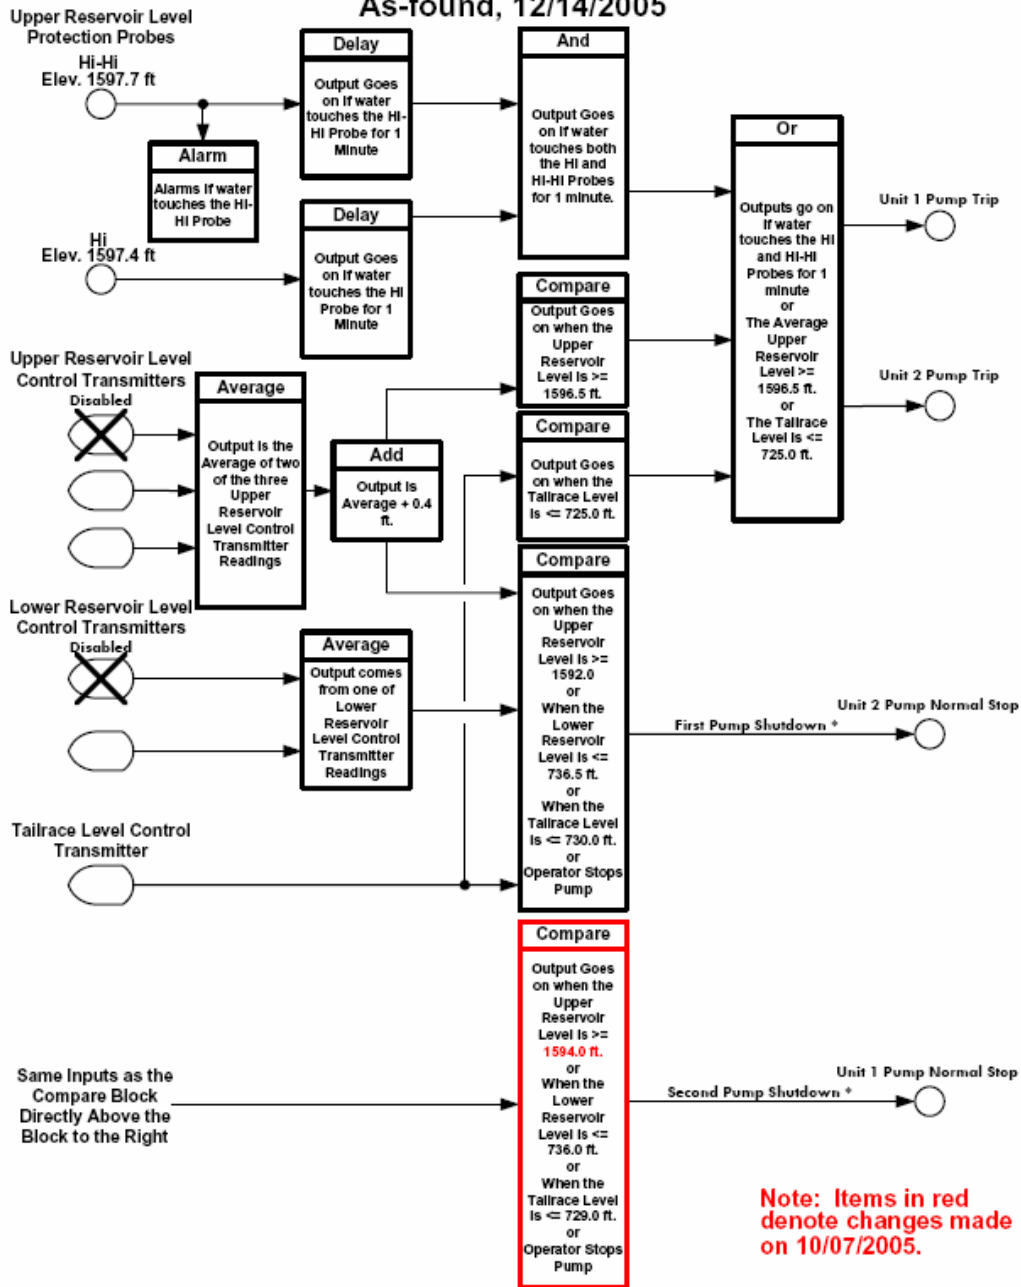
Figure 7-31

Note: Due to programming error made on Sept. 16, 2005, Unit 2 pump shutdown due to level protection probe response was disabled.
