**PDHonline Course A118 (1 PDH)**

# **Repair of Historic Clay Tile Roofs**

# 30 Preservation Briefs

## The Preservation and Repair of Historic Clay Tile Roofs

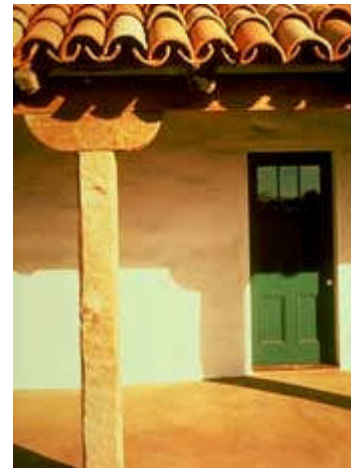
**Tapered barrel clay roof tiles were custom made for the restoration of the 1820s Indian barracks at Mission Santa Cruz in California. Photo: NPS files.**

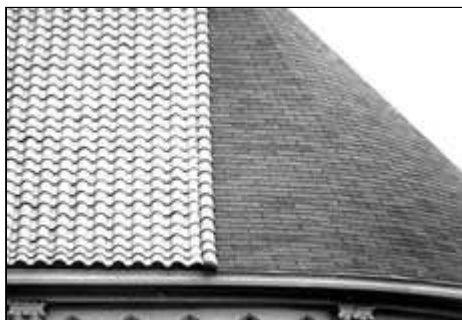
**Asphalt shingles are an incompatible replacement substitute for the original Spanish clay tiles. Photo: NPS files.**

building with materials other than matching natural clay tiles. Concrete, metal or plastic tiles are generally not appropriate substitutes for clay roofing tiles. They lack the natural color variations of clay tile, and they do not have the same texture, shape, thickness or surface irregularities.

Although much concrete tile and composition tile is produced to resemble the general shape, if not the exact profile, of clay roofing tiles, concrete tile is generally too thick and also lacks the range of colors inherent in natural clay tile. Concrete tile is not a compatible substitute material to repair or replace individual historic clay tiles.

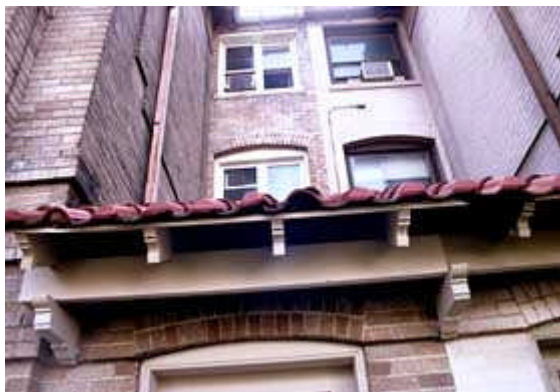
An eave closure or *birdstop* to keep out birds is notably absent from the replacement tile in the center of the bottom row. Photo: NPS files.

**Field and Specialty Tile.** The tiles that cover the majority of the flat surface of the roof are called field tile. Some roof shapes, particularly conical towers or turrets, require tiles of graduated sizes, and some shapes or patterns of field tile also require specially shaped finish tiles to complete the roof covering package. Other uniquely-shaped tiles were made to fit odd-shaped spaces and places including dormers and valleys, roof hips, rakes, ridges and corners. There are also finish tiles that fulfill certain needs, such as eave closures or clay plugs called "birdstops." These are intended to keep out snow and rain, and birds from

nesting in the voids under the bottom row of curved tiles. Different patterns and designs can also be created by combining, or mixing and matching flat tiles with dimensional tiles.

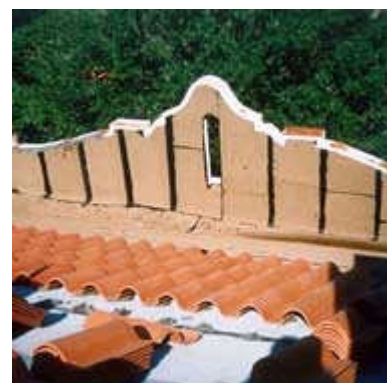
**Projections on the underside of these replacement Spanish clay tiles help them adhere to the cement mortar on the roof sheathing. Photo: NPS files.**
