Rock Engineering Series: Rock Slopes

Practical Rock Engineering

A slope stability problem in Hong Kong

Analysis of rockfall hazards

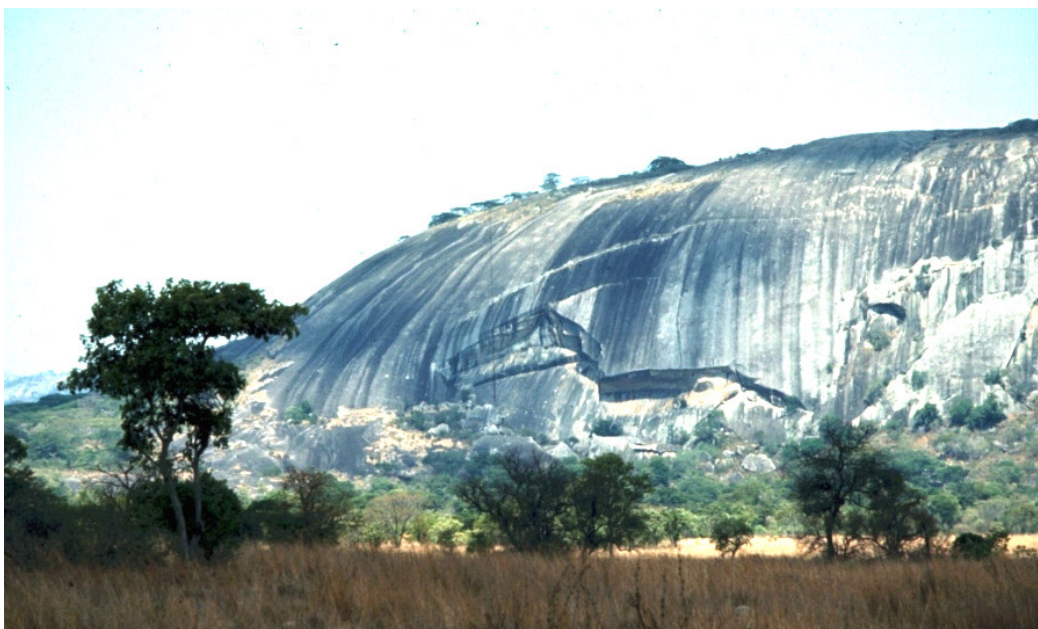
Figure 2: Sheet jointing in granite. These features, sometimes referred to as 'onion skin' joints, are the result of exfoliation processes during cooling of the granite.

The rock mass in which the slope adjacent to the Sau Mau Ping Road was cut is unweathered granite with exfoliation or sheet joints similar to those illustrated in Figure 2. These joints are parallel to the surface of the granite and the spacing between successive joints increases with increasing distance into the rock mass. Undercutting of these sheet joints can cause a rock slide such as that illustrated in Figure 3.

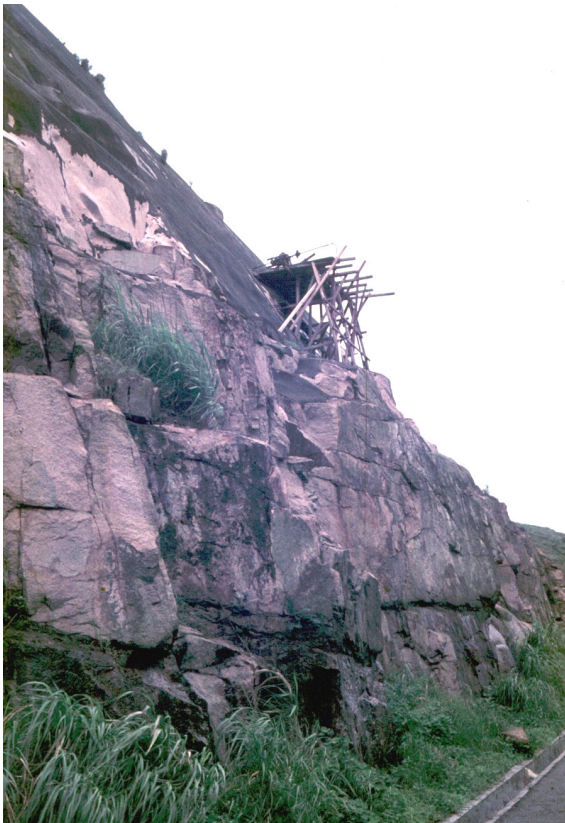
Figure 10: Drilling horizontal drain holes into the face of one of the benches of the Sau Mau Ping slope.

Figure 10 shows the drilling of the horizontal drain holes into the slope face and Figure 11 shows the drilling of the vertical holes into which the piezometers were installed. These piezometers were monitored for the next few years, while preparations for the final stabilisation of the slope were made, and the road was closed to traffic on two occasions when water levels were considered to be dangerously high.

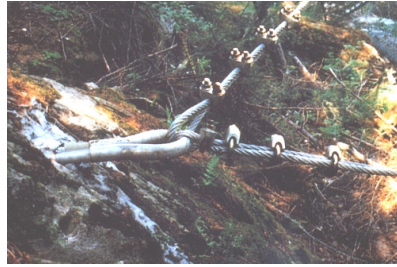
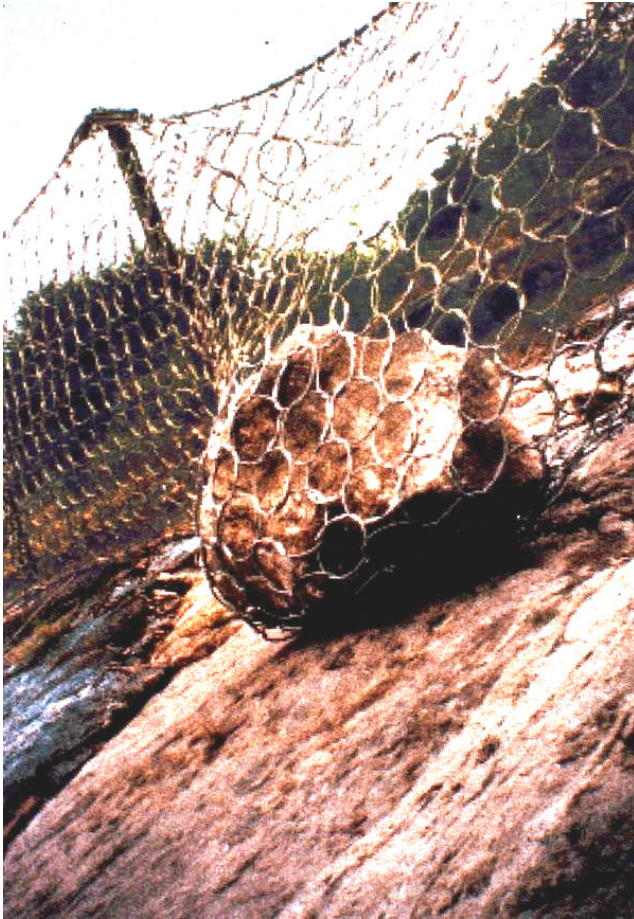
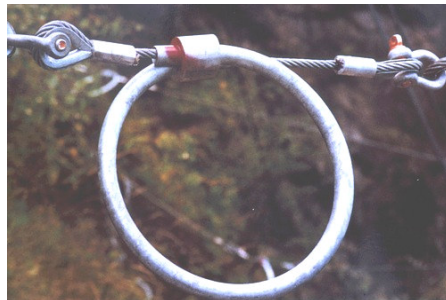
a: Anchor grouted into rock with cables attached.

b: Geobruigg ring net shown restraining a boulder. These nets can be designed with energy absorbing capacities of up to 2500 kNm which is equivalent to a 6 tonne boulder moving at 20 m per second.

c: Geobruigg energy absorbing ring. When subjected to impact loading the ring deforms plastically and absorbs the energy of the boulder

Figure 6: Details of a rockfall net system manufactured by Geobruigg of Switzerland.

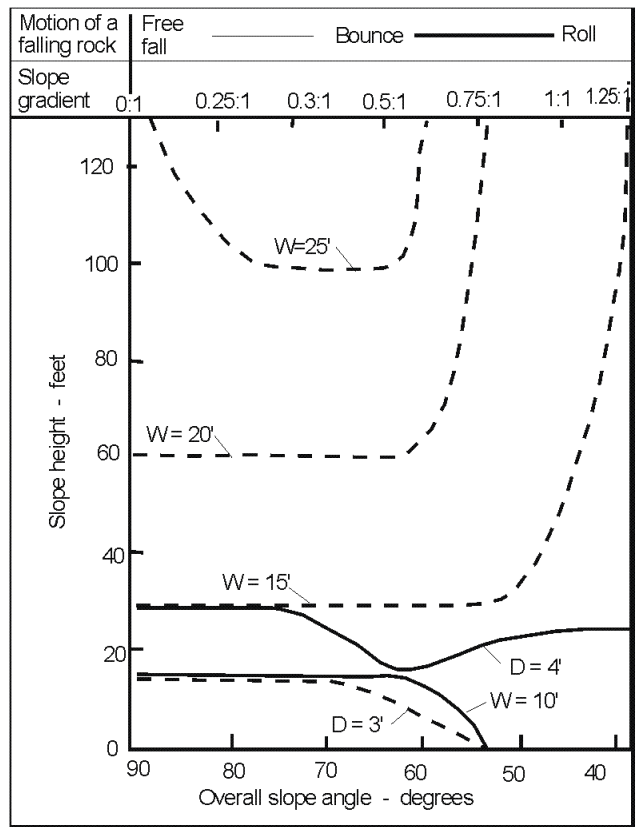
Ditch Design Chart

Figure 8: Rockfall ditch design chart based upon work by Ritchie (1963).

A simple design chart for ditch design, based upon work by Ritchie (1963), is reproduced in Figure 8.

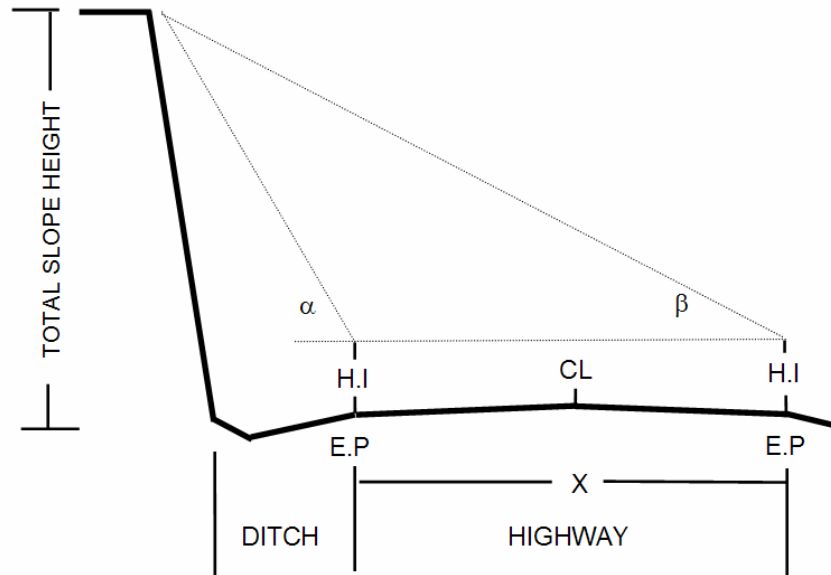
height plus the additional slope height (vertical distance). A good approximation of vertical slope height can be obtained using the relationships shown below.

$$\text{TOTAL SLOPE HEIGHT} = \frac{(X) \sin \alpha \sin \beta}{\sin (\alpha - \beta)} + \text{H.I.}$$

where X = distance between angle measurements
H.I = height of the instrument.

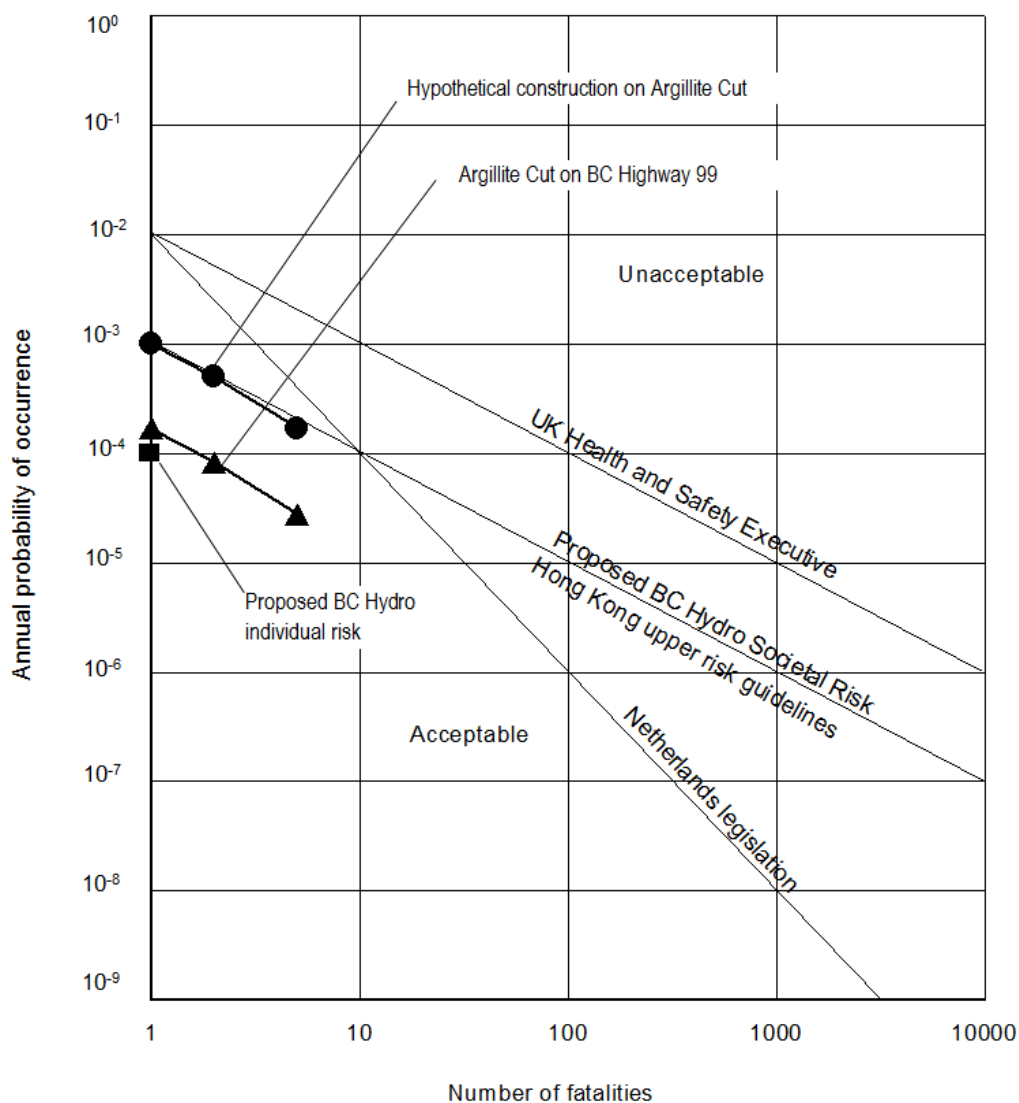
Figure 14: Comparison between risks of fatalities due to rockfalls with published and proposed acceptable risk criteria.

Figure 14, based on a graph published by Nielsen, Hartford and MacDonald (1994), summarises published and proposed guidelines for tolerable risk. The line marked 'Proposed BC Hydro Societal Risk' is particularly interesting since this defines an annual probability of occurrence of fatalities due to dam failures as 0.001 lives per year or 1 fatality per 1000 years. A great deal of effort has gone into defining this line and I consider it to be directly applicable to rock slopes on highways which, like dams, must be classed as major civil engineering structures for which the risks to the public must be reduced to acceptable levels.
