Ethical Issues from the Tacoma Narrows Bridge Collapse

Instructor: J. Paul Guyer, P.E., R.A., Fellow ASCE, Fellow AEI

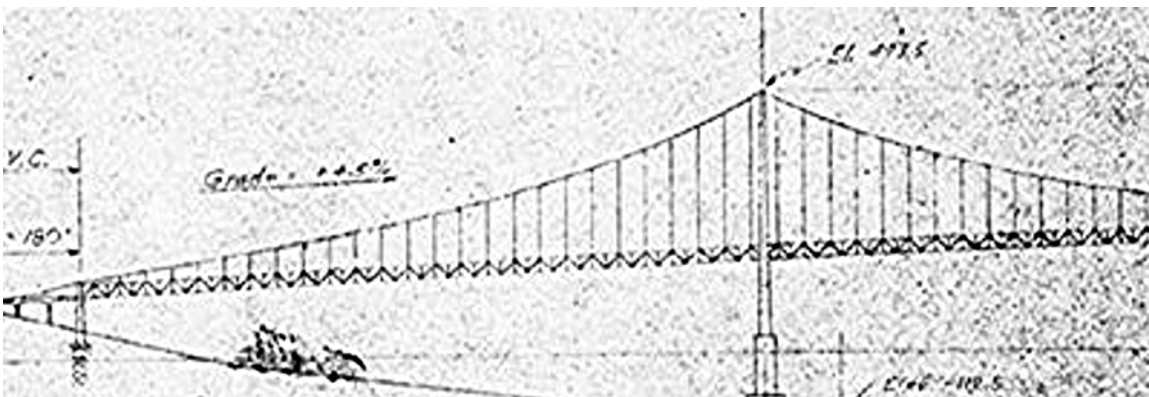
Figure 3

The Eldridge Design
(Washington State DOT records)

With the prospect of federal funding now in view, the Washington Department of Highways, under the direction of engineer Clark Eldridge, prepared plans for a suspension bridge using convention suspension bridge design practices as they were known at that time....specifically, the roadway deck was supported by deep (25-foot) truss girders to stiffen it. The Authority submitted the Eldridge design to the federal Public Works Administration (PWA) with a request for \$11 million.

At this point a well known New York bridge engineer, Leon Moisseiff, submitted a proposal to the PWA and the Reconstruction Finance Corporation (RFC) to design the bridge at a cost of \$8 million.... a substantial saving. Most of the cost saving was due to Moisseiff's replacement of the 25-foot deep roadway support truss girders with 8-foot deep plate girders. This was unquestionably a more elegant and slender design, but greatly reduced the stiffness of the bridge.

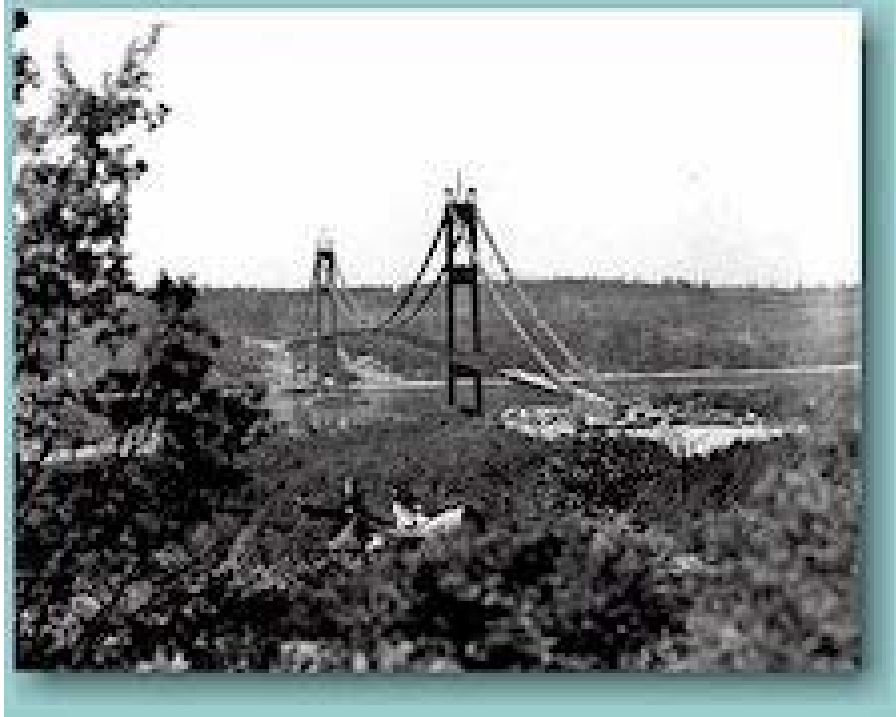
Figure 5

Tacoma Narrows Bridge Under Construction

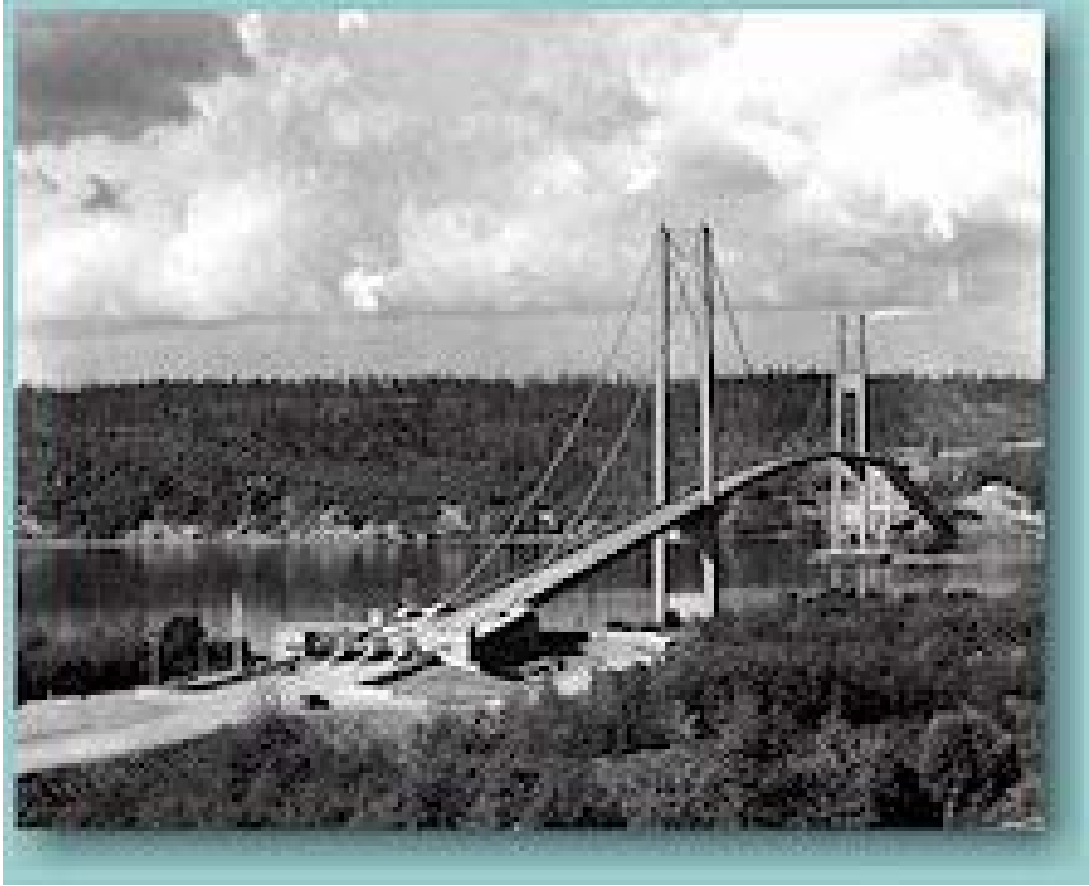
Figure 6

Tacoma Narrows Bridge Completed

The use of such shallow and narrow girders proved to be the undoing of the bridge. With such thin roadway support girders, the deck of the bridge was insufficiently rigid and was easily moved about by winds. The bridge became known for its movement. A modest wind could cause alternate halves of the center span to visibly rise and fall several feet over four- to five-second intervals. This flexibility was experienced by the builders and workmen during construction, which led some of the workers to christen the bridge "Gallopig Gertie." The nickname soon stuck, and even the public felt these motions on the day that the bridge opened on July 1, 1940.

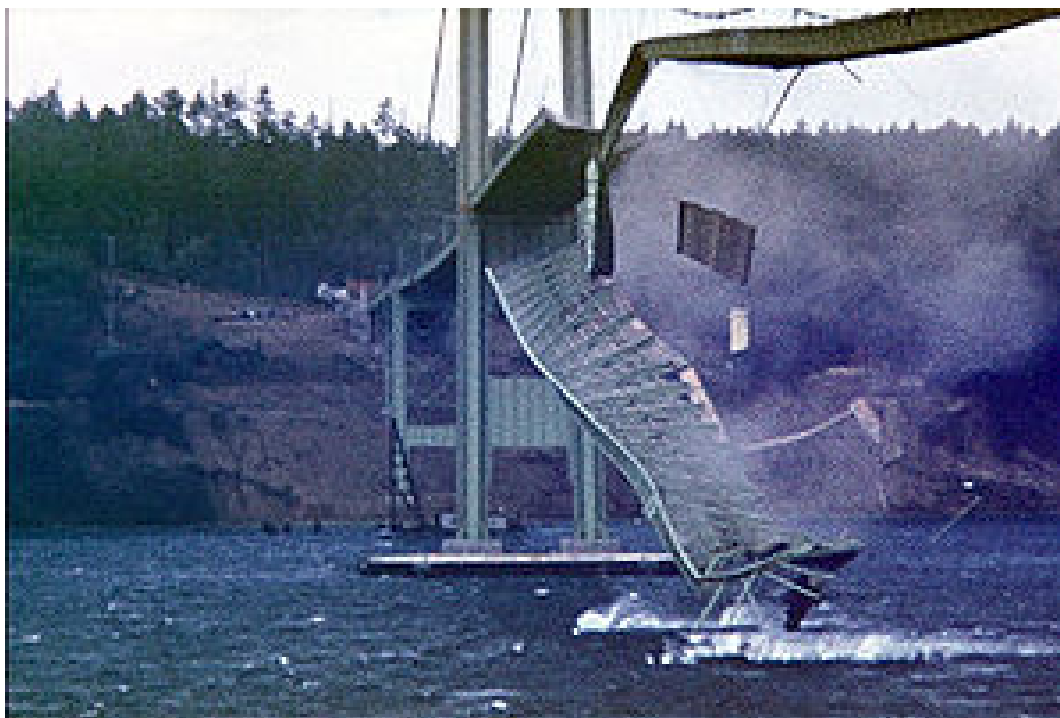
Figure 7

Collapse of the Tacoma Narrows Bridge on November 7, 1940
(University of Washington Libraries. Manuscripts, Special Collections, University Archives Division, PH Coll. 290.36)

On the morning of November 7, 1940 the wind was blowing through the Narrows at a steady speed of about 42 miles per hour. At 10 AM the bridge began to oscillate severely in the torsional mode and the bridge was closed to traffic. At 11:10 AM the center span collapsed.

The amplitude of the motion produced by the fluttering increased beyond the strength of the suspender cables. Once several cables failed, the weight of the deck transferred to the adjacent cables that broke in turn until the central deck collapsed.

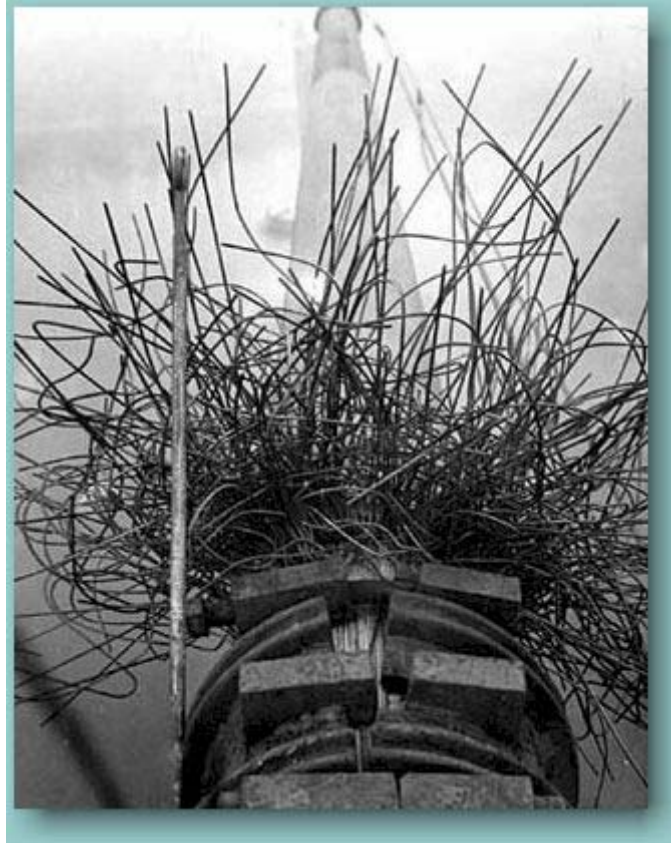
Figure 8

Broken Cable

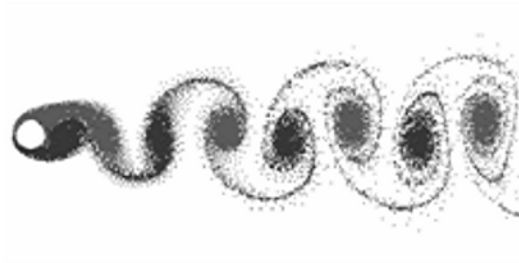
Figure 9
Vortex Shedding

Where ω_r is the natural (resonant) frequency of the structure. Each structure has natural frequencies. For resonance to occur, it is necessary to have periodicity in the excitation force. The suggested cause for periodicity in the wind force was vortex shedding. Non-streamlined bodies like bridge decks, in the wind shed wakes whose characteristics depend on the size and shape of the body and the properties of the air. These wakes are accompanied by alternating low-pressure vortices on the downwind side of the body. This is called the “Von Kármán vortex street”. The body will try to move toward the low-pressure zone, in an oscillating movement called vortex-induced vibration. If

the frequency of vortex shedding matches the resonance frequency of the structure, the structure will begin to resonate and the structure's movement can become self-sustaining.

The frequency of the vortices in the von Kármán vortex street is called the Strouhal frequency f_s , and is given by

Where U is the flow velocity, D is a characteristic length of the non-streamlined body and S is the dimensionless Strouhal number, which depends on the body in question. For Reynolds Numbers greater than 1000, the Strouhal number is approximately equal to 0.21. In the case of the Tacoma Narrows, D was approximately 8 feet and S was 0.20.

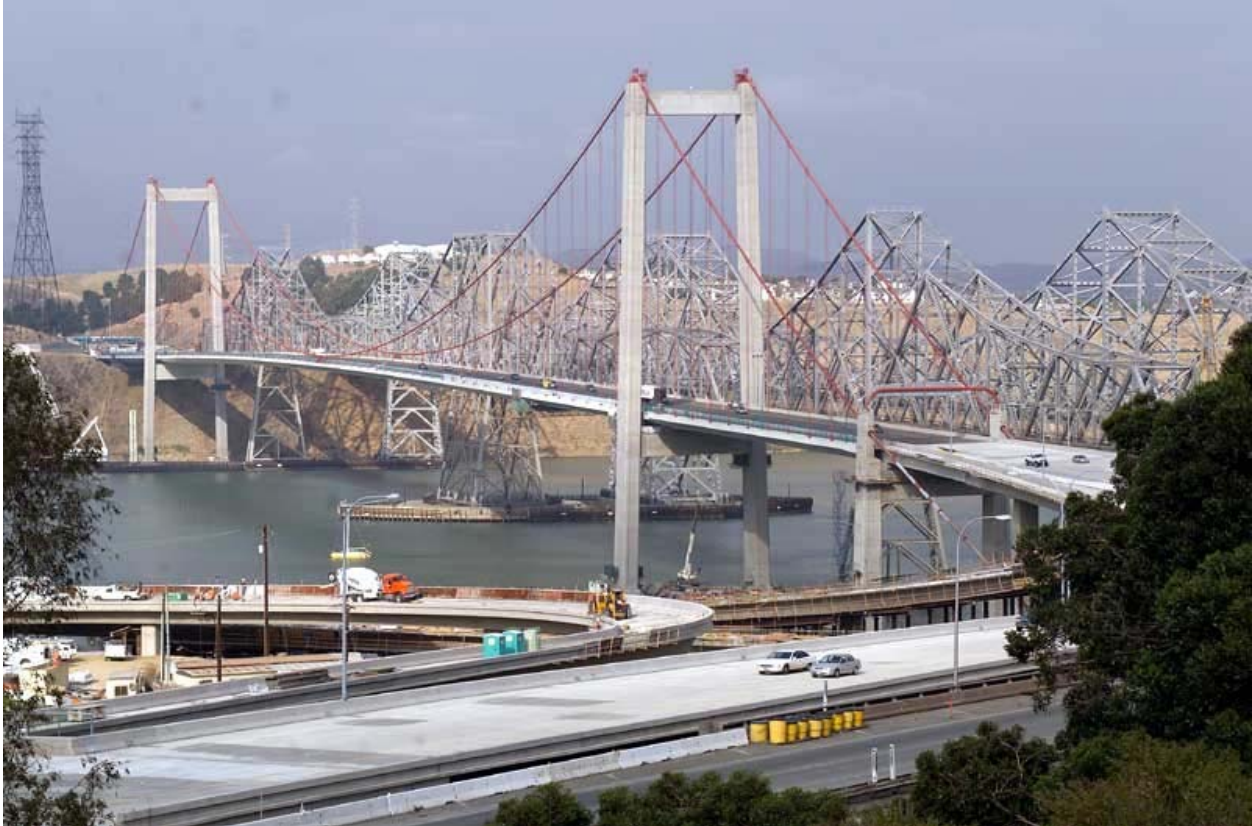
Figure 9

The "third" Carquinez Bridge
(the "first" and "second" bridges are seen beyond; the "first" was subsequently demolished)
(California Department of Transportation)

Today, of course, modeling studies are a primary design tool used by bridge engineer's to design major bridges. And computers using numerical methods such as finite-elements provide a greatly enhanced modeling tool in some instances. The "third" Carquinez Bridge west of Sacramento and completed in 2003 is an example of the state of the art in suspension bridge design. Wind tunnel testing and computer modeling were important tools employed in the design process. Note the slender, solid roadway support girders, similar to those in the Tacoma Narrows bridge design.
