Engineering Ethics Case Study: The Taum Sauk Reservoir Failure

Taum Sauk Upper Dam Breach FERC No. P-2277

Technical Reasons for the Breach
of December 14, 2005

FERC Independent Panel of Consultants (IPOC)

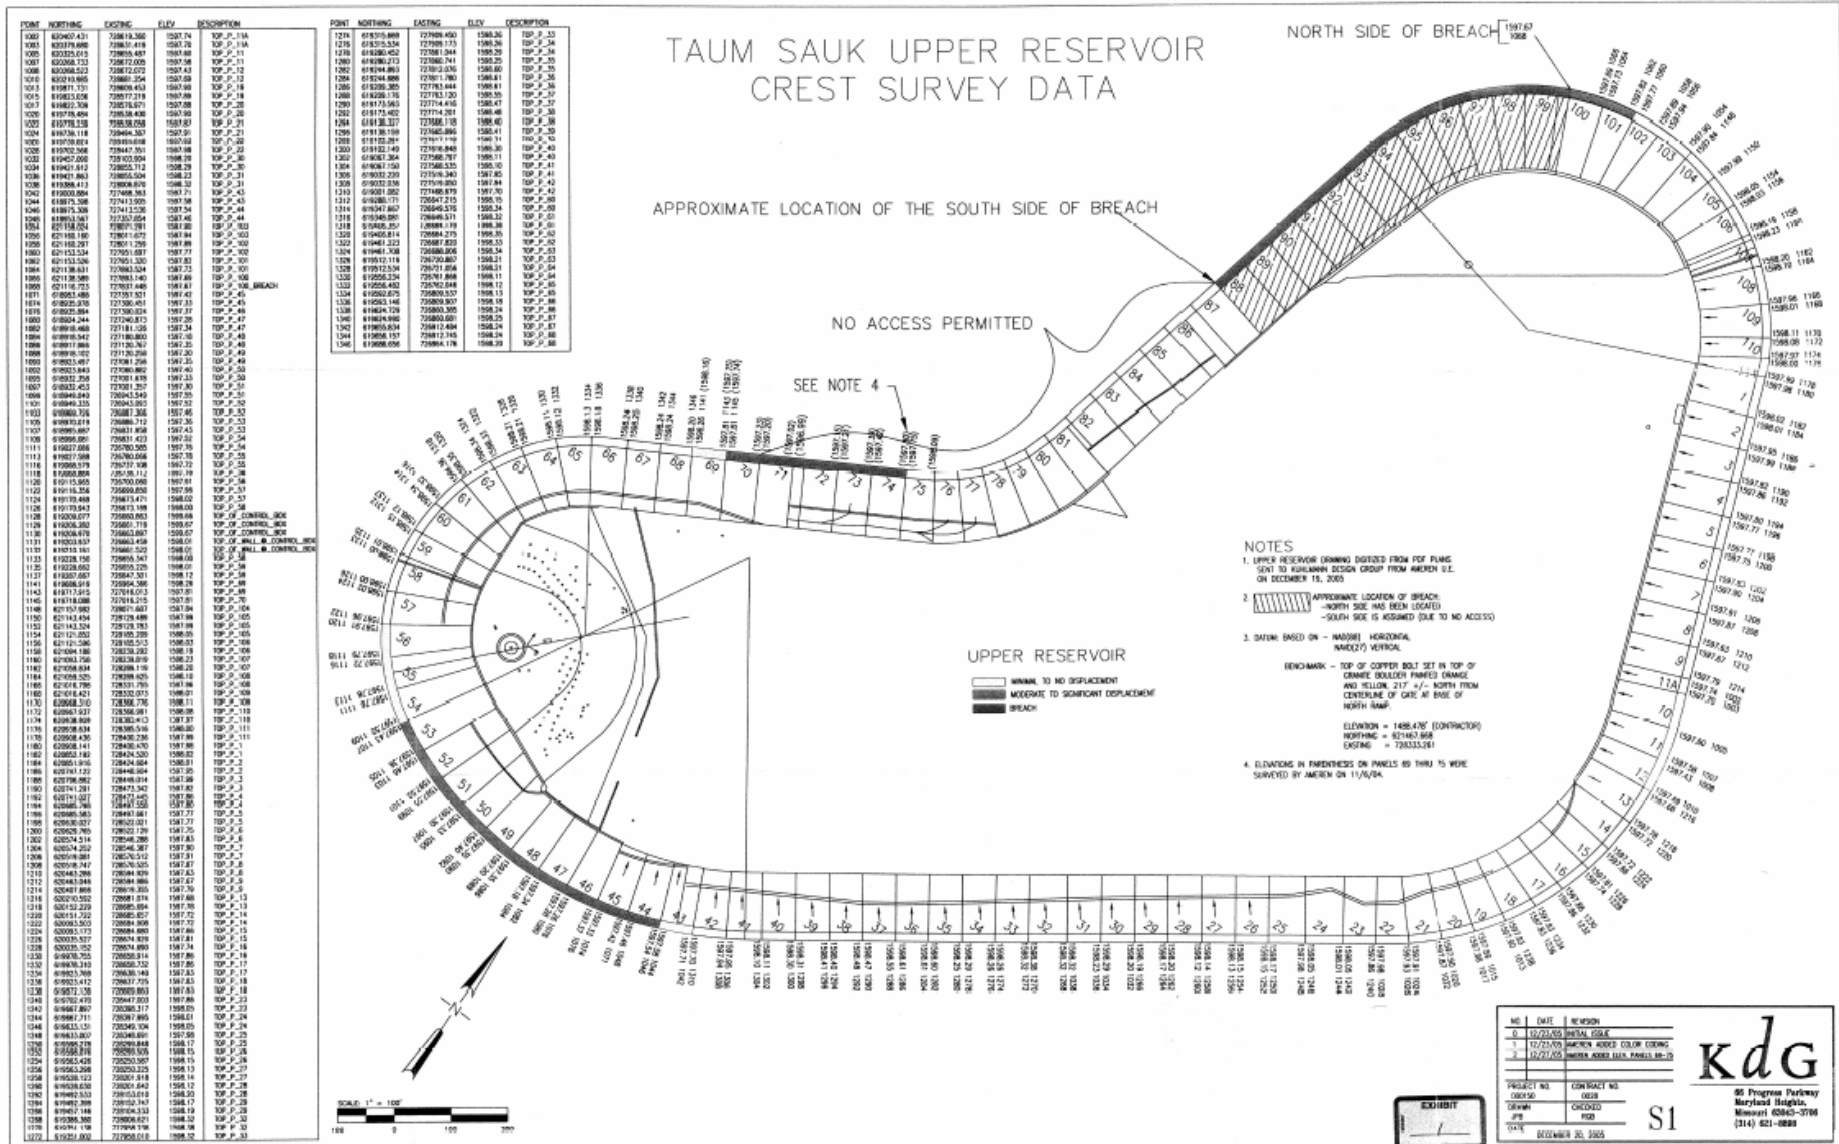
Figure 3-5
(See Large Drawing S1 Provided)

Taking into account the elevations of the end panels in each overflow group from Figure 3-5 it appears as if the maximum reservoir level could range between Elev. 1597.7 and 1597.9.

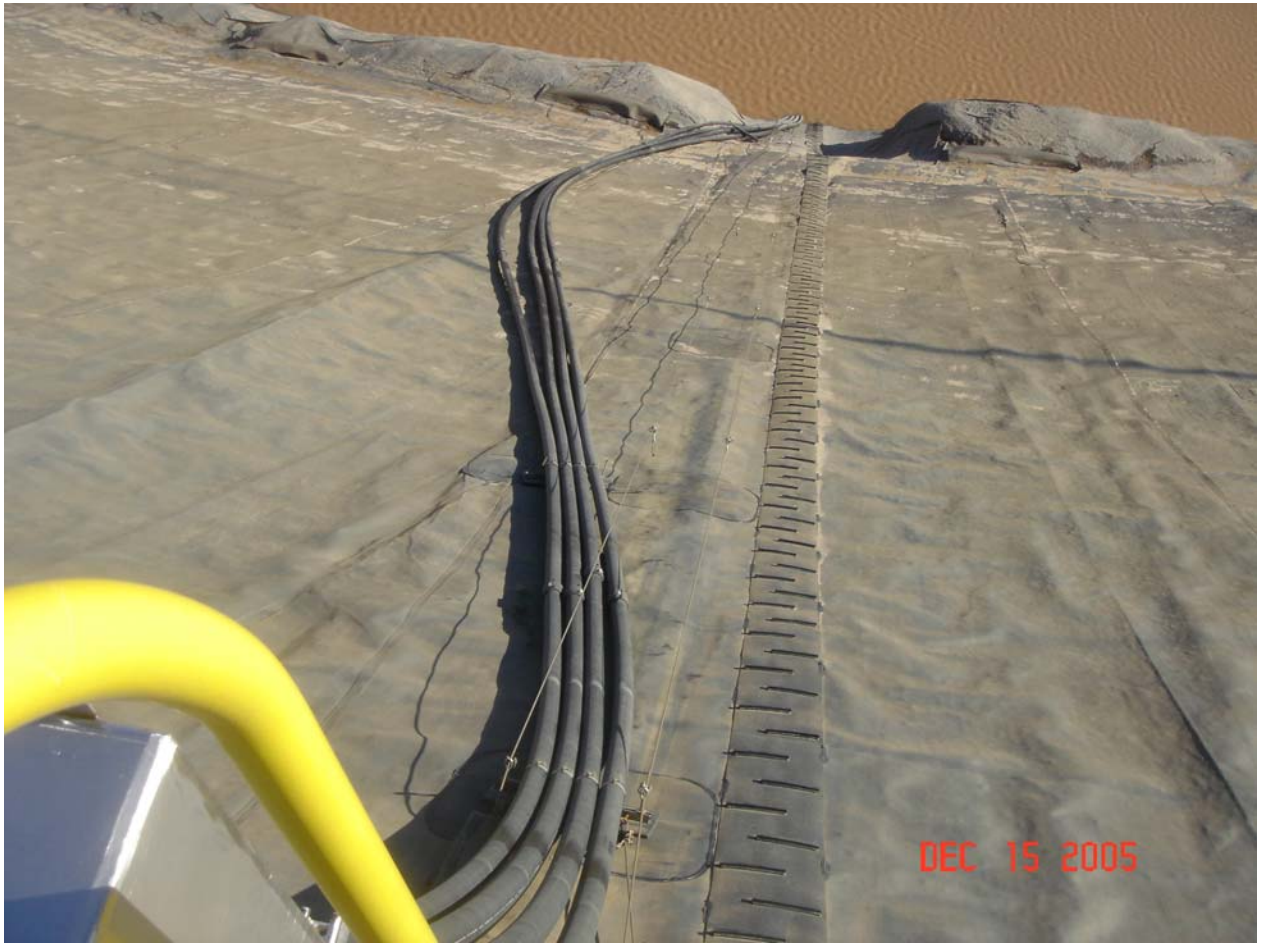
Figure 7-4

A visual examination of the pressure transducer protective pipes, Figures 7-3 through 7-5, shows that the protective pipes had moved from their straight alignment in the lower elevation of the reservoir. Since the transducer cables remained fixed at their instrument box on the parapet wall (Figure 7-6), any movement of the protective pipes from their initial straight alignment would produce an upward movement of the pressure transducer and a corresponding negative error in the water level reading. That is, the reported water level would be less than the actual level.

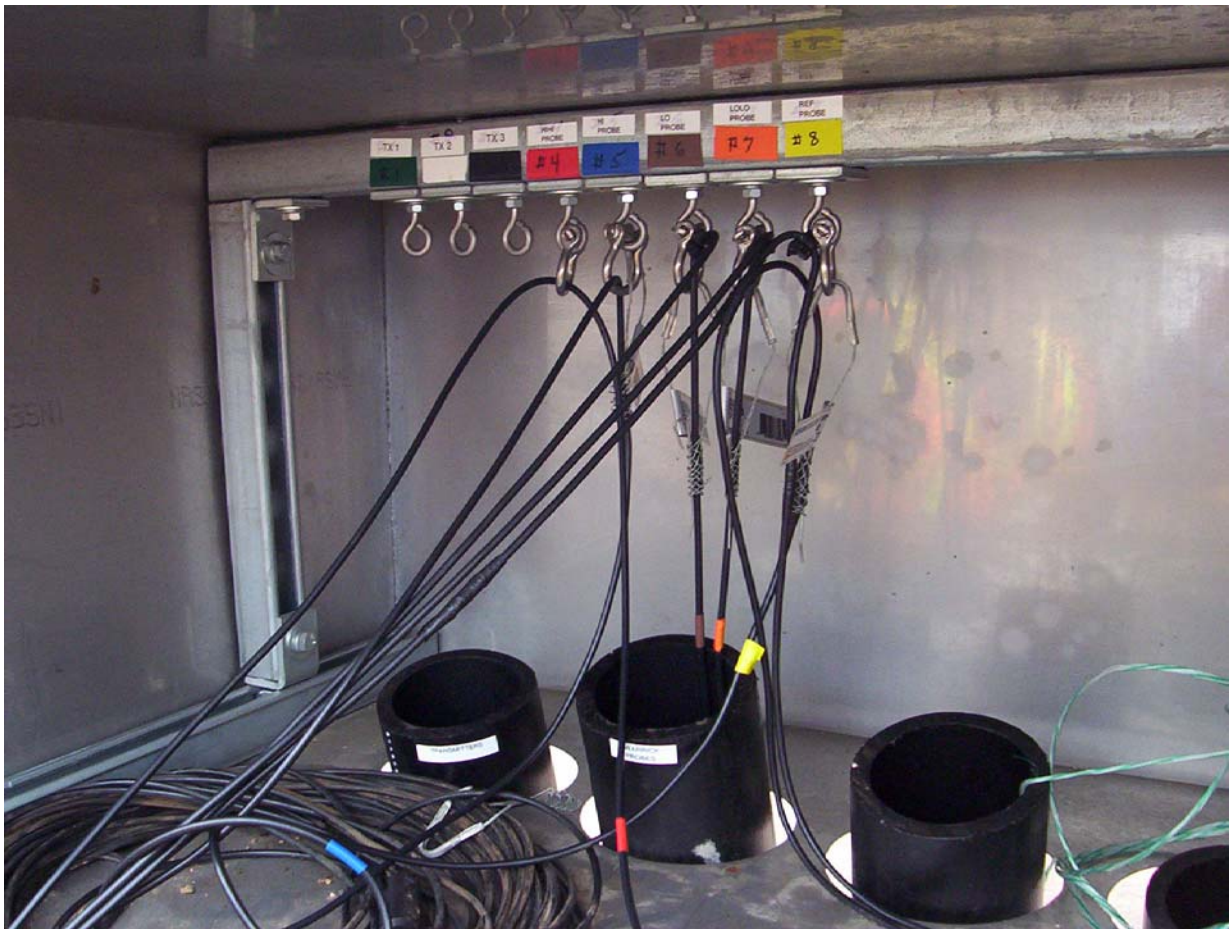
Figure 7-6

**Upper ends of protective pipes
with instrument cables in enclosure on parapet.
Pressure transducers use left pipe
and conductivity probes use the second pipe from left.**

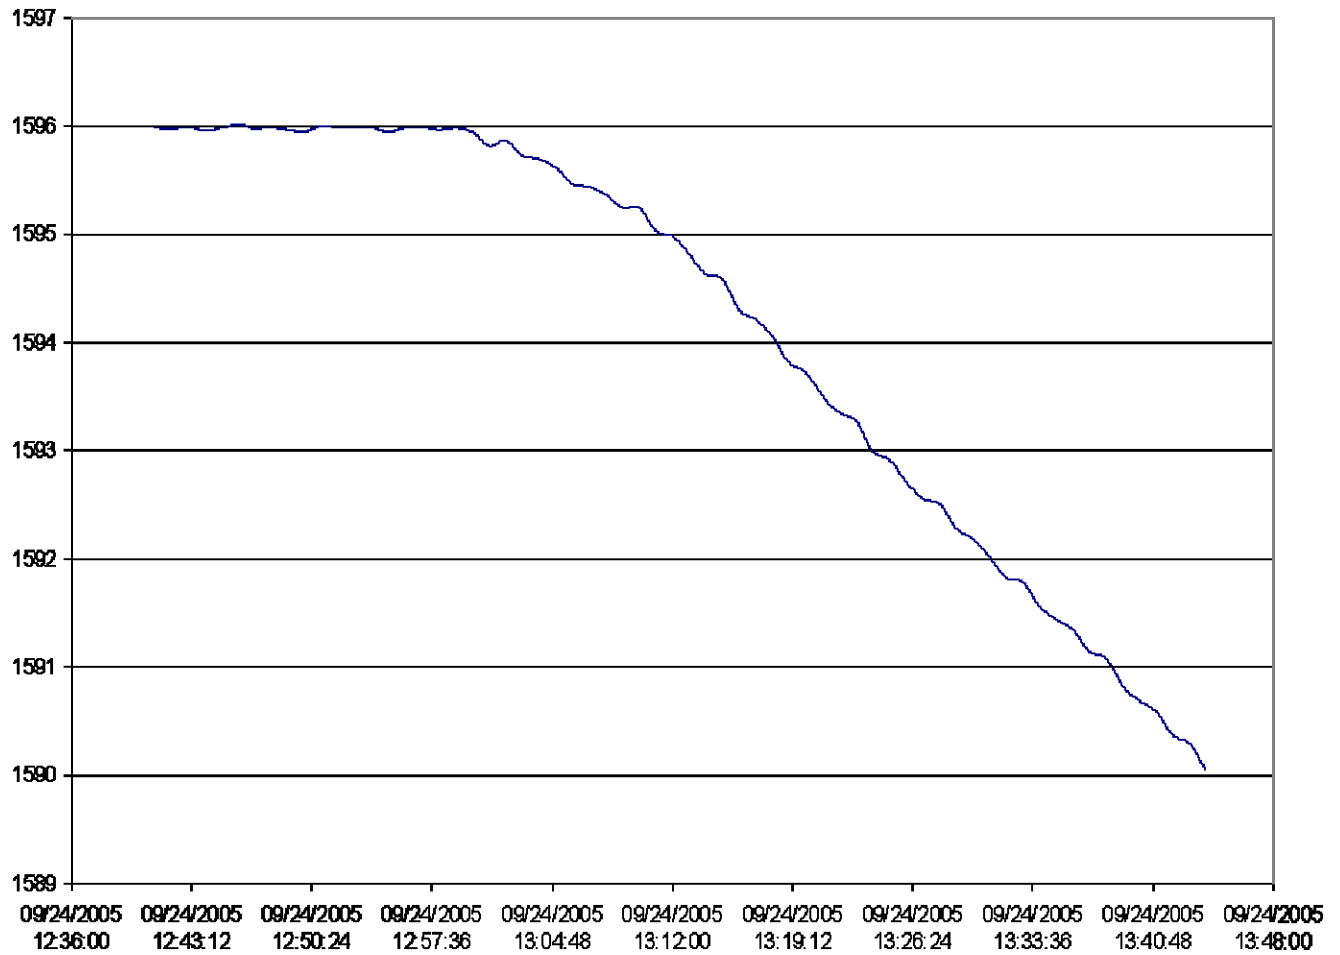
Figure 7-11

Figures 7-9 through 7-11 show upper reservoir water level readings taken during and prior to the Hurricane Rita event.

Generation start on day prior to Hurricane Rita. Note smaller level variations compared to next day.

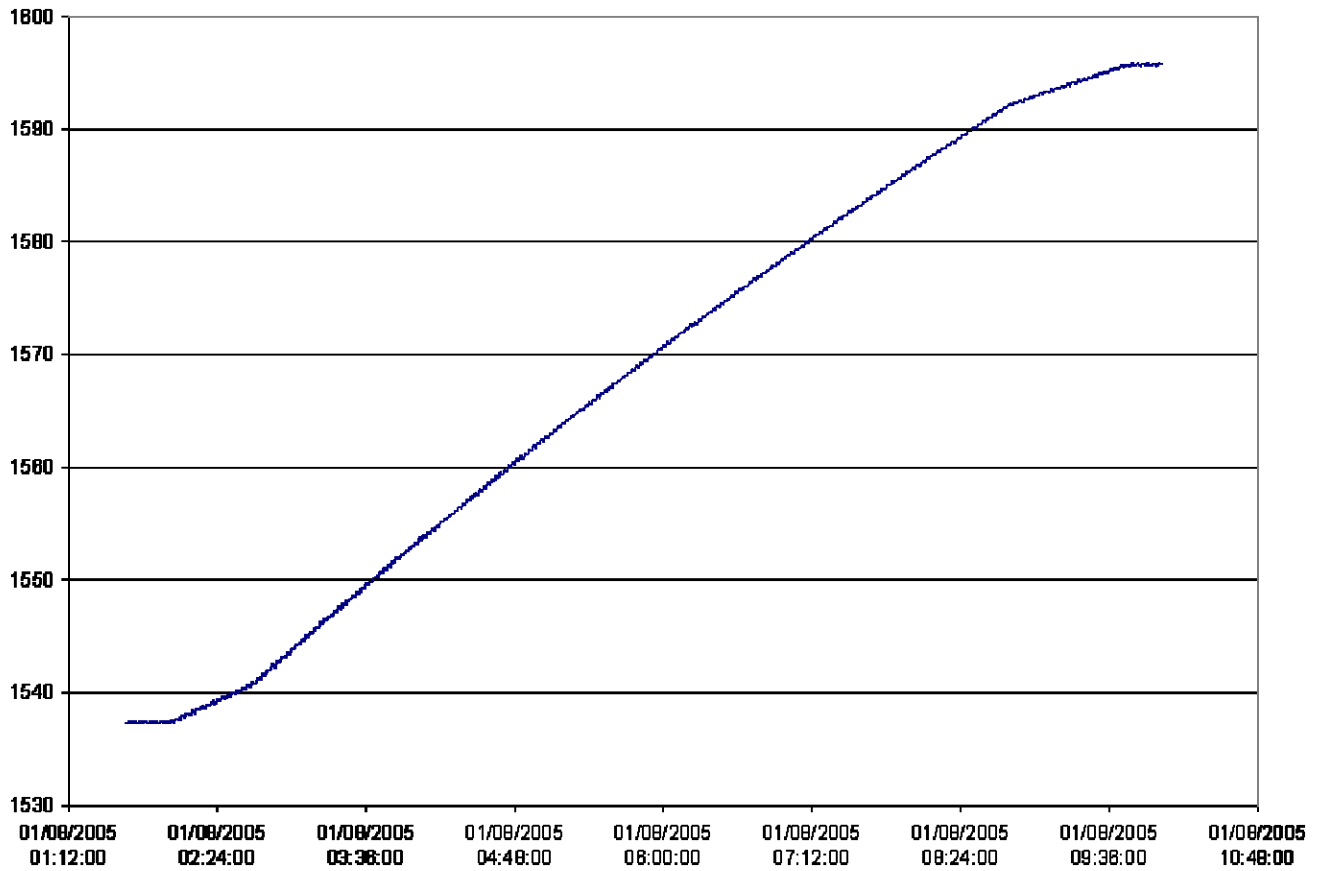
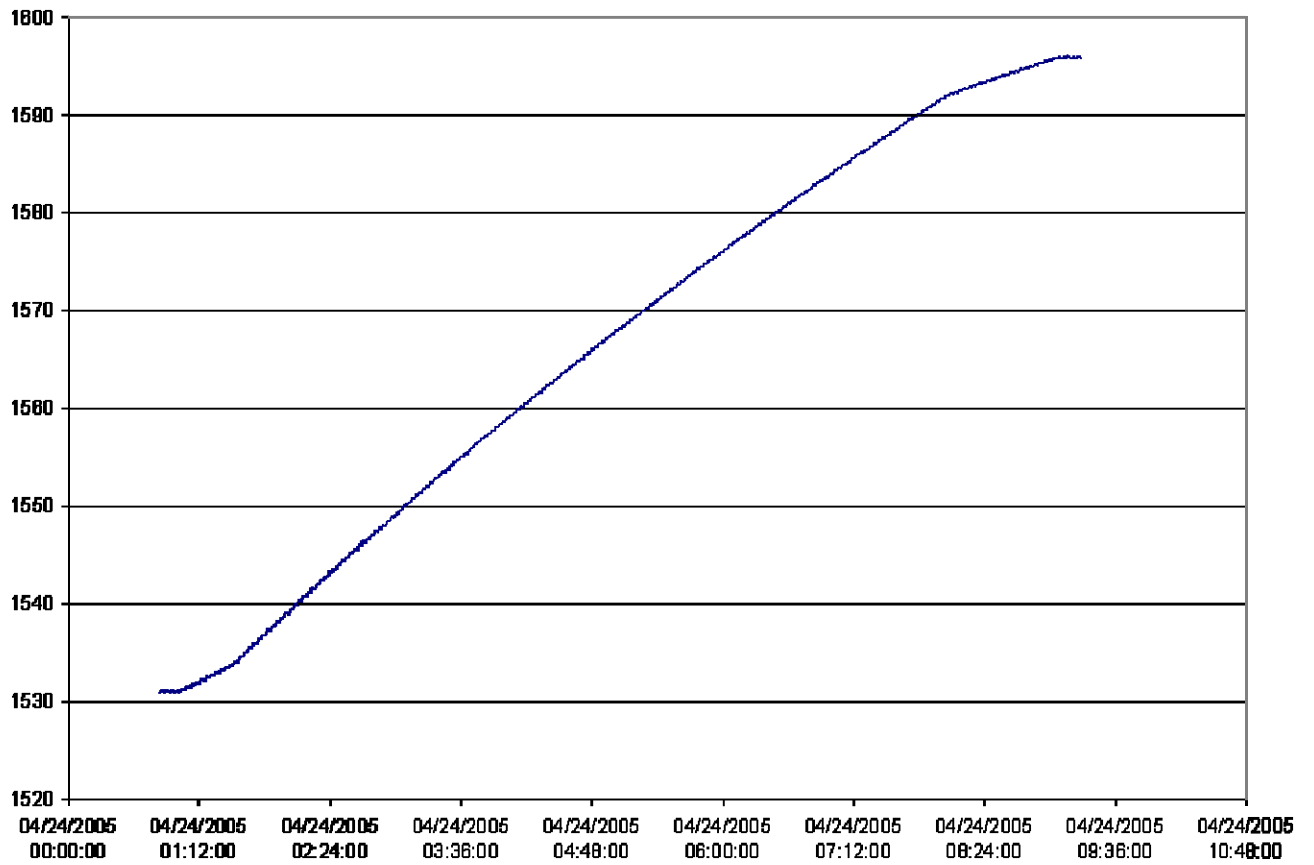
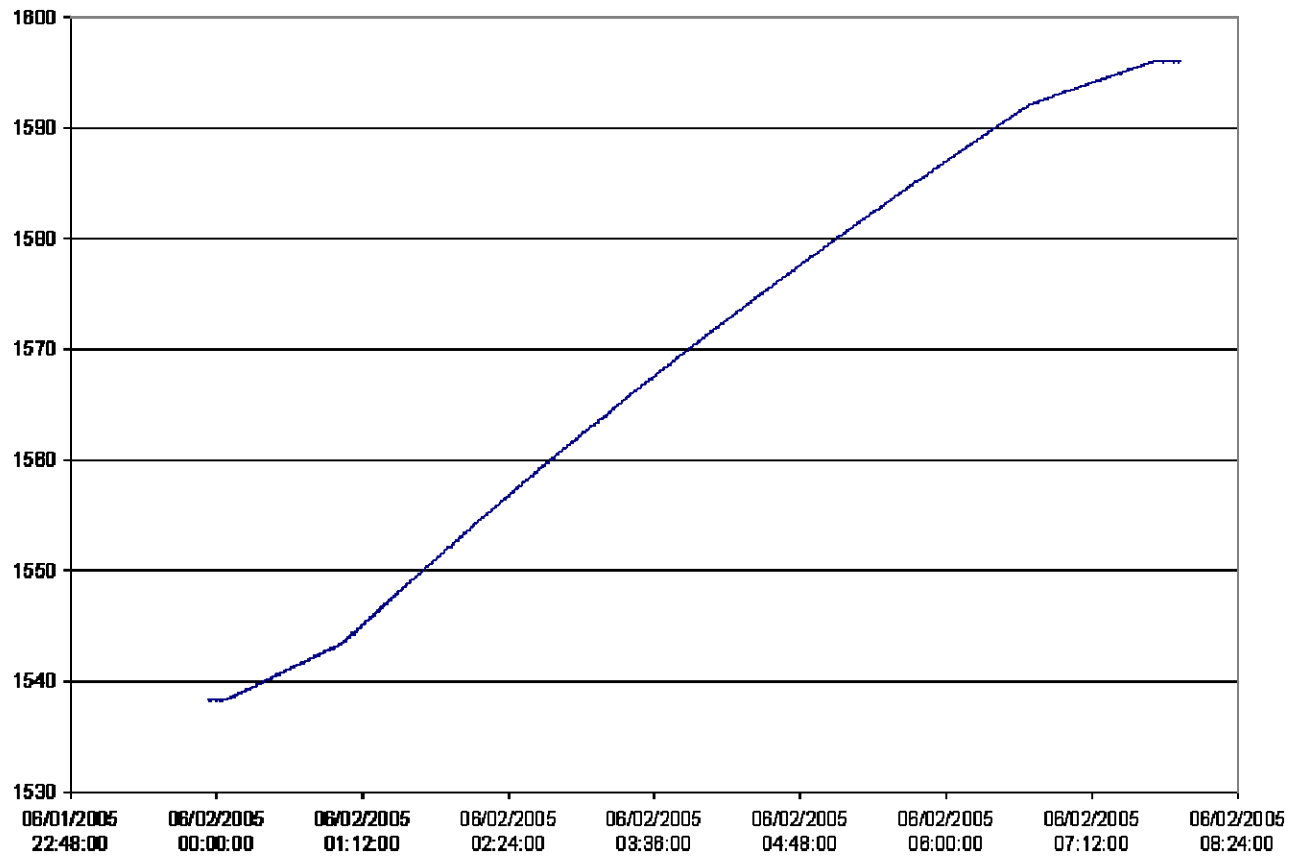
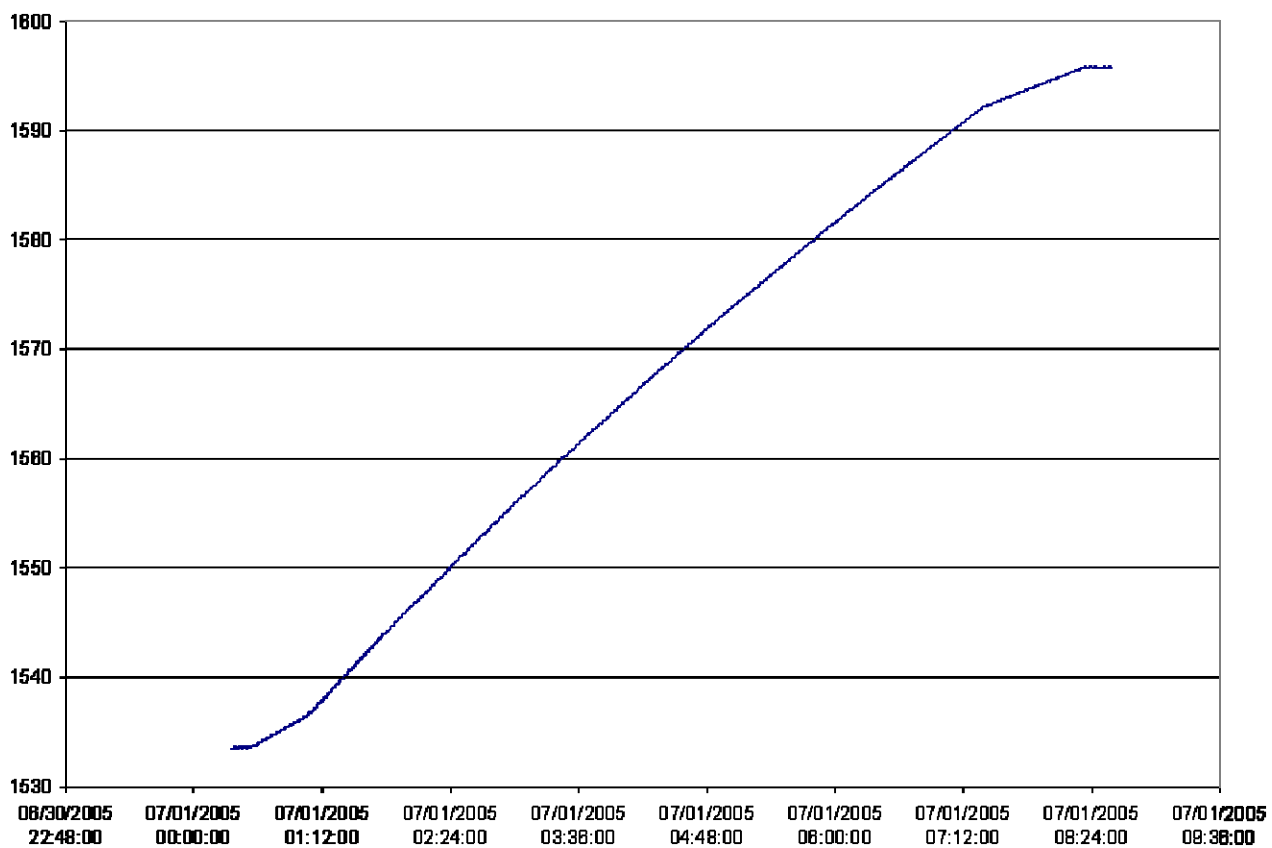
A review of two pump operations during 2005 shows that the upper reservoir water level indications are reasonably stable until early August. Figures 7-15 through 7-22 are examples of these levels from the pressure transducers. Beginning in early August, the water level plots begin to show the erratic behavior that increased until December 14, 2005.
