Review of the Devastating Impacts of Woody Plants on Earthen Dams

Technical Manual for Dam Owners

Impacts of Plants on Earthen Dams

FEMA 534 / September 2005

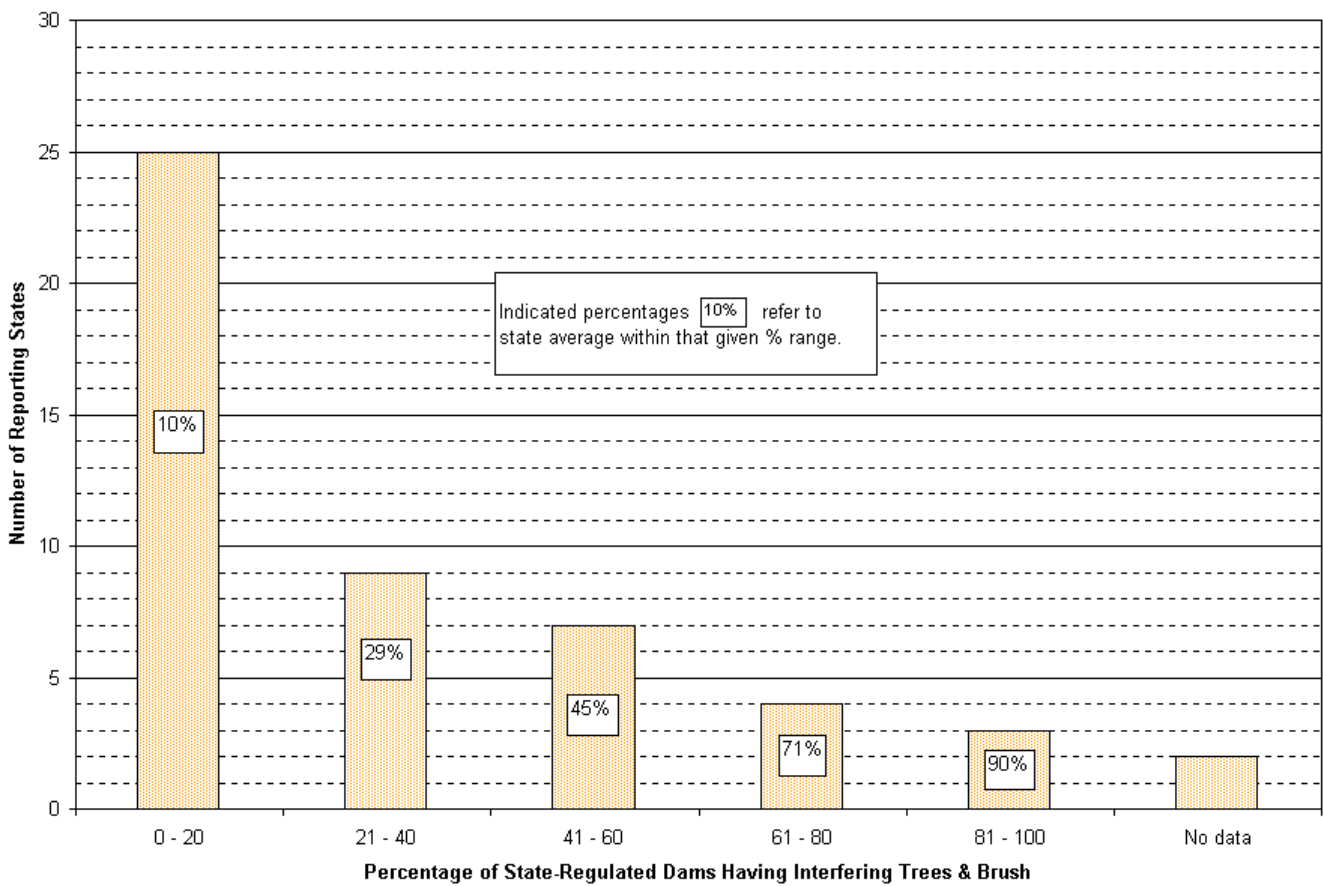
Figure 4. Estimated percentages of state-regulated dams where trees and brush are considered a deterrent to effective safety inspections.

Figure 4 gives a breakdown of the percentage ranges of regulated dams where the 48 reporting state dam safety officials shown in Figure 1 estimate that trees and brush hinder safety inspections in their respective states (ASDSO, 1999). While half the states report having only 20 percent or fewer dams with significant trees and woody vegetation that hinder inspections, vegetation on an estimated 30,000 or nearly a third of the collective state-regulated dams, is reported to obstruct effective dam safety inspections.

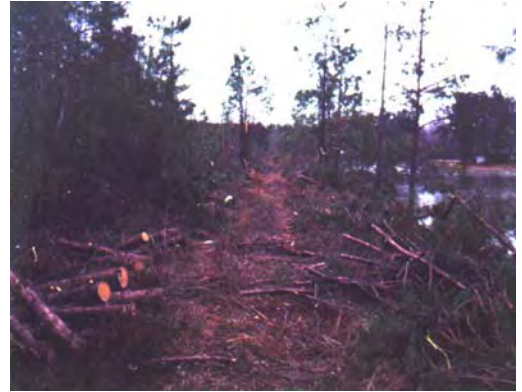
Figure 6. Trees cut prior to removing stumps and roots from dam.

Figures 6 and 7 illustrate extensive efforts necessary to restore a heavily wooded earthen dam to a desirable vegetated and maintained condition.

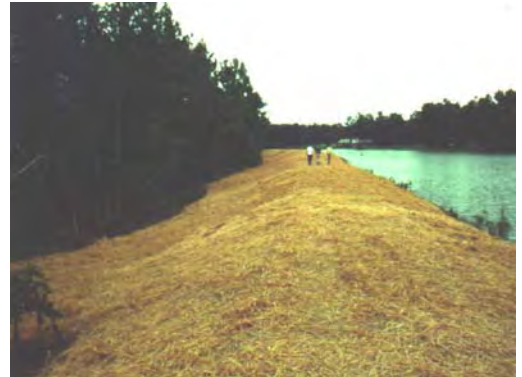
Figure 7. Completed remediation job after removing stumps, seeding, fertilizing & mulching.

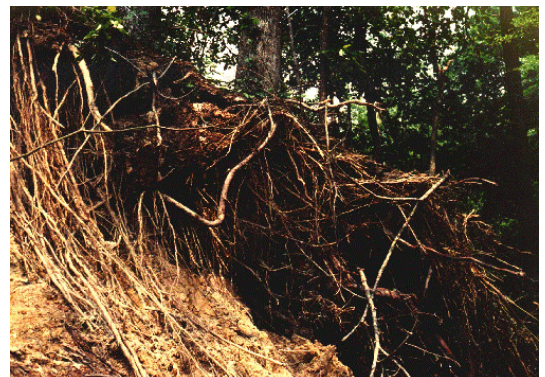
Figure 8. Exposed tree roots in overtopped dam.

Twenty-nine states indicated documented evidence where vegetation on dams has either caused dam failure or negatively affected their safe operation. Sixteen states had no documented evidence and five states had no response. Several states provided photos (Figure 8) and information on tree caused failures or dam

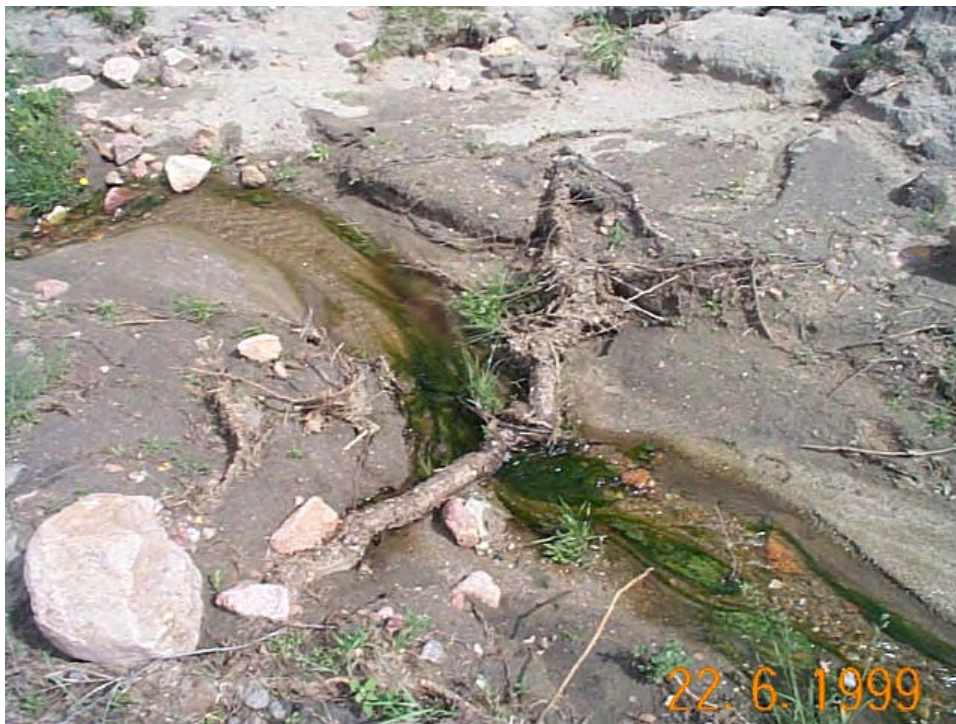
Figure 9. Large pine tree root located in the channel of the breach opening of a failed Air Force Academy waste lagoon pond dam (David Eyre, Senior Civil Engineer, Air Force Academy, Colorado, 1999).

safety problems. The most recent documented dam failure due to tree root penetration occurred in May 1999 at an unnamed Air Force Academy dam near Colorado Springs. Here, an approximately 13-ft. high dam with a pond capacity of less than 5 acre-feet of horse stable waste water failed, releasing its contents and injuring a horse in a stable located about 100 yards downstream. The failure occurred after more than 7 inches of rain had fallen in the previous 72 hours. The dam had several pine trees on its crest and faces, and the breach opening exposed an extensive, deep root system. Roots up to 4 inches in diameter were found in the breach area. Figure 9 shows an example of a large root exposed in the bottom of the channel at the breach. The dam had not overtopped, and the failure was attributed to internal erosion of the decomposed granite embankment material along the roots. A tree had been located directly over the breach.

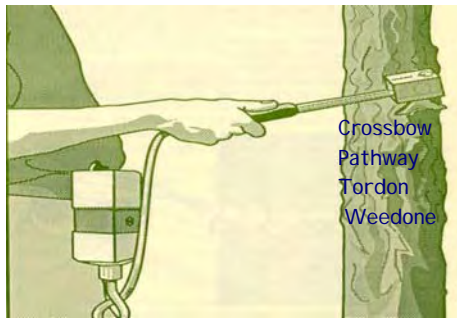
Crossbow
Pathway
Tordon
Weedone

Figure 5c. Hypohatchet application.

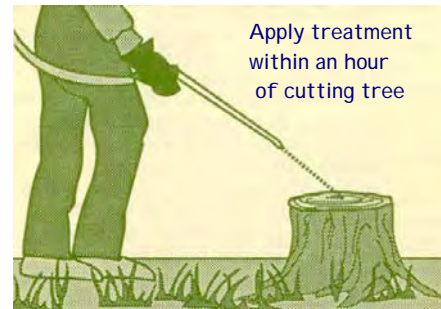
Apply treatment
within an hour
of cutting tree

Figure 5d. Cut-stump application.

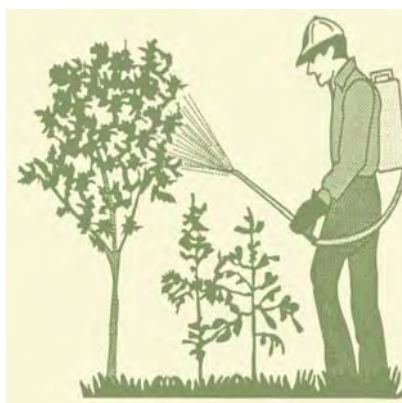
Vanquish
Weedone
Weedmaster
Crossbow
Banvel
Roundup
Accord
Arsenol
Chopper
Pathway
Tordon
Touchdown
Spike
Garland

Figure 5e. Backpack foliar application on dam.

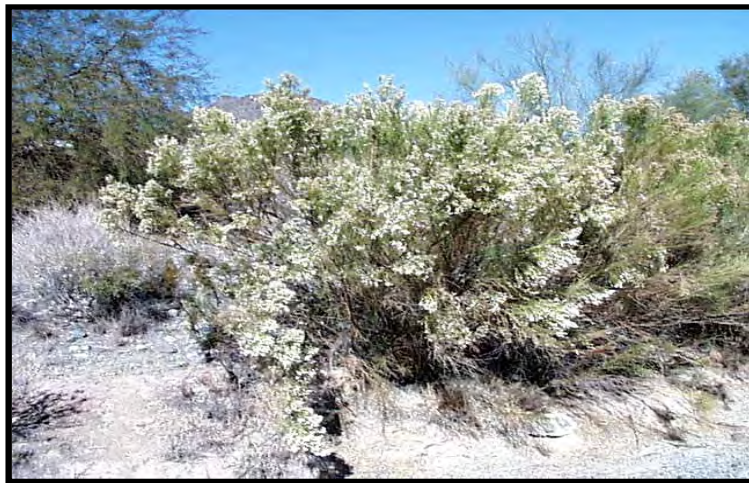
Figure 7. Deep-rooting Desert Broom Plant

Deep-rooted desert plants, when left unchecked, can propagate rapidly on earthen dams located in arid and semi-arid regions of the U. S. Some of these deep-rooted plants include Desert Broom shown in Figure 7, Salt Cedar, Mesquite, Cypress, Cottonwood and Paloverde. All of these species require considerable effort to control and should not be allowed to become established anywhere on dams. Palm trees can be a problem in that they are shallow-rooted, but develop a large root ball that can produce large cavities when toppled during high winds. Upstream and downstream access roads, in place at many dams, should be utilized to create a buffer zone between these species and the toe of dams.

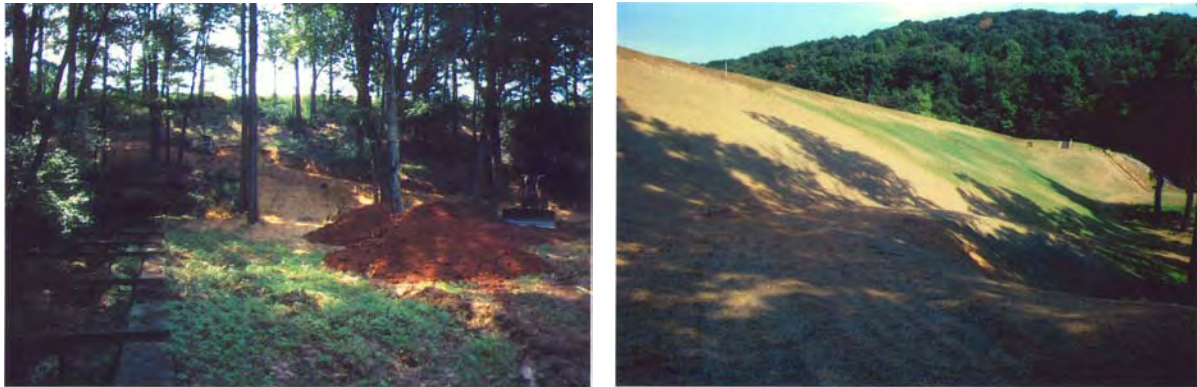
Figure 1. Restored Downstream Slope on Fishing Creek Dam, Maryland (1991-92)

State and federal dam safety officials and other dam safety experts agree that trees have no place on dams. Federal agencies and some states do not allow trees to grow on dams. However, it is estimated that about a third of the nation's 77,000 inventoried dams have sufficient woody vegetation to hinder effective dam safety inspections (ASDSO, 2000; Tschantz, 2000). Most states require dam owners to remove trees and undesirable vegetation, but the cost of clearing and grubbing trees and restoring the dam embankment slopes and crest is often cost prohibitive for many dam owners, usually running into thousands of dollars. It would seem that regular control of woody vegetation and maintaining the surface on an earthen is relatively inexpensive, compared to removing trees on and repairing damage from neglected dams such as shown in Figure 1.

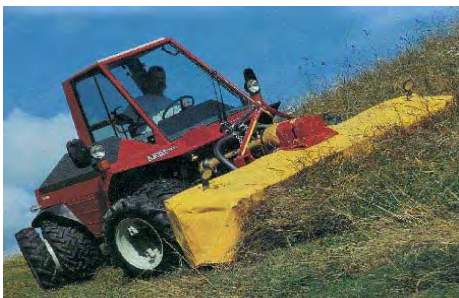
Figure 3. Example of slope mower (Terratrac© photo used with permission from AEBI North America, Inc.)

Figure 3 illustrates the use of a slope mower for easing the burden of maintenance for state and federal agencies and for other multiple or large dam owners.

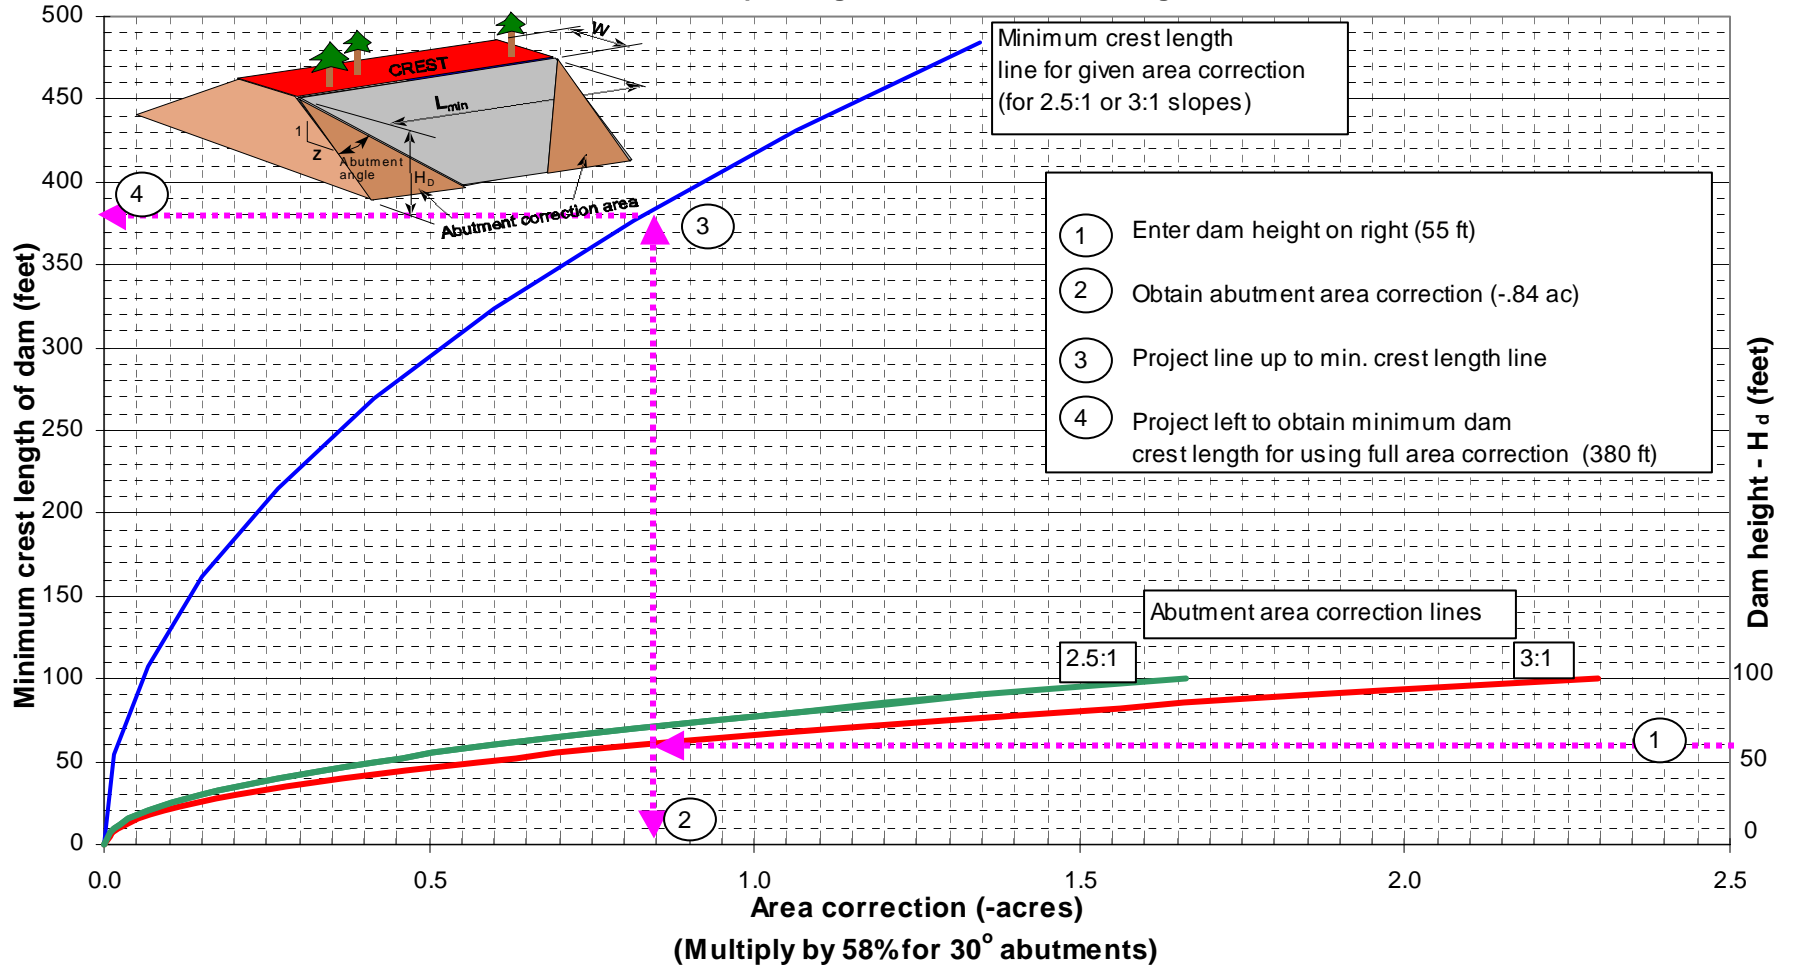
Chart 3. Abutment area corrections vs. dam height for 2.5H:1V & 3H:1V side slopes, with 45° abutment angle and corresponding minimum dam crest length
