**FHWA Bridge Inspector's Manual  
Sections 8.3-5 - Steel Superstructures**

SECTION 8: Inspection and Evaluation of Common Steel Superstructures  
TOPIC 8.3: Steel Two-Girder Systems

# Topic 8.3 Steel Two Girder Systems

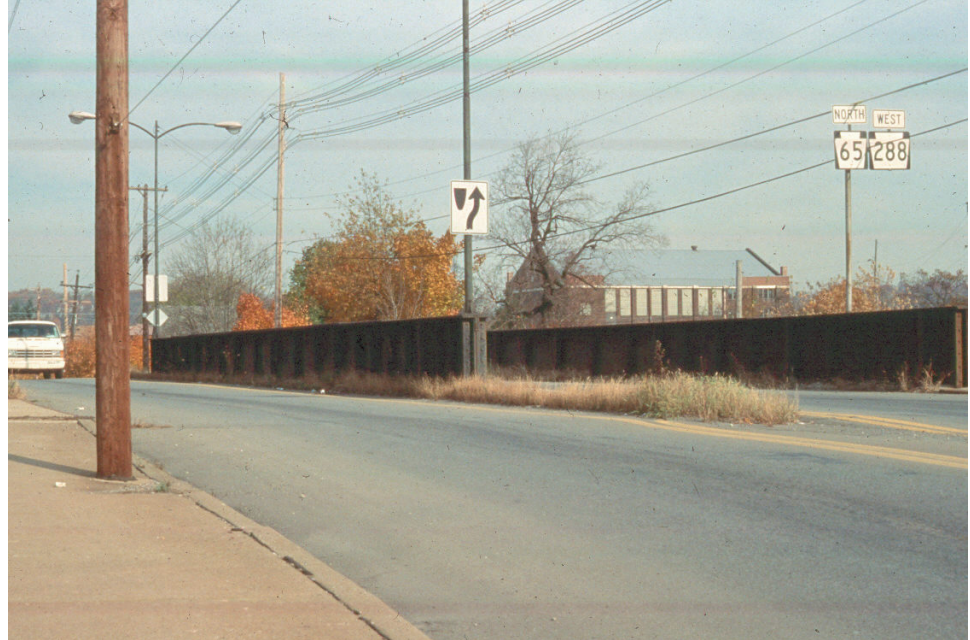
A rare type of through girder has three or more girders, with the main girders actually separating the traffic lanes (see Figure 8.3.4). These structures are most likely converted railroad or trolley bridges.

**Figure 8.3.4** Through Girder Bridge with Three Girders

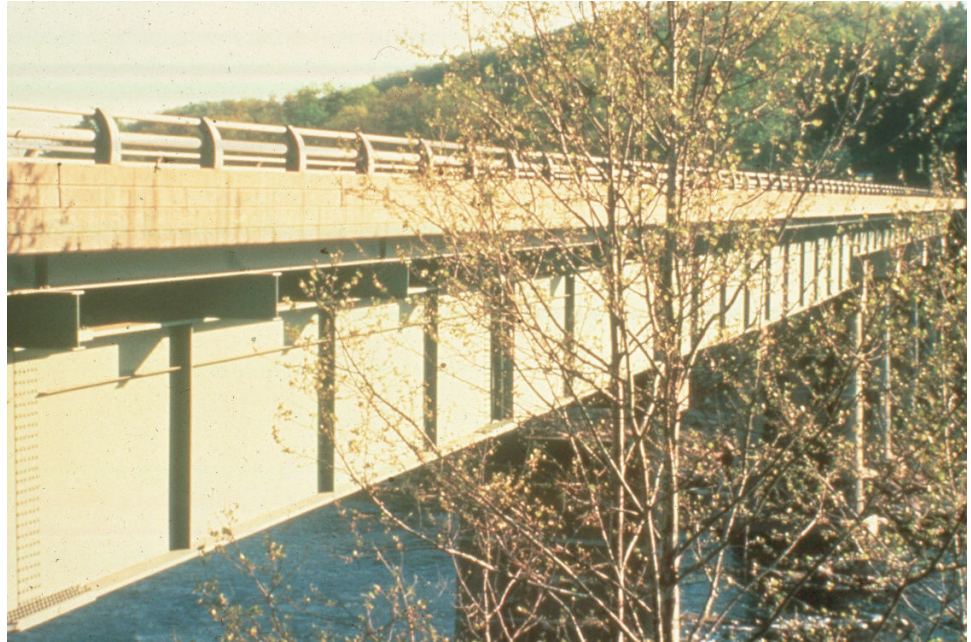
The girder-floorbeam-stringer (GFS) system consists of floorbeams connected to the main girders, and longitudinal stringers, parallel to the main girders, connected to the floorbeams (see Figure 8.3.6). The stringers may either connect to the web of the floorbeams or be stacked on top of the floorbeams, in which case they may be continuous stringers. Stringers are usually rolled beams and are considerably smaller than the floorbeams. It is also possible to find floorbeams that are stacked on top of the main girders, and the floorbeams may extend or overhang from the girders (see Figure 8.3.7).

**Figure 8.3.7** Two Girder Bridge with GFS System with Stacked Floorbeam and Stringers

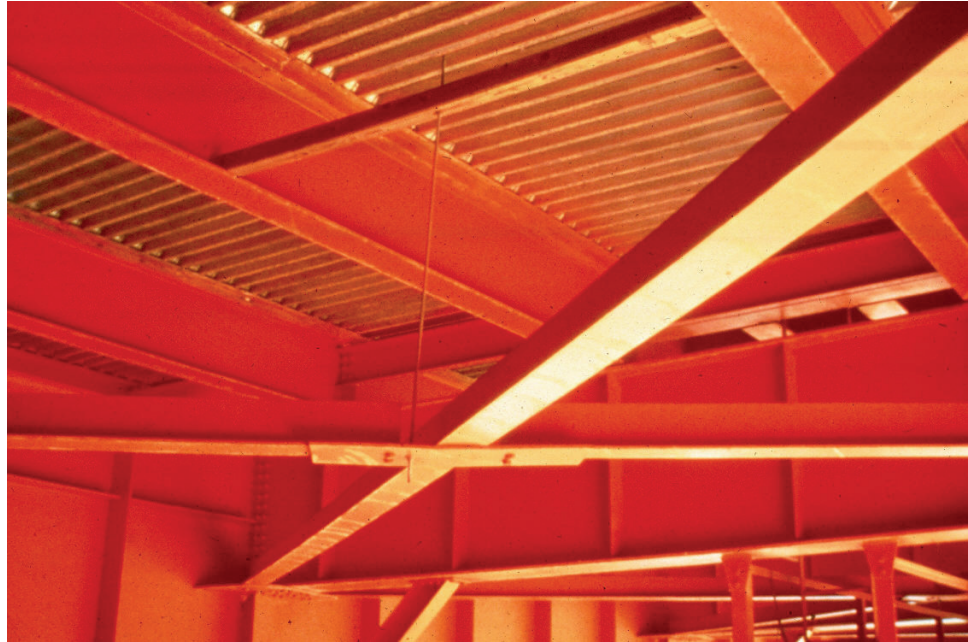
The primary members of a two girder bridge are the girders, floorbeams, and stringers, if present. The secondary members are diaphragms and the lateral bracing members, if present. These secondary members usually consist of angles or tee shapes placed diagonally in horizontal planes between the two main girders. The lateral bracing is generally in the plane of the bottom flange. Lateral bracing serves to minimize any differential longitudinal movement between the two girders (see Figure 8.3.8). Not all two girder bridges will have a lateral bracing system. Diaphragms, if present, are usually placed between stringers.

**Figure 8.3.8** Underside View of Deck Girder Bridge with Lateral Bracing System

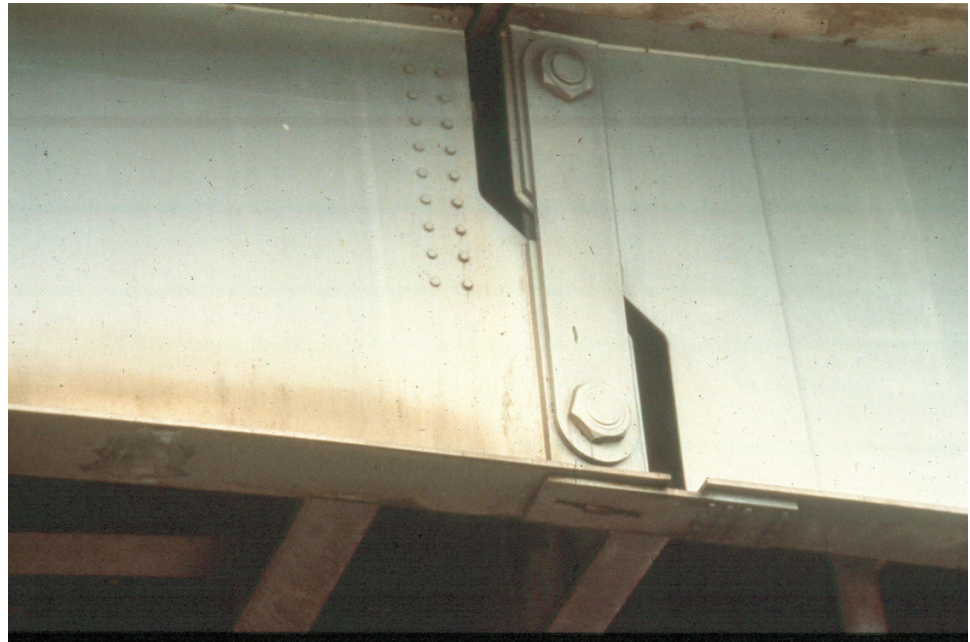
Pin and hanger assemblies in two girder bridges are fracture critical members (see Figure 8.3.10). Failure of one pin or one hanger will cause collapse of the suspended span since there is no alternate load path (e.g., Mianus River Bridge). Pins are considered “frozen” when corrosion restricts rotation. The pins and hangers experience additional bearing, torsion, bending and shear stresses when the pin and hanger assembly is frozen. This is a critical situation when it occurs on a (load path) nonredundant two girder bridge.

**Figure 8.3.10** Two Girder Bridge with Pin and Hanger Connection

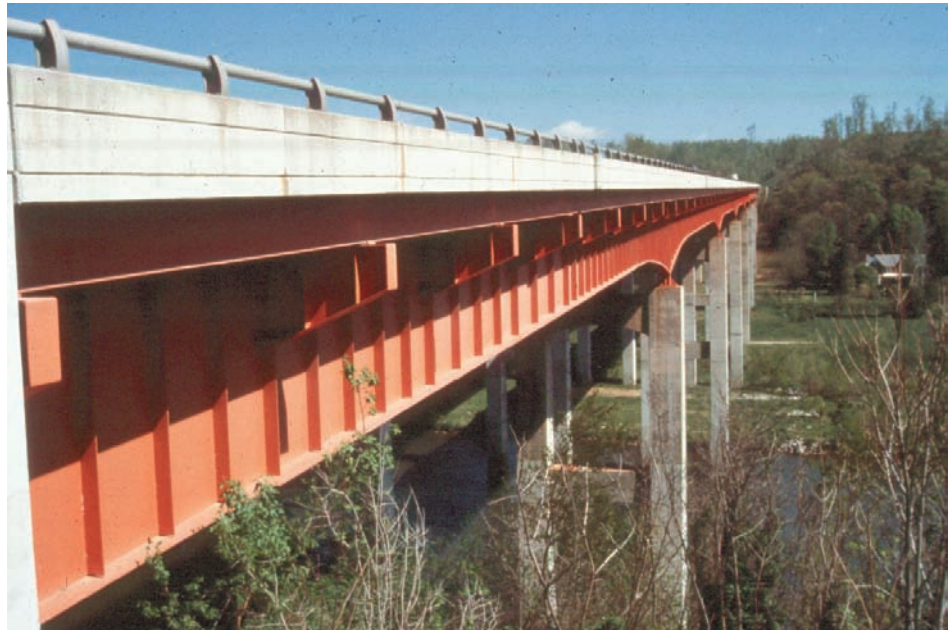
The flexure zone of each girder includes the entire length between the supports (see Figures 8.3.13 and 8.3.15). Investigate the tension and compression flanges for corrosion, loss of section, cracks, dings, and gouges. Check the flanges in high stress areas for bending or flexure-related damage. Examine the compression flange for local buckling and, although it is uncommon, for elongation or fracture of the tension flange. On continuous spans, the beams over the intermediate supports have high flexural stresses due to negative moment. Check flange splice welds and longitudinal stiffener splice welds in tension areas (see Figure 8.3.14).

**Figure 8.3.13** Flexural Zone on a Two Girder Bridge

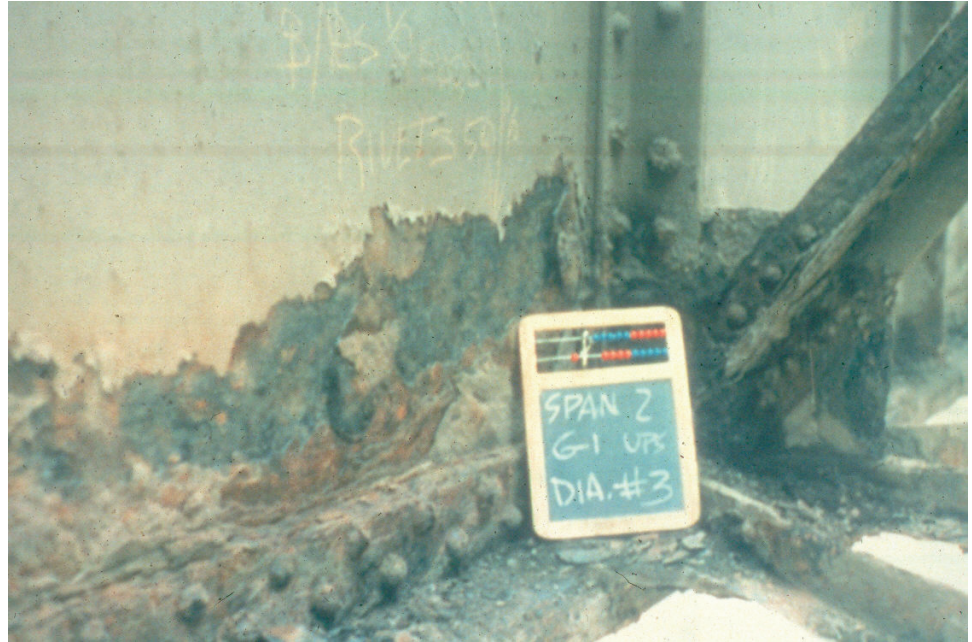
Investigate the diaphragms, if present, and the connection areas of the lateral bracing for cracked welds, fatigue cracks, and loose fasteners. Inspect the bracing members for any distortion or corrosion (see Figures 8.3.16 and 8.3.17). Distorted or cracked secondary members may be an indication the primary members may be overstressed or the substructure may be experiencing differential settlement.

**Figure 8.3.16** Lateral Bracing Connection on a Deck Girder Bridge

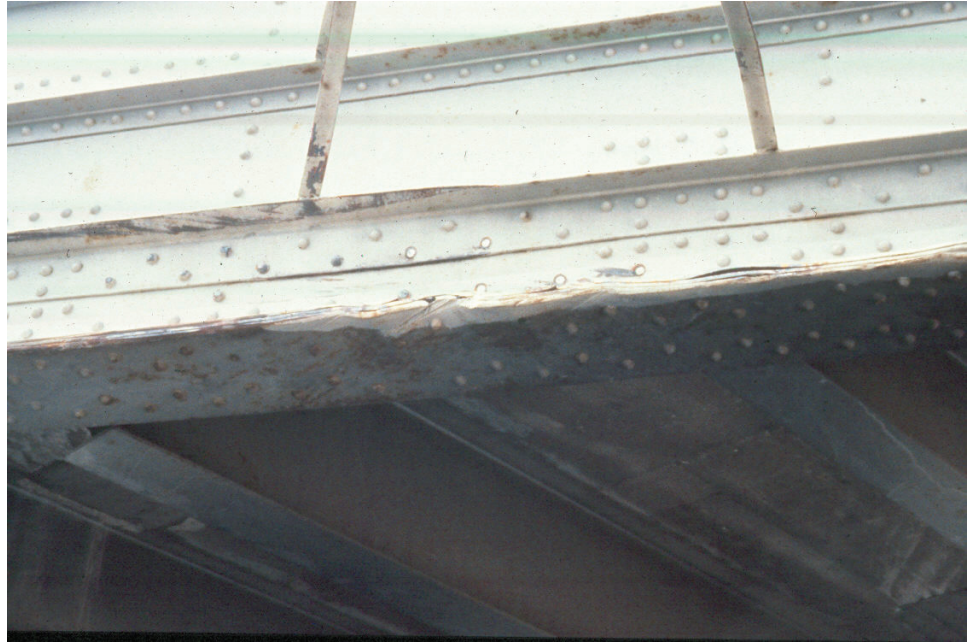
Check underneath the bridge for collision damage to the main girders and bracing if the bridge crosses over a highway, railway, or navigable channel. Document any cracks, section loss, or distortion found (see Figures 8.3.18 and 8.3.19). On a through girder bridge, investigate the main girders along the curb lines and at the ends for collision damage.

**Figure 8.3.19** Collision Damage to a Through Girder Bridge

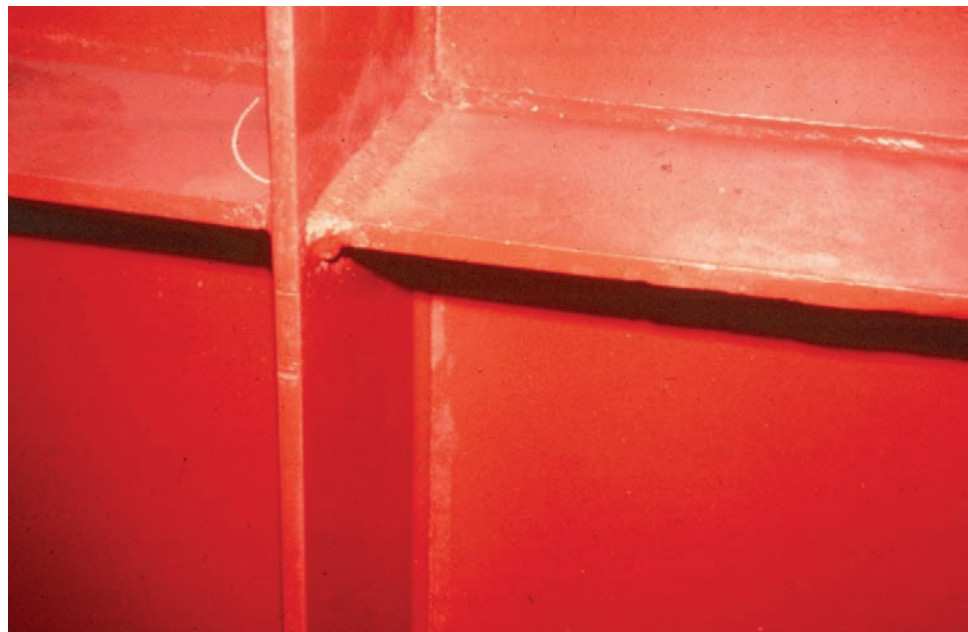
Check web stiffener welds, welded web/flange splices, and intersecting welds (see Figures 8.3.20 and 8.3.21). Also inspect any attachment welds located in the tension zone of the girder and floorbeam bracket tie plate (see Figure 8.3.22), especially unplanned miscellaneous attachment welds, such as utility brackets.

If the structure has been painted, breaks in the paint accompanied by rust staining indicate the possible existence of a fatigue crack. Investigate the areas surrounding field splice cover plates on the tension flange. The suspected crack area should be cleaned to determine the existence of a crack and its extent. If a crack with rust staining exists in the paint, the fatigue cracks in the steel can already be up to 6 mm (1/4 inch) deep in the beam flange. Check any attachment welds located in the superstructure tension zones, such as traffic safety features, lighting brackets, utility attachments, catwalks and signs. Welds are considered to be intersecting if they are within 6 mm (1/4 inch) from each other (see Figure 8.3.21).

**Figure 8.3.21** Intersecting Welds

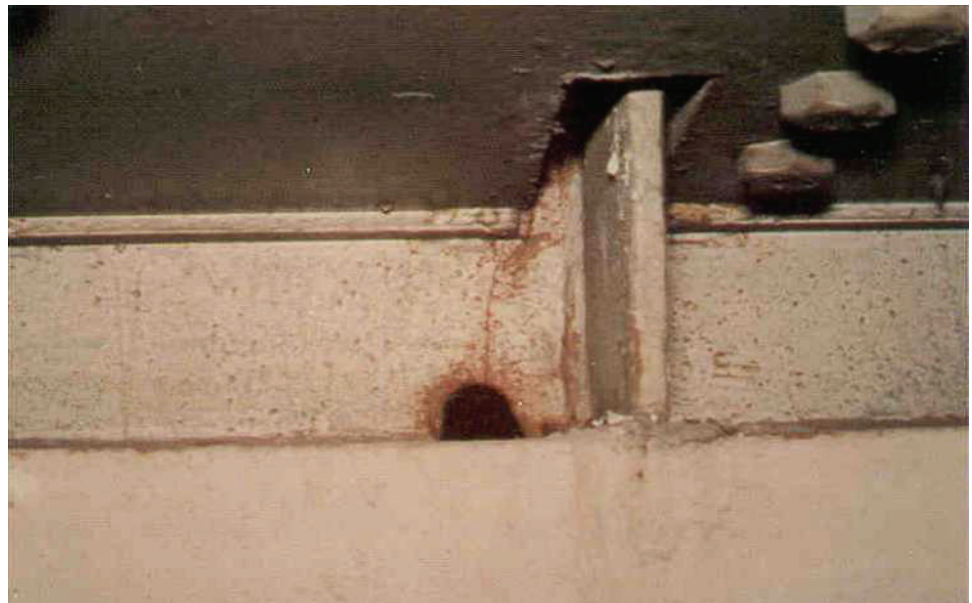
At the lower end of floorbeam connection plates that are not welded to the tension flange of girders, the condition of local out-of-plane distortion and bending of the web plate usually is less severe. This is because the tension flange is not restrained from lateral movement, which is sufficient to reduce the web plate bending. However, if the bottom flange is restrained from lateral deflection, fatigue cracks will develop along the web to flange weld.

**Figure 8.3.25** Crack Caused by Out-of-plane Distortion

The above figures show examples of potential for lateral gusset plate out-of-plane distortion problems. Vertical deflection of the lateral bracing causes stresses in the lateral bracing gusset plates. The welds connecting the lateral bracing gusset plate to the girder web may experience fatigue cracking. In addition to possible cracks at the internal gap, the ends of the gusset fillet weld should be equally suspect.

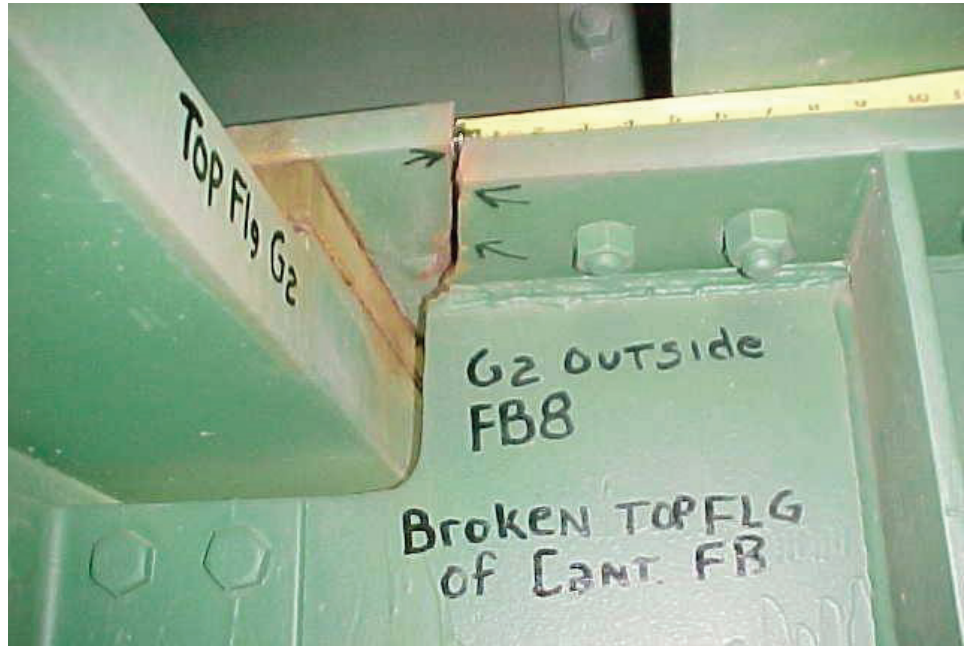
The floorbeam may be connected to the girder web (see Figure 8.3.28). Inspect for cracks in the floorbeam and girder. A tie plate may be utilized to reduce the fatigue stresses in the floorbeam/girder connection (see Figure 8.3.29). Carefully inspect the tie plate for fatigue cracking.

**Figure 8.3.28** Cracked Cantilever Floorbeam

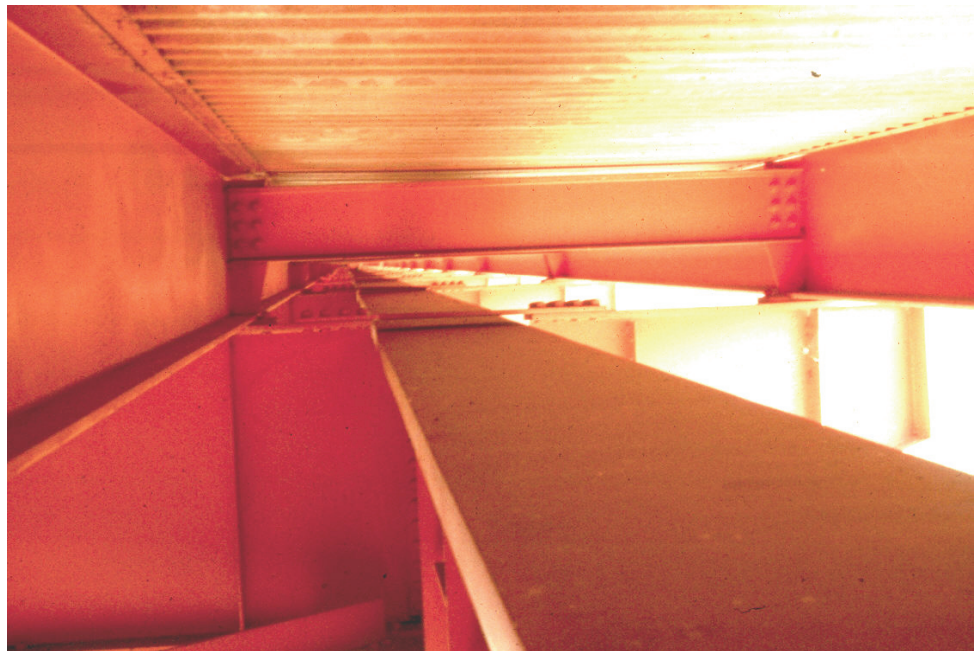
**Figure 8.3.29** Tie Plate for Cantilever Floorbeam

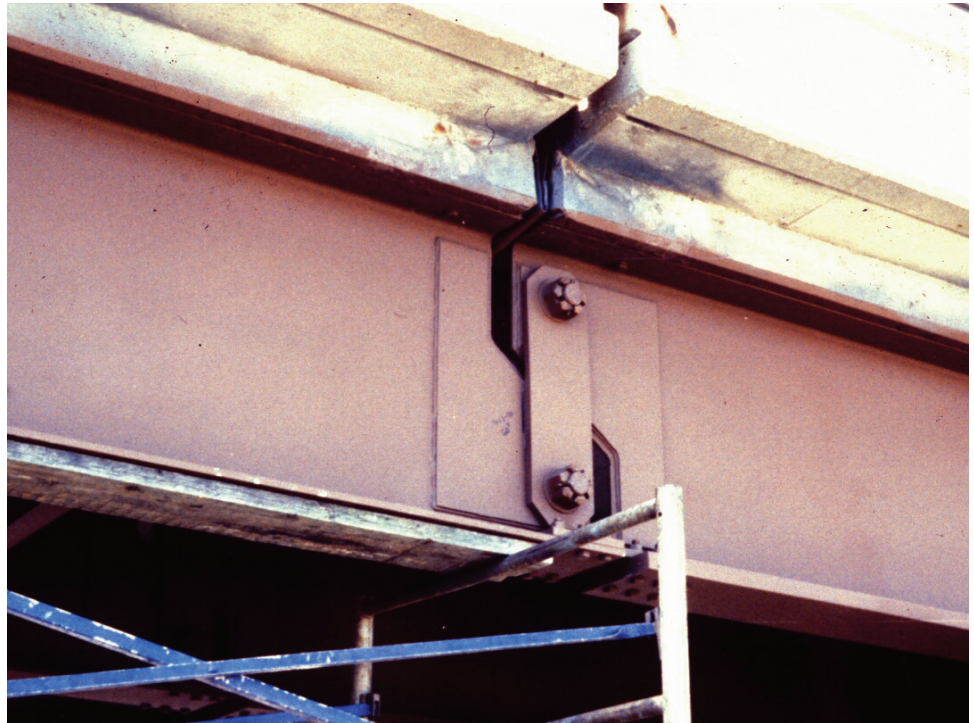
Pin and hanger assemblies are devices put in bridges to permit expansion movement and rotation (see Figure 8.4.1). If only rotation of the joint is desired, one pin is used (see Figure 8.4.2). When expansion (longitudinal) movement is also required, a system consisting of two pins with hanger links between them is used.

**Figure 8.4.1** Typical Pin and Hanger Assembly

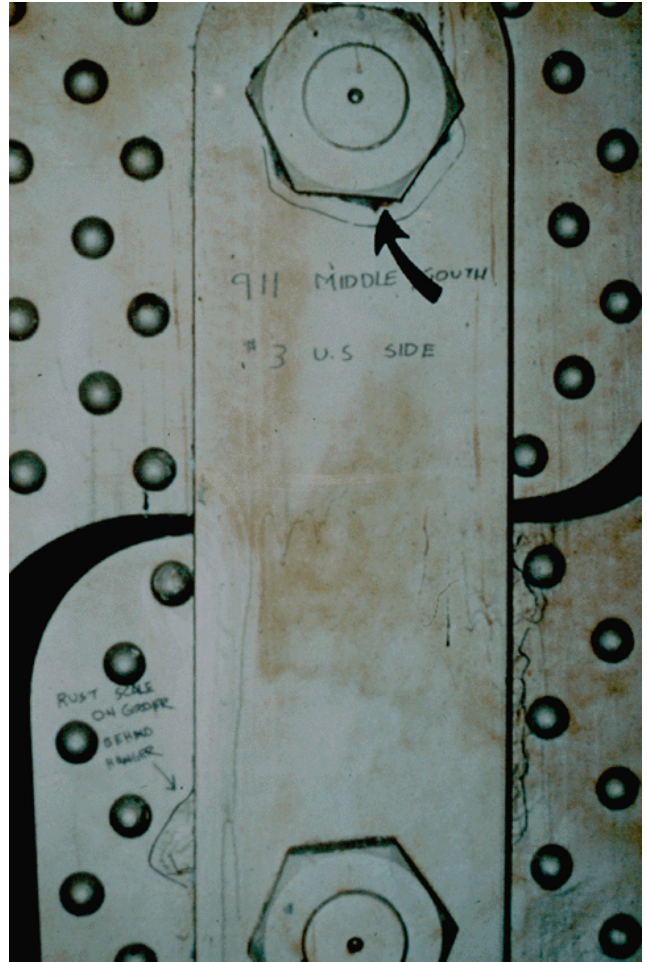
**Figure 8.4.6** Threaded Pin with Retaining Nut

The primary members of a pin and hanger assembly are the pin and the hanger link. The pin may be drilled to accept a through-bolt (see Figure 8.4.5) or threaded to accept a large nut (see Figure 8.4.6). Threaded pins are often stepped (or shouldered) to accept a small diameter nut. The hanger link may be a plain flat plate with two holes or an eyebar shaped plate (see Figure 8.4.7).

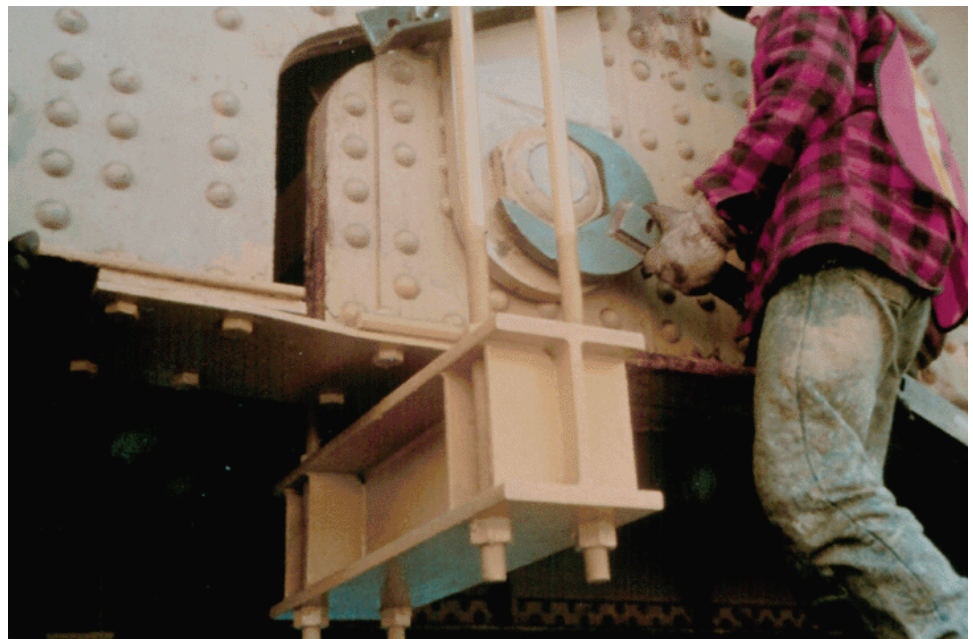
**Figure 8.4.9** Retaining Nut

The secondary members of a pin and hanger assembly include through-bolts and the pin cap (see Figure 8.4.8), nuts (see Figure 8.4.9), cotter pins on small assemblies with pins less than 100 mm (4 inches) in diameter, spacer washers and doubler plates which reinforce the beam web around the pin hole (see Figure 8.4.10).

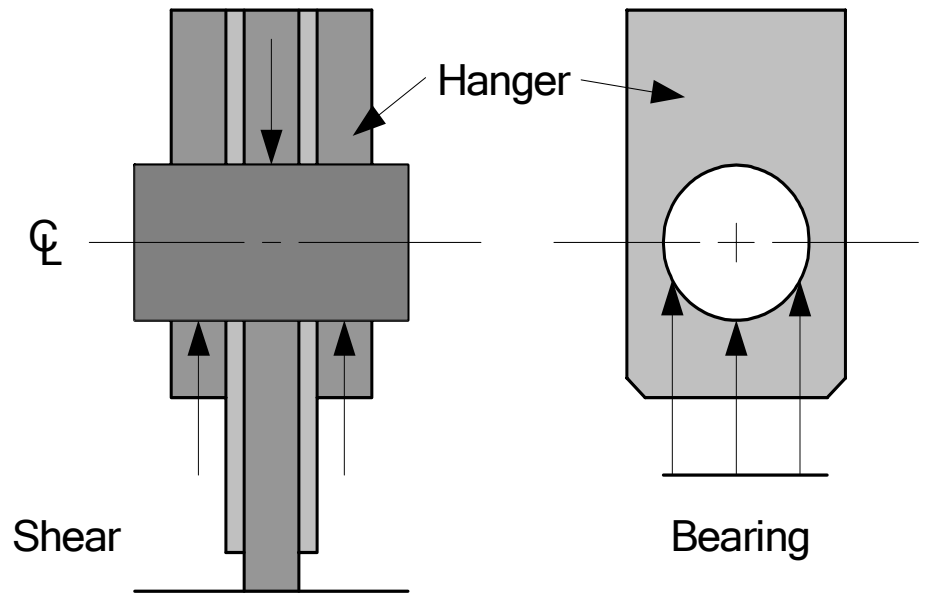
**Figure 8.4.13** Design Stress in a Pin (Shear and Bearing)

Pins are designed to resist shear and bearing on the full thickness of the hanger (see Figure 8.4.13). However, in addition to the designed forces, pins can see very high torsion (twisting) forces if they lose their ability to turn freely (see Figure 8.4.14). Corrosion and rust packing can inhibit or prevent the pins from turning properly. Pins can also be subjected to excessive bearing stress if the hanger shifts over the pin shoulder (see Figure 8.4.14).

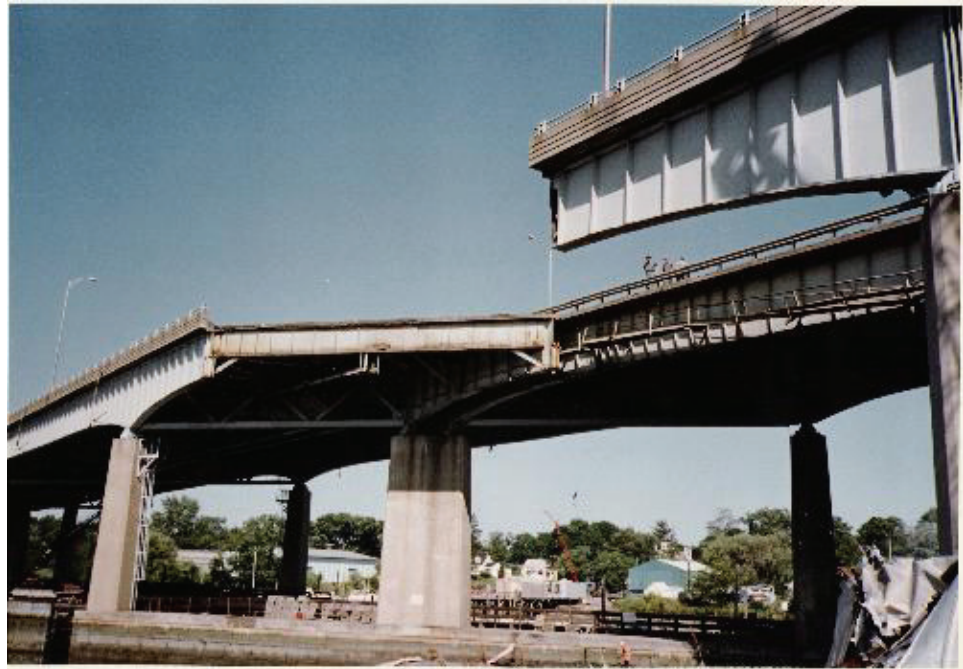
**Figure 8.4.15** Mianus River Bridge Failure

AASHTO “Manual for Condition Evaluation of Bridges”, Section 3.12 calls for special attention during the inspection of pin and hanger connections on two or three girder systems. Failure of one pin or one hanger will cause collapse of the suspended span since there is no alternate load path. The collapse can be catastrophic as demonstrated by the Mianus River Bridge failure shown in Figure 8.4.15. The Mianus River Bridge failed due to the formation of rust between the hangers and the girder webs. As steel rusts, the rust can occupy up to 10 times the original steel volume causing unwanted expansion forces when in a confined space. When rust creates this type of expansion force, it is called “rust packing”. In the case of the Mianus River Bridge, the rust packing pushed the hangers to the ends of the deteriorated pins and the pins eventually failed in bearing.

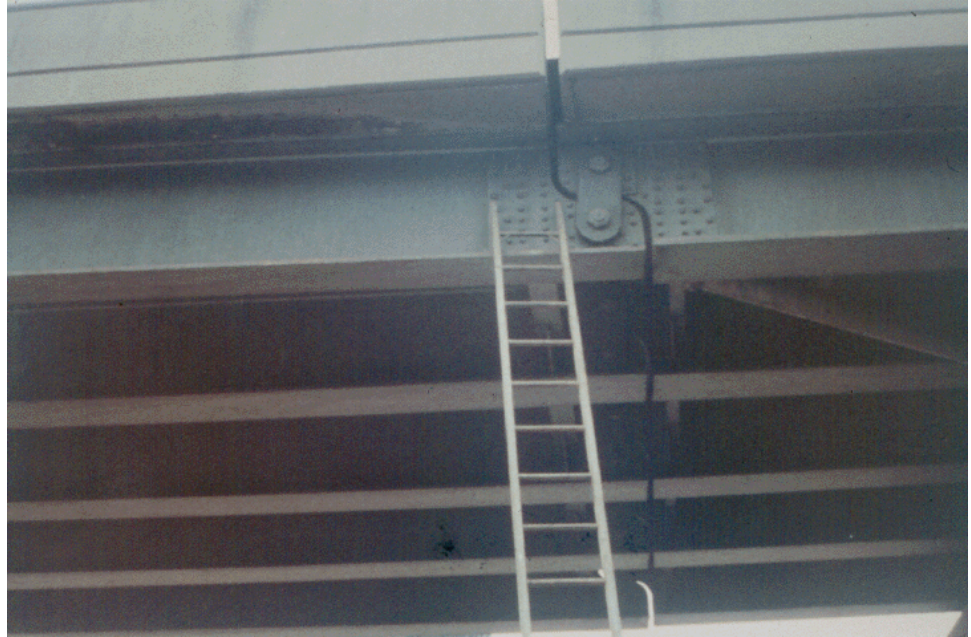
**Figure 8.4.16** Multi-girder Bridge with Pin and Hanger Assemblies

Pin and hanger assemblies in multi-girder structures are not technically fracture critical, since multiple load paths are available. However, they do have the potential for progressive collapse. If all the pin and hanger assemblies at a joint location are frozen and consequently overstressed, the failure of one could cause an adjacent assembly to fail and so on (see Figure 8.4.16).

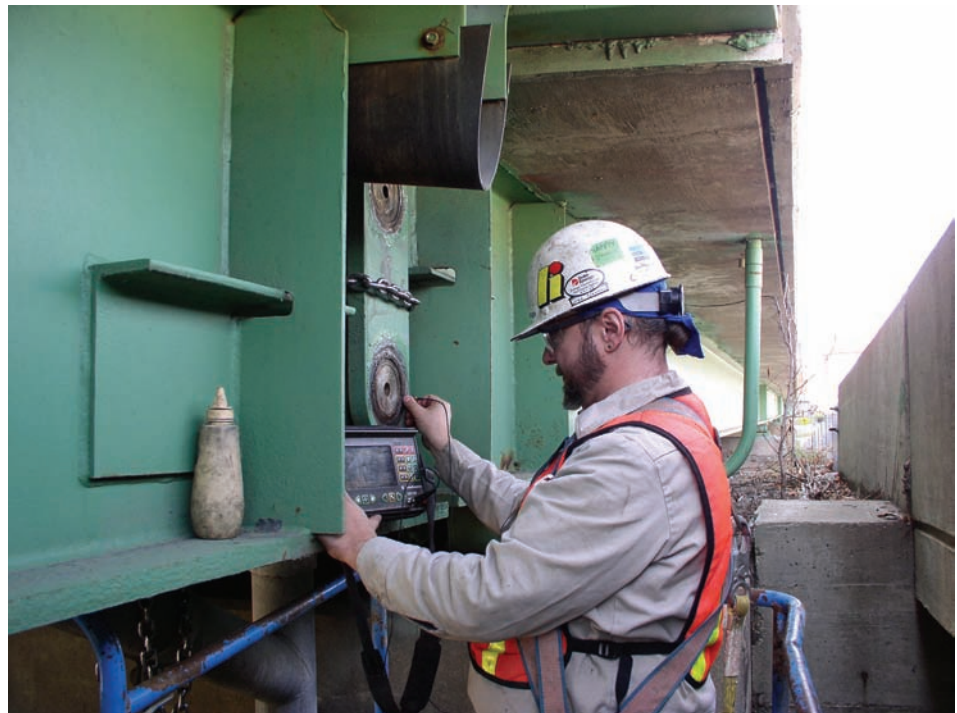
**Figure 8.4.17** Ultrasonic Testing of a Pin

Ultrasonic testing is currently the most common means available of checking pins in place (see Figure 8.4.17). For the results to be valid, careful planning and testing by trained individuals is required. For a more detailed look at ultrasonic testing refer to Topic 13.3.

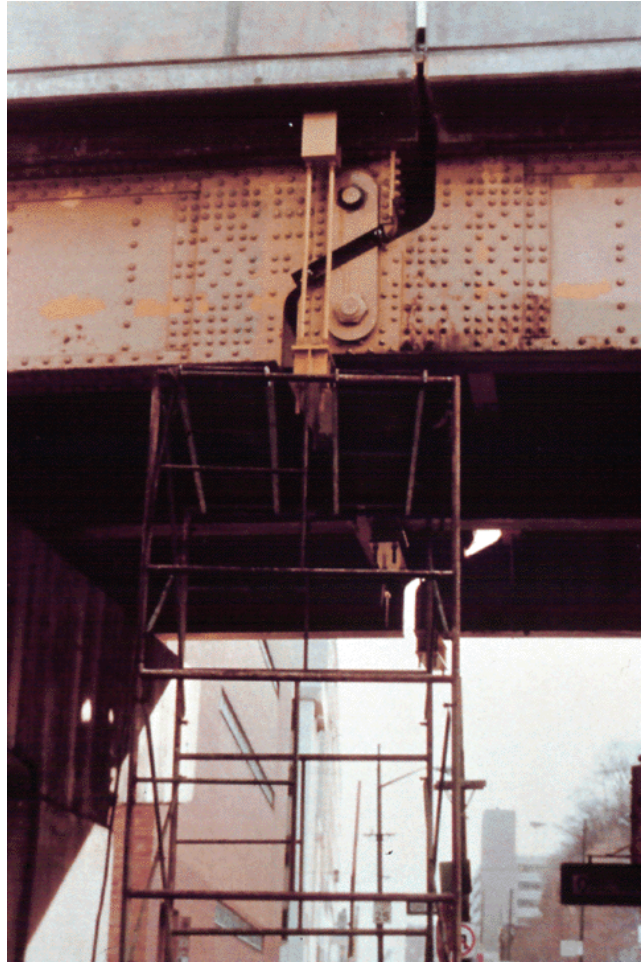
**Figure 8.4.18** Alternate Hanger Link Retaining System

Another method for inspecting the pin is to disassemble the pin and hanger unit. Disassembly of a pin and hanger joint should be undertaken only after proper engineering design is performed and auxiliary support supplied. It is not a routine bridge inspection procedure (see Figure 8.4.18).

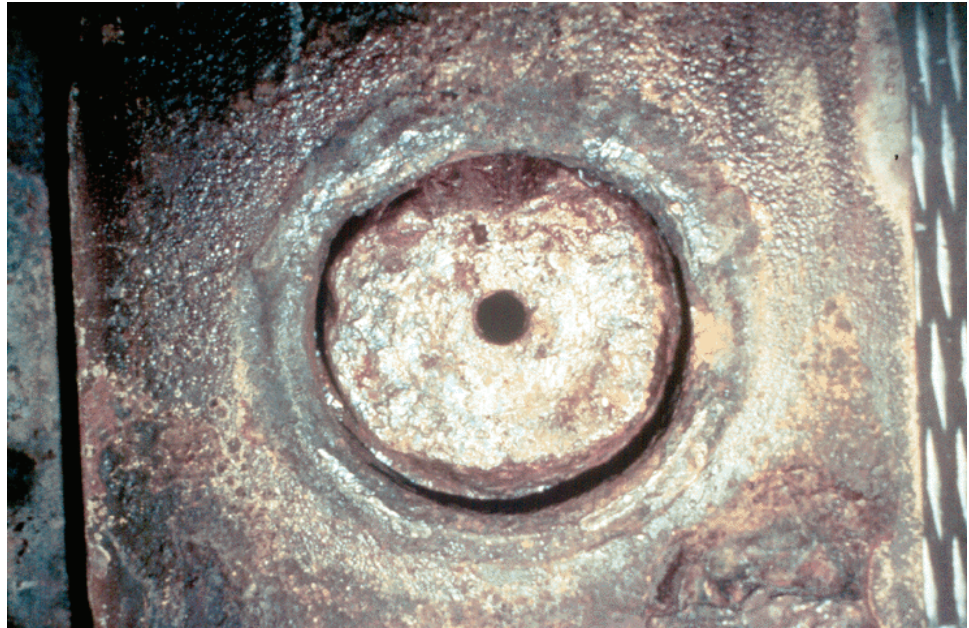
**Figure 8.4.23** Corroded Pin and Hanger Assembly

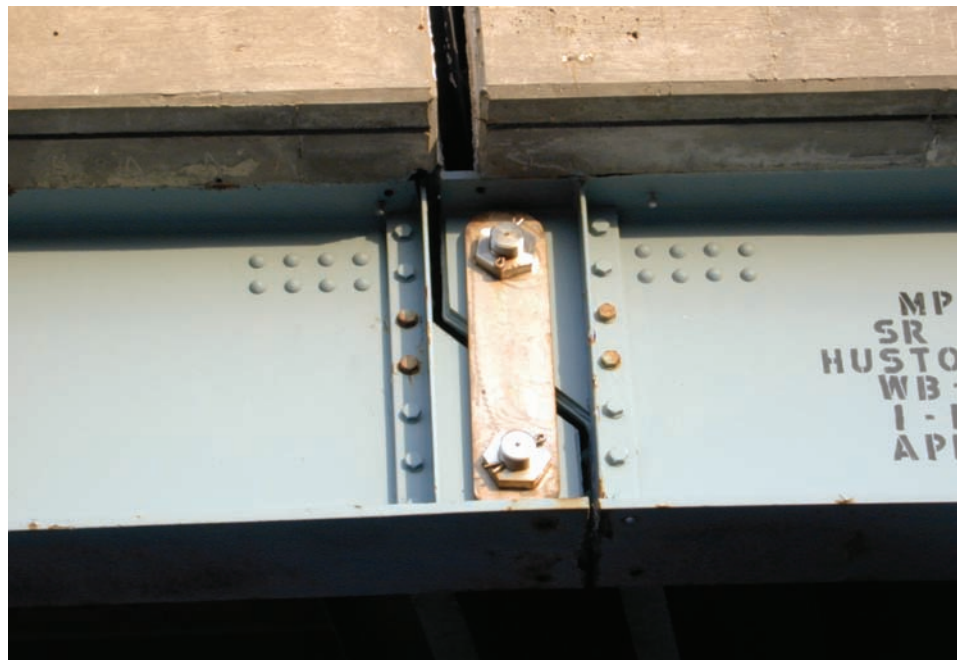
**Figure 8.4.25** Stainless Steel Pin and Hanger Assembly

Replacing the pin and hanger assembly in kind with a structural grade of stainless steel eliminates potential failures due to corrosion related problems. Placing a non-metallic insert and washer prevents corrosion between the pin and hanger and allows for normal rotation.

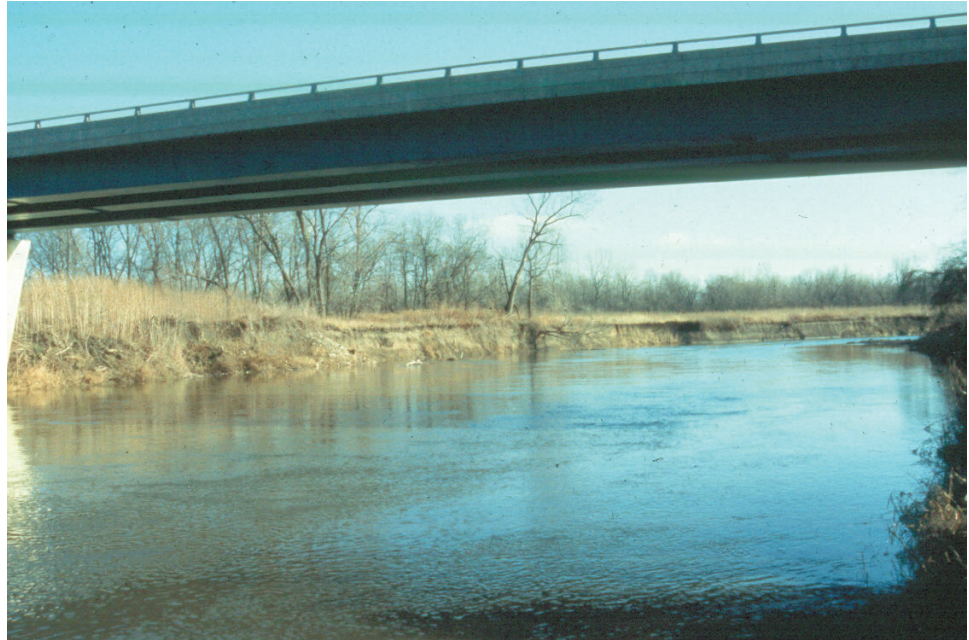
**Figure 8.5.1** Simple Span Box Girder Bridge

Box girder bridges are used in simple spans of 75 feet or more (see Figure 8.5.1) and in continuous spans of 100 feet or more. They are frequently used for curved bridges due to their high degree of torsional rigidity (see Figure 8.5.2).

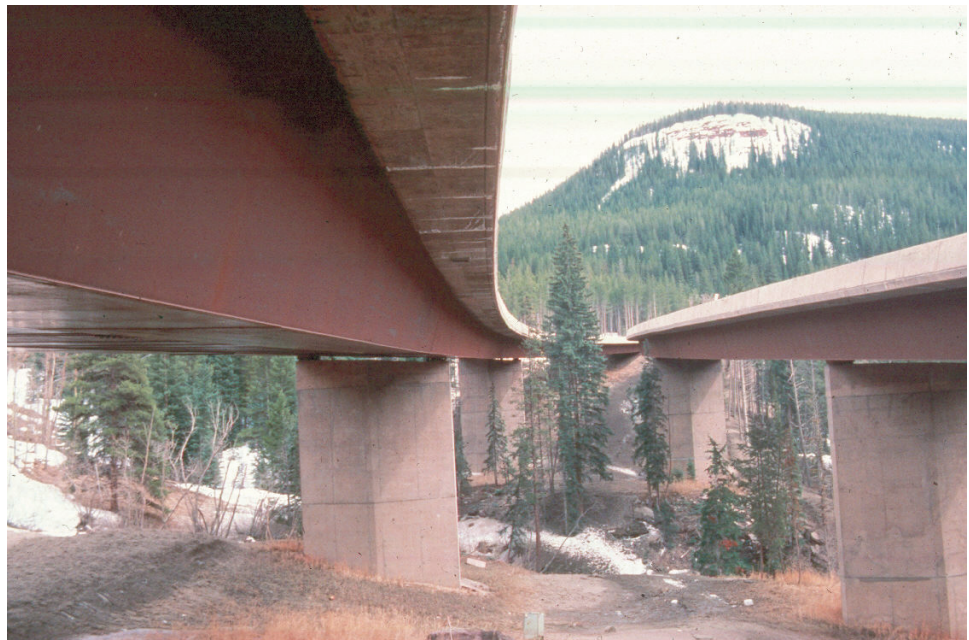
**Figure 8.5.2** Curved Box Girder Bridge

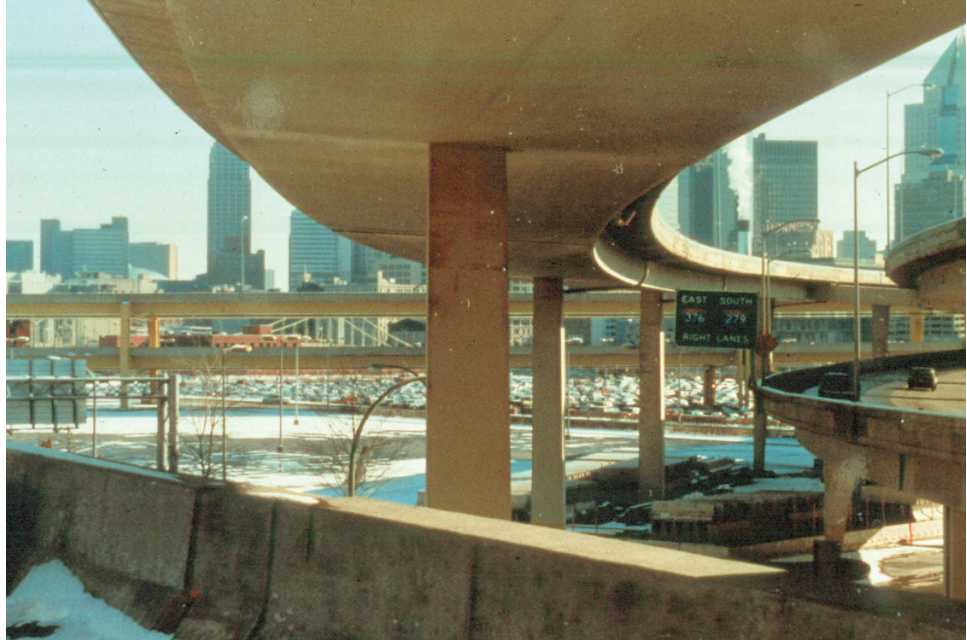
**Figure 8.5.3** Box Girders With Cantilevered Supports for Deck

A box girder bridge can use a single box configuration (see Figure 8.5.3) or have multiple (spread) boxes in its cross section (see Figure 8.5.4). Several factors such as deck width, span length, terrain and even aesthetics can all play a role in determining which configuration will be used.

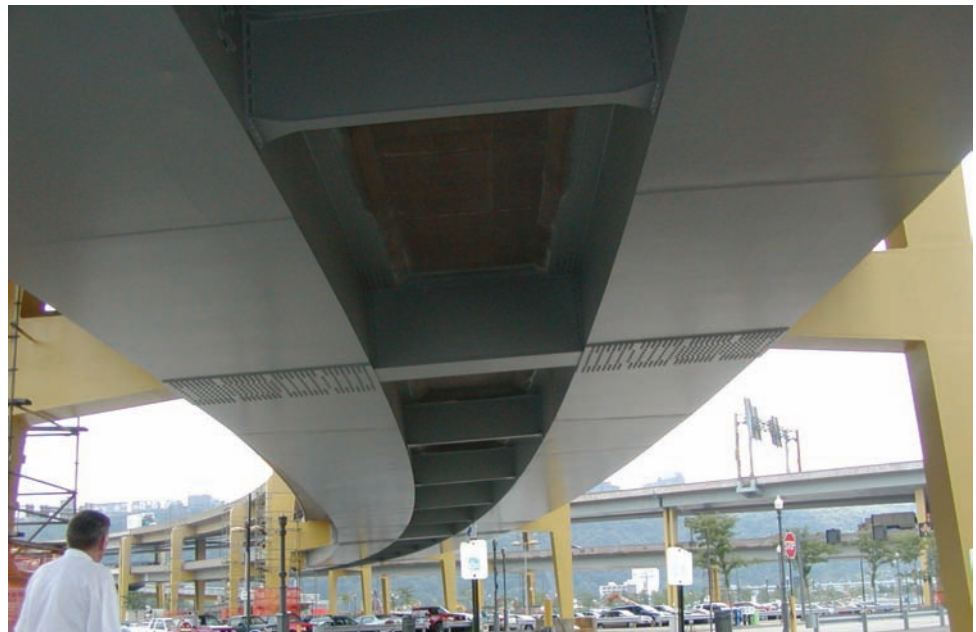
**Figure 8.5.4** Spread Box Girders

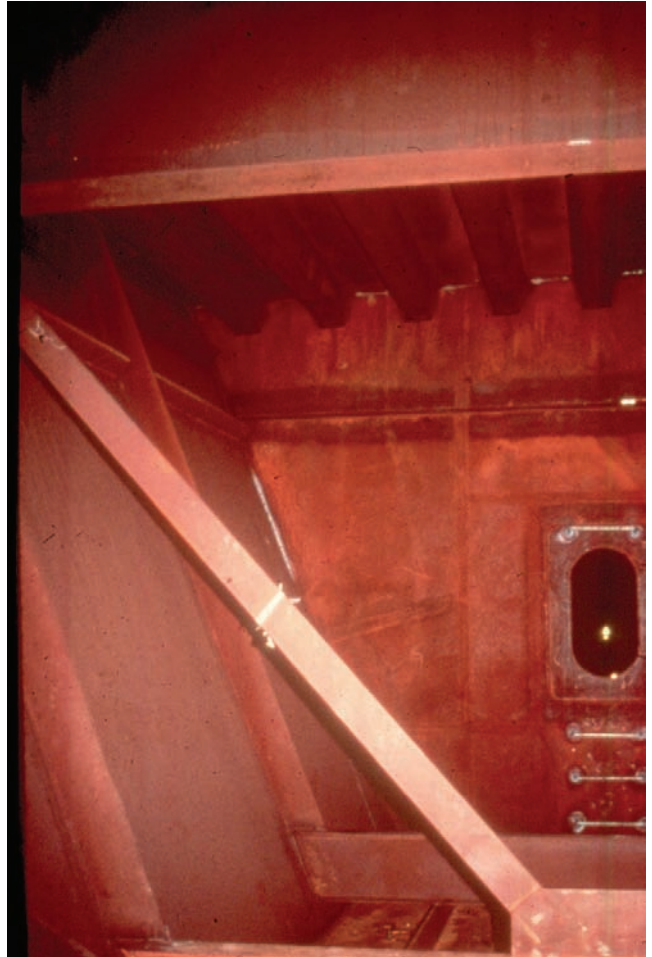
**Figure 8.5.5** Diaphragms – K Bracing and Plate

The primary members of a box girder bridge are the box girders (including all internal bracing) and, on a curved bridge, the diaphragms. On a straight bridge, the diaphragms are secondary members. Diaphragms can be solid plates, rolled shapes (e.g., I-beams and channels), or cross frames constructed with angles, tee shapes, and plates (see Figure 8.5.5). Diaphragms may be on the interior or exterior of the box.

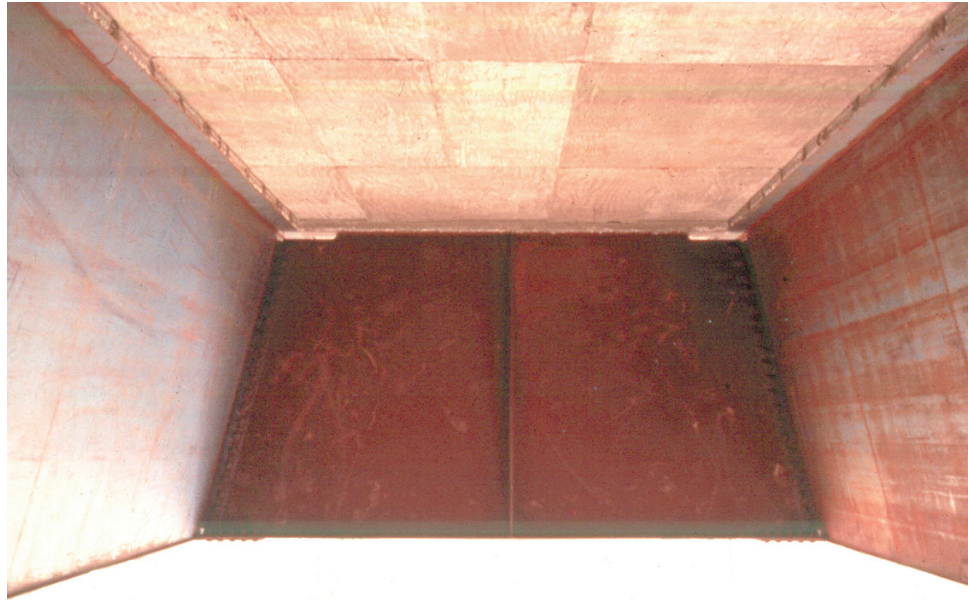
**Figure 8.5.6** External Diaphragm

The webs and bottom flange of large box shapes must be stiffened in areas of compressive stress. This is accomplished in part by stiffeners located inside the box member. The stiffeners are designed to help the box girder resist buckling due to torsional and shear forces. The stiffeners limit the unsupported length of the web and bottom flange, which result in increased stability of the box girder. Box girders may also incorporate both diaphragm and top flange lateral bracing systems. External diaphragms may be used between box girders (see Figure 8.5.6). Box girders typically have an opening or access door to allow the bridge inspector to examine the inside of the box (see Figure 8.5.7).

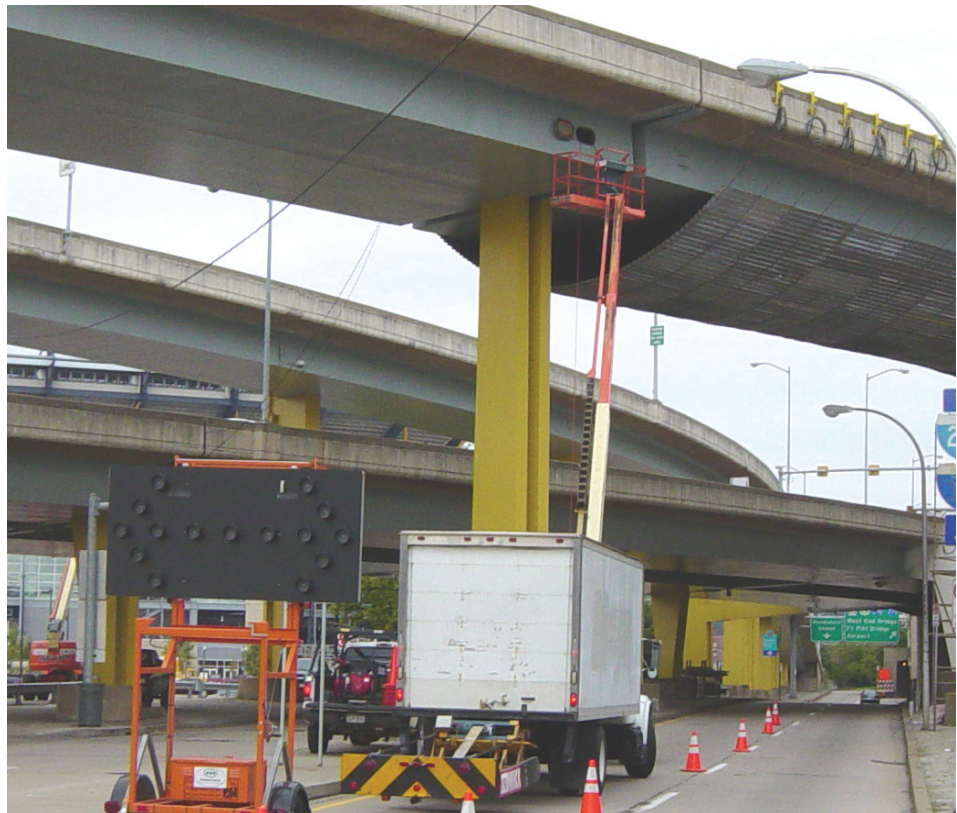
**Figure 8.5.7** Box Girder Access Door

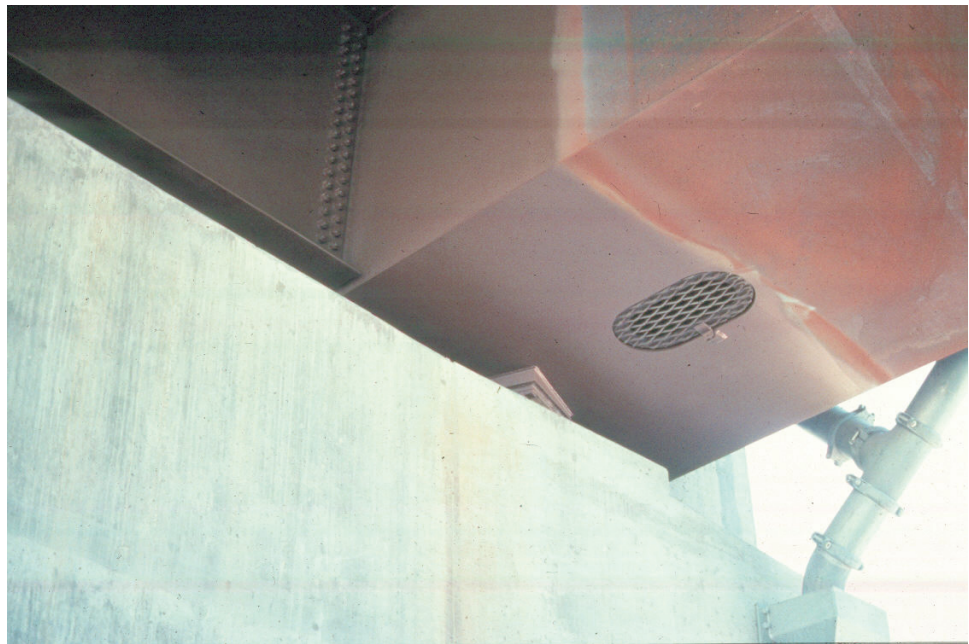
**Figure 8.5.10** Box Girder Shear Zone

Examine the web areas near substructure supports for cracks, section loss and buckling (see Figure 8.5.10). Be sure to include intermediate supports provided by piers (see Figure 8.5.11).

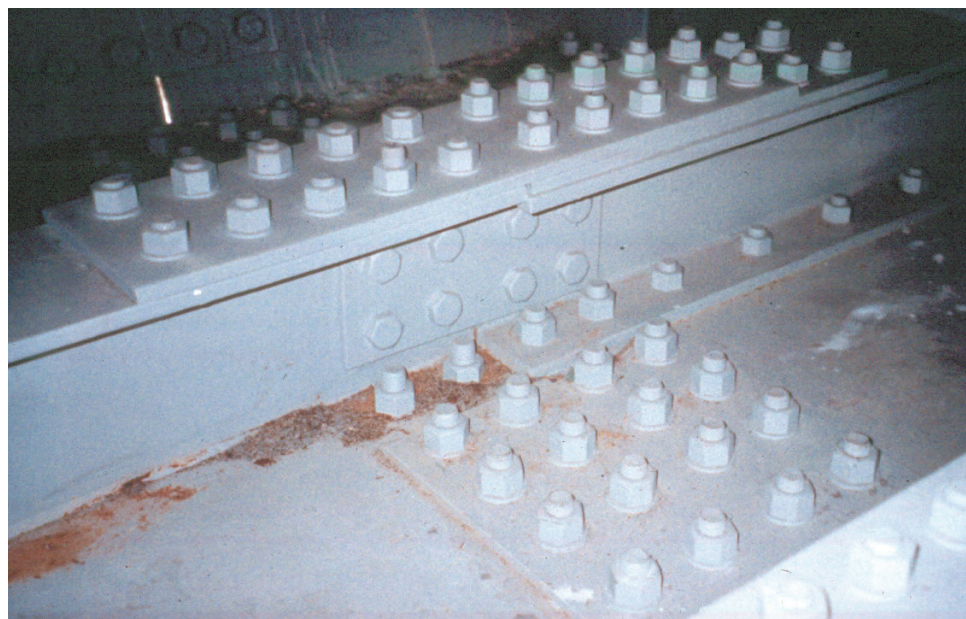
**Figure 8.5.12** Field Splice

Check all welds and welded attachments inside the box. This includes web stiffeners, flange stiffeners, diaphragms, lateral bracing, and stay-in-place deck panels. Stiffener weld terminations in tension zones are a special concern. Butt welds joining adjacent longitudinal stiffeners on the bottom flange serve as potential sources for cracks to propagate into the bottom flange. Check all intersecting welds between the webs and flanges, particularly in tension areas. Welds are considered to be intersecting if they are within 6 mm (1/4 inch) from each other. Check field splice areas, especially where stiffeners are welded to the web or bottom flange (see Figure 8.5.12).
