**FHWA Bridge Inspector's Manual  
Sections 8.3-5 - Steel Superstructures**

SECTION 8: Inspection and Evaluation of Common Steel Superstructures  
TOPIC 8.3: Steel Two-Girder Systems

# Topic 8.3 Steel Two Girder Systems

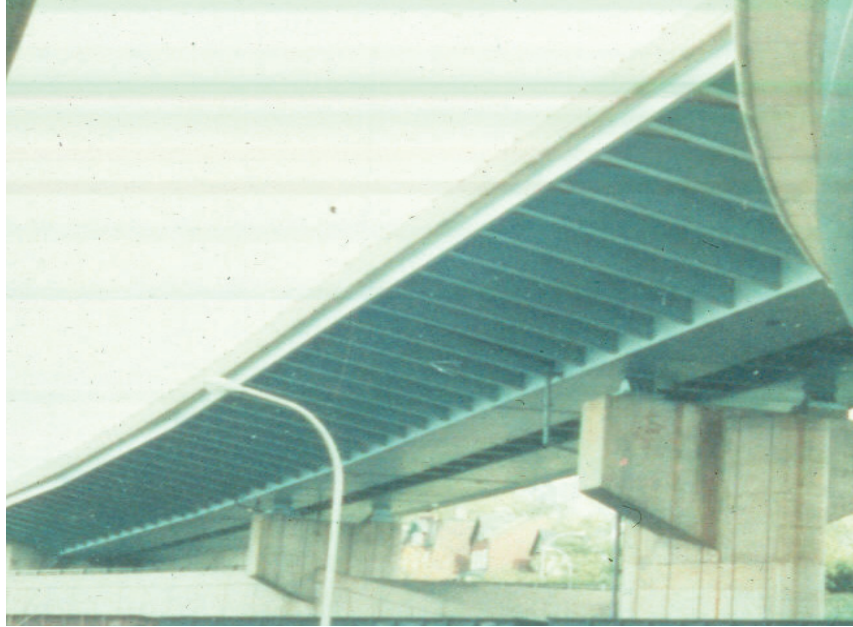
**Figure 8.5.14** Non-redundant Box Girder Bridge

The redundant nature of a box girder bridge depends primarily on the number of box girders in the span. If two or less box girders are used, the structure is considered nonredundant and the box girders are fracture critical members (see Figure 8.5.14). All previous inspection reports should be reviewed before performing the inspection to note any areas of particular concern. All reported deficiencies should be checked to ensure no further development has occurred.

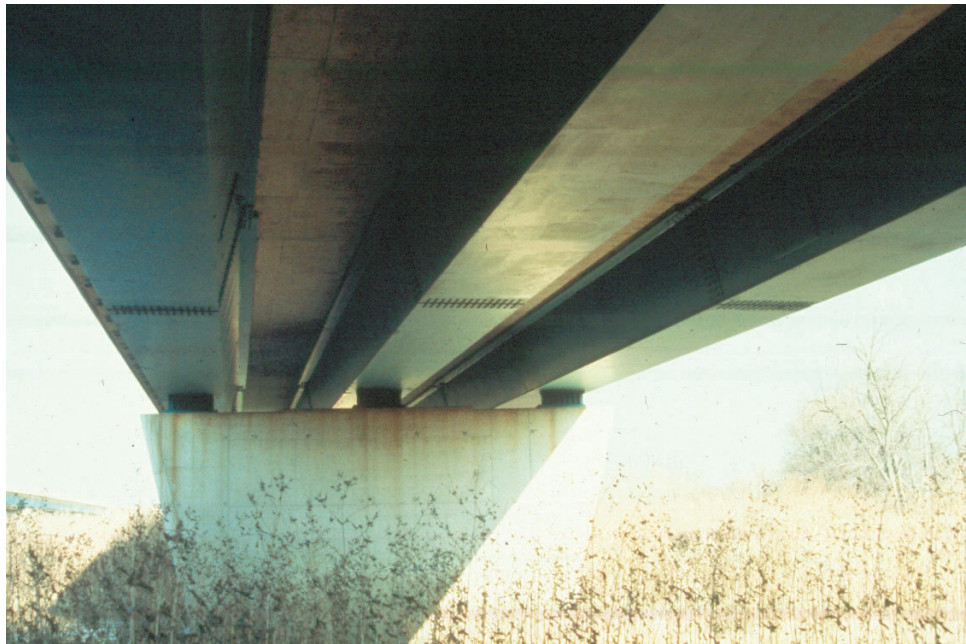
**Figure 8.5.15** Redundant Box Girder Bridge

If three or more box girders are used, the structure is generally considered redundant (see Figure 8.5.15). However, if the spacing of the box girders is large, the structure may not be redundant.

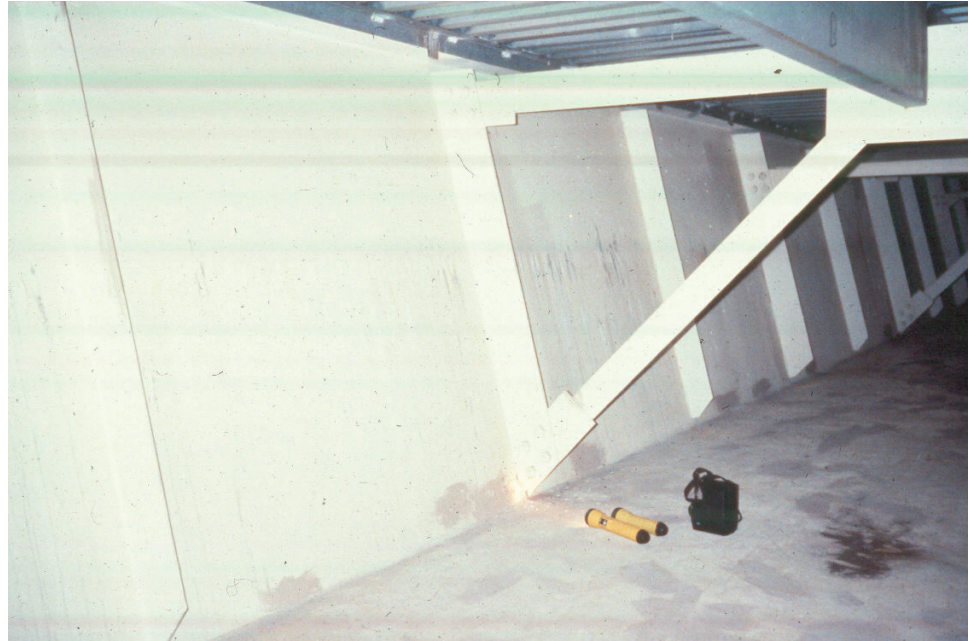
**Figure 8.5.16** Box Girder Internal Diaphragm Not Attached to Flange

The web gap detail between the web and the transverse stiffeners is another area that is prone to cracking (see Figure 8.5.16). Similar to a girder and floorbeam connection, the top flange is restrained from lateral movement and cracks may develop in the region as a result of web plate bending.
