PDHonline Course C220 (6 PDH)

Assessing the Vulnerability at Coastal Sites

Chapter 7: Identifying Hazards

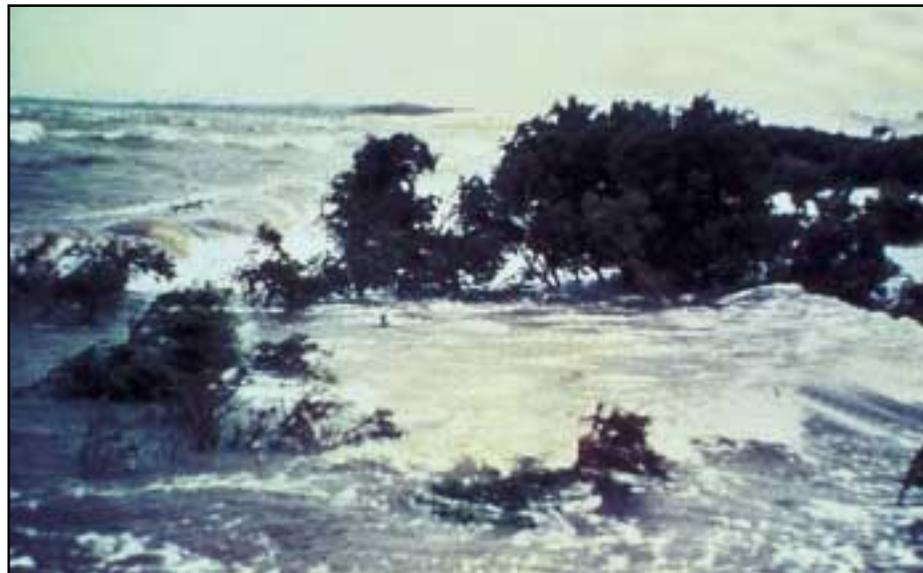
Figure 7-1
Hurricane Frederic (1979).
Storm surge and waves
overtopping a coastal barrier
island in Alabama.

Tropical cyclones and coastal storms are capable of generating high winds, coastal flooding, high-velocity flows, damaging waves, significant erosion, and intense rainfall (see Figure 7-1). Like all flood events, they are also capable of generating and moving large quantities of waterborne sediments and floating debris. Consequently, the risk to improperly sited, designed, or constructed coastal buildings can be great.

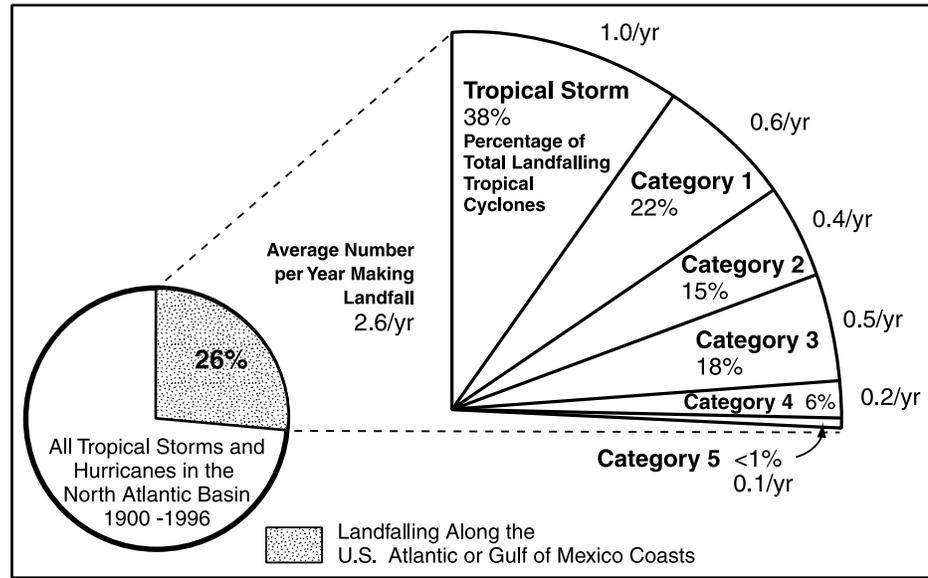
Statistics in Figure 7-2 show average landfall frequencies and characteristics. Actual numbers and classes of landfalling storms can vary considerably: actual data show as few as 0 and as many as 5 landfalling storms in any given year.

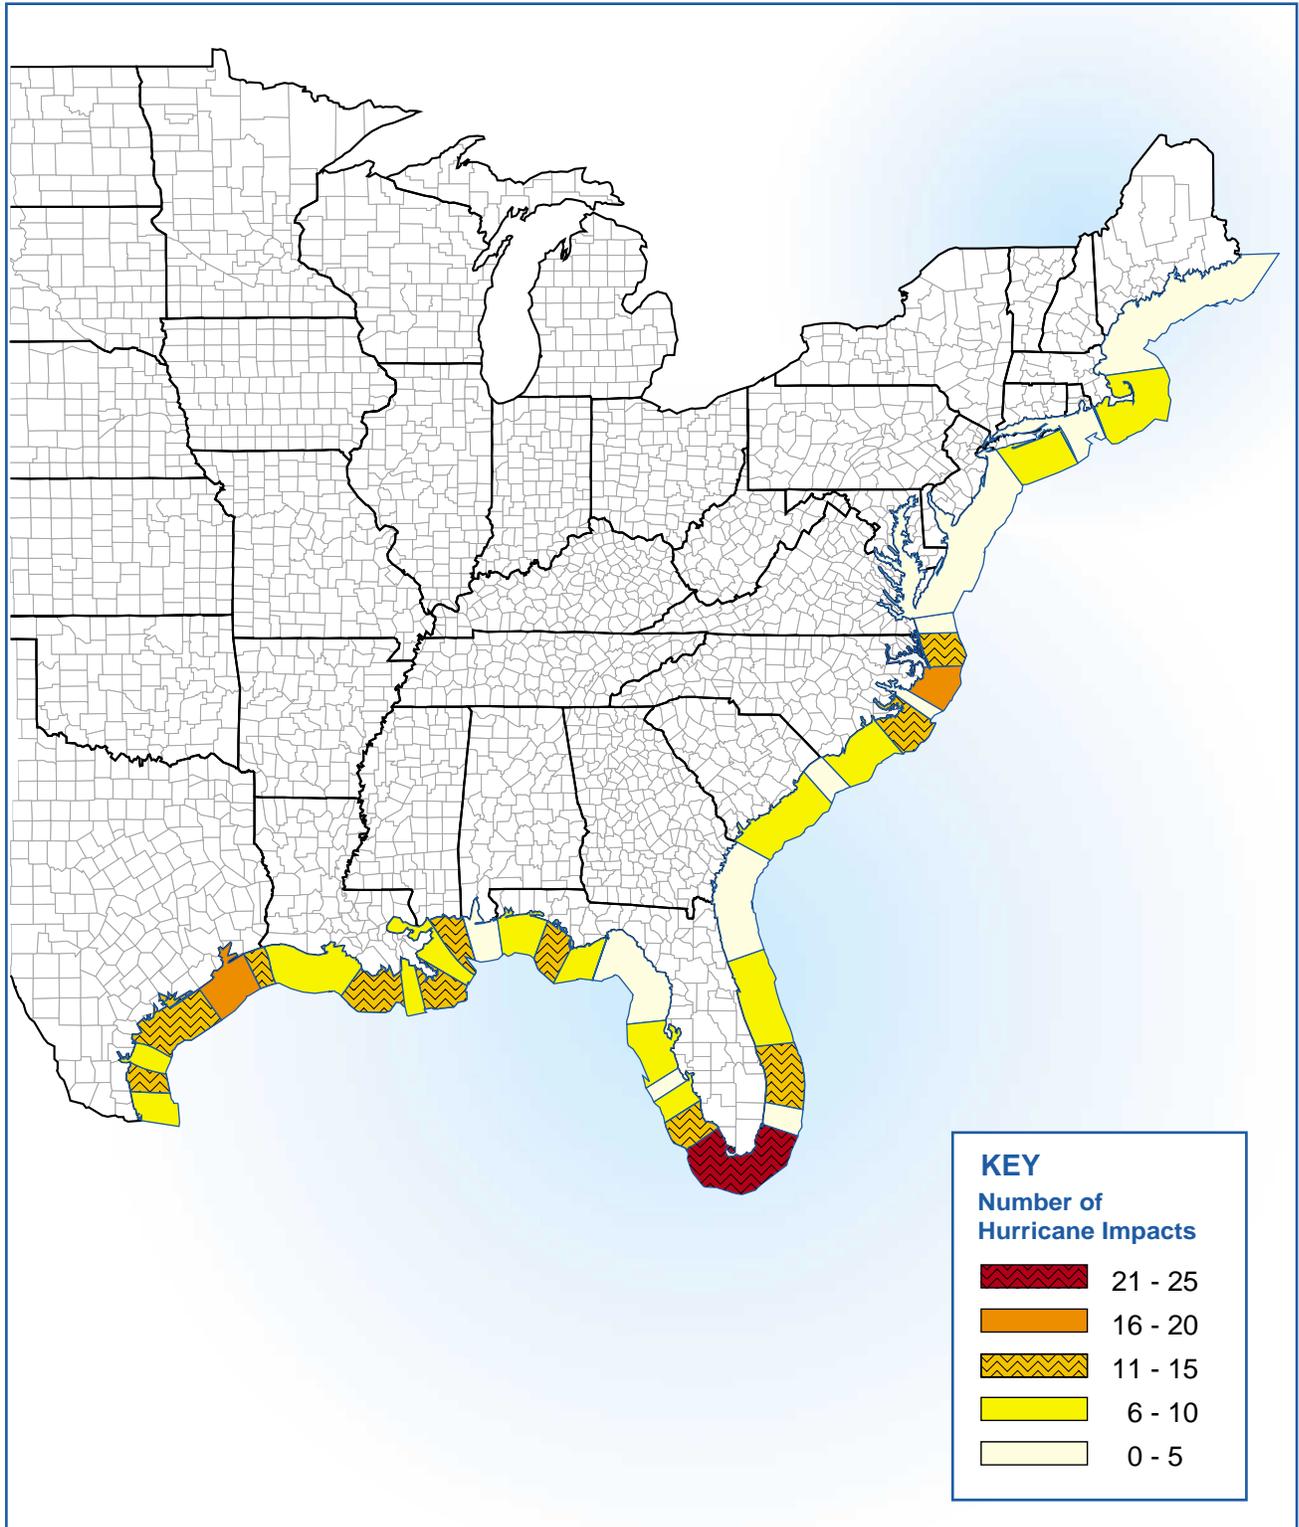
Figure 7-3 Total number of direct and indirect impacts by landfalling hurricanes for coastal counties from Texas to Maine, 1900–1994. Adapted from FEMA (1997b).

Tropical cyclone landfalls are not evenly distributed on a geographic basis. In fact, there is a wide variation in the incidence of landfalls. Figure 7-3 illustrates this point for the Atlantic and Gulf of Mexico coasts. The figure shows the total number of direct and indirect impacts of landfalling hurricanes between 1900 and 1994 (generally speaking, a direct impact occurs when the eye makes landfall in the county of interest, and an indirect impact occurs when the eye makes landfall in an adjacent county).

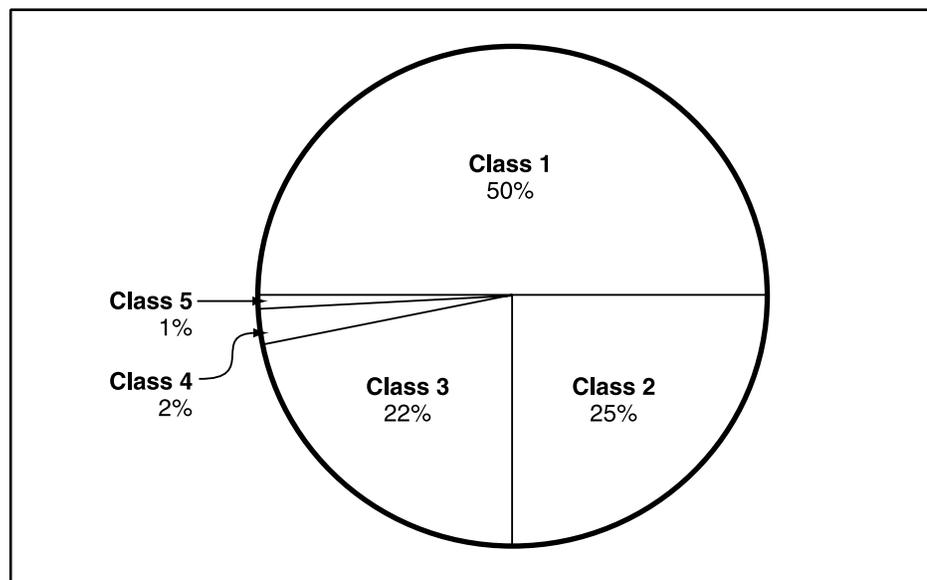
Figure 7-4
Classification (by Dolan-Davis scale) of northeasters at Cape Hatteras, North Carolina, 1942–1984.

Dolan and Davis (1992) reviewed weather records for the period 1942 to 1984 and found 1,347 northeasters that produced deepwater significant wave heights in excess of 5 feet near Cape Hatteras, North Carolina (31 storms per year). Figure 7-4 shows how these storms were classified. Note that of the 1,347 identified northeasters, only 7 were Class 5 storms, including the March 5-7, 1962 storm (see Figure 7-5) and the October 28–November 3, 1991 storm.

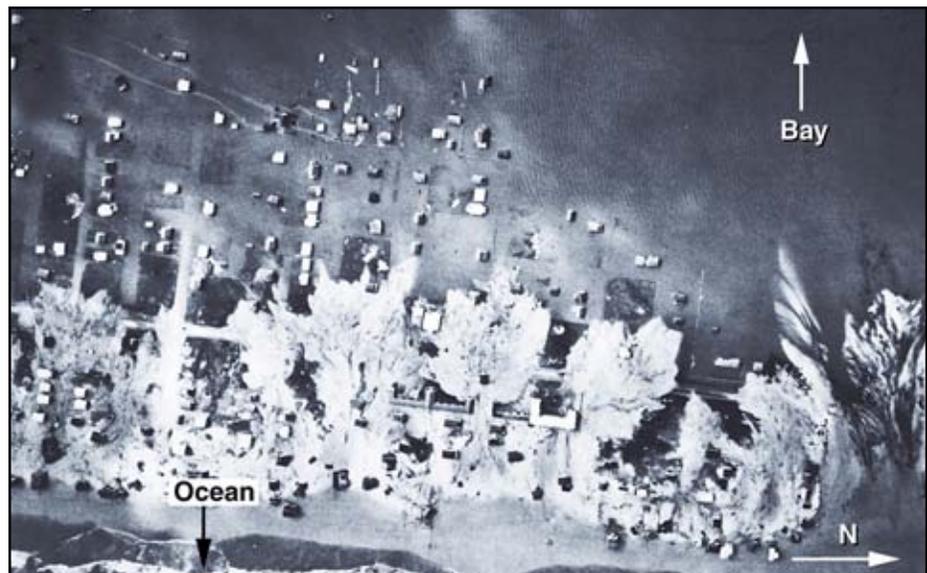
Figure 7-5
March 1962 northeaster. Flooding, erosion, and overwash at Fenwick Island, Delaware.

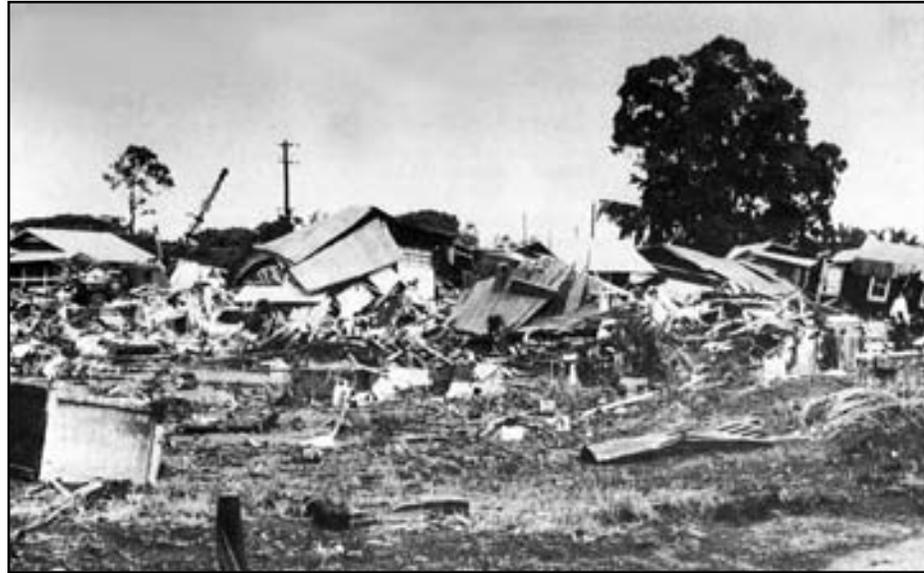
Hilo, Hawaii. Damage from the 1960 Tsunami (from Camfield 1994). Courtesy of *Journal of Coastal Research*.

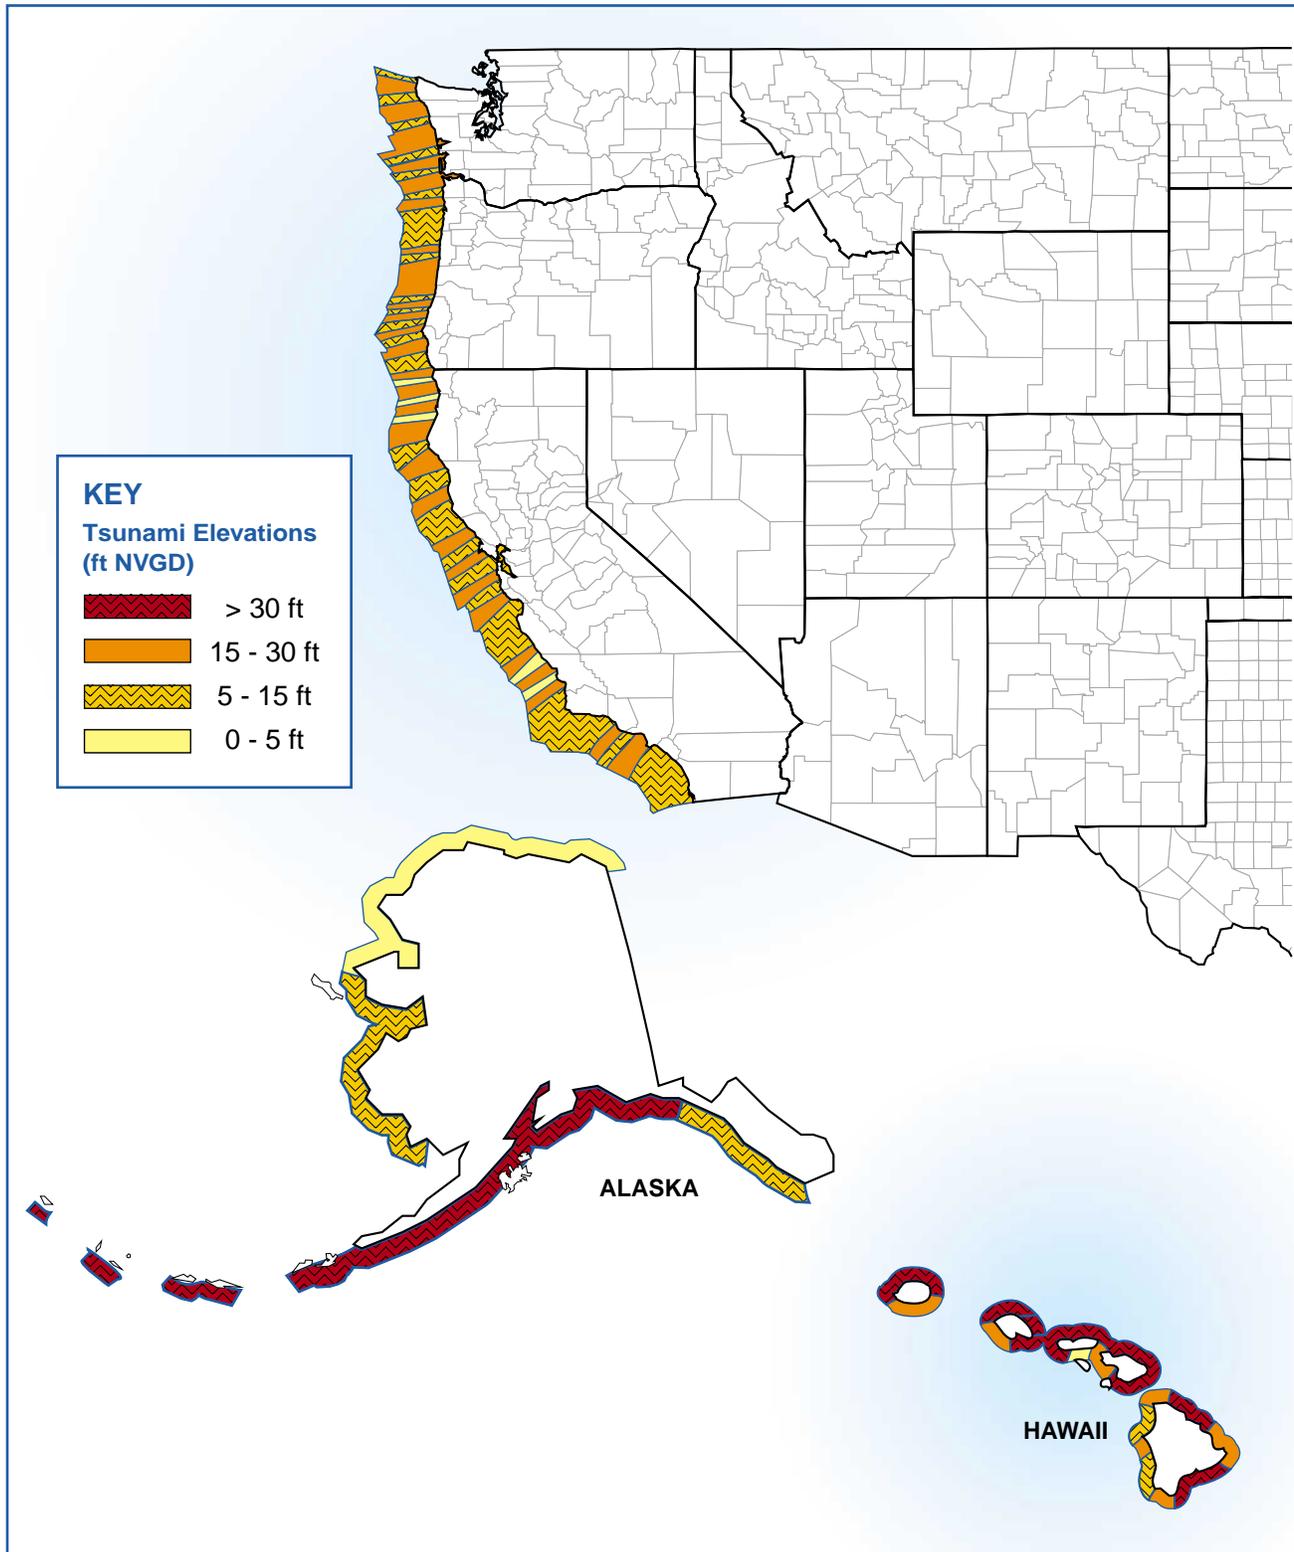
Figure 7-7 Tsunami elevations with a 90-percent probability of not being exceeded in 50 years – western United States, Alaska, and Hawaii. Adapted from FEMA (1997b).

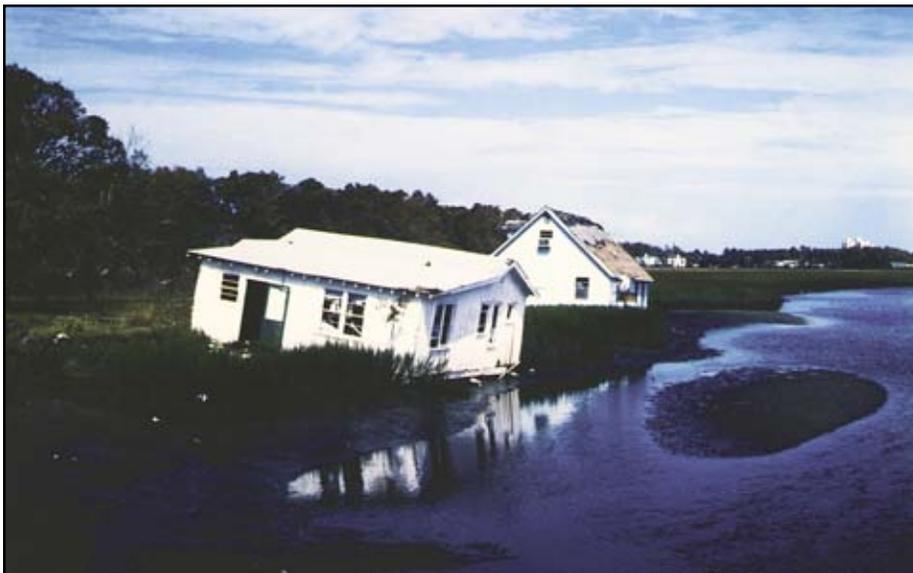
Standing water or slowly moving water can induce horizontal *hydrostatic forces* against a structure, especially when floodwater levels on different sides of the structure are not equal. Also, flooding can cause vertical hydrostatic forces, or *flotation* (see Figure 7-8).

Figure 7-8 Hurricane Hugo (1989), Garden City, South Carolina. Intact houses were floated off their foundations and carried inland. 7-13

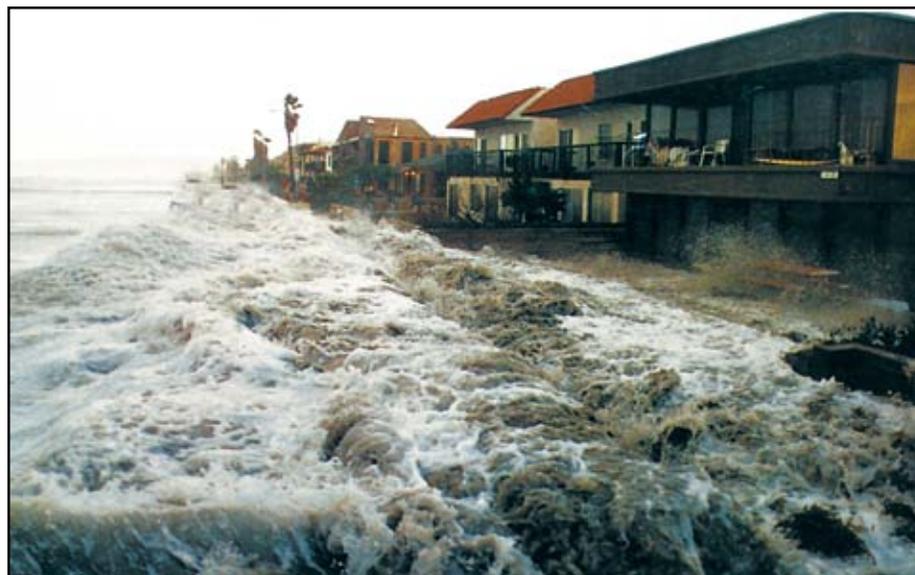
Storm surge and wave runup across boardwalk at South Mission Beach, California, during January 1988 storm. Photograph by Dana Fisher, courtesy of *Shore and Beach*.

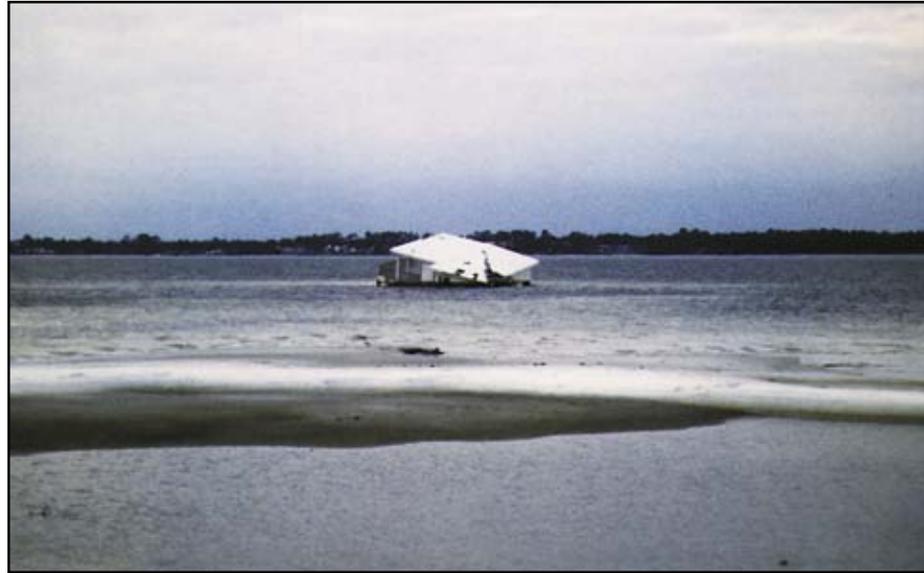
Figure 7-11
Pile-supported house in the area of channeled flow shown in Figure 7-10. The building foundation and elevation successfully prevented high-velocity flow, erosion, and scour from destroying this building.

This house was also in an area of channeled flow during Hurricane Opal. The house was undermined and washed into the bay behind the barrier island; as a result, the house is now a total loss and a threat to navigation.

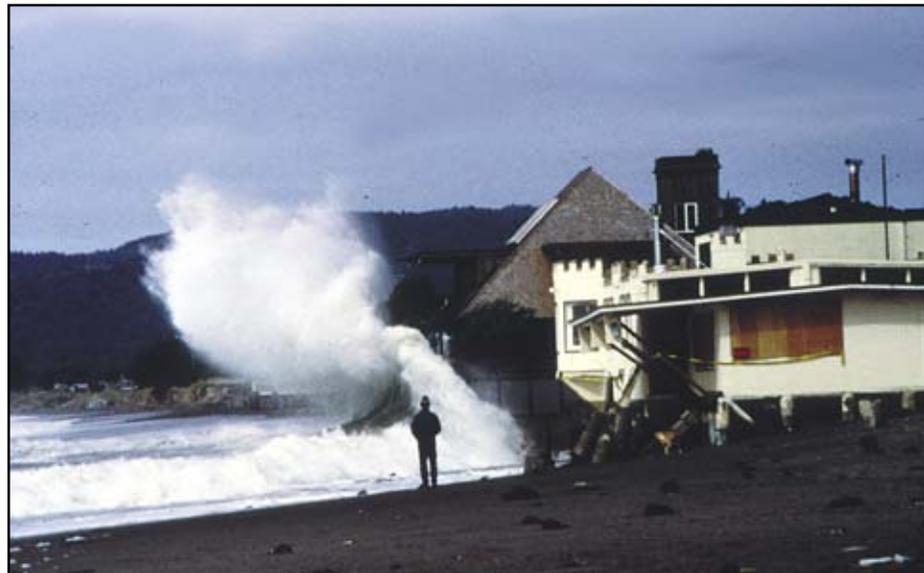
Storm waves breaking against a seawall in front of a coastal residence at Stinson Beach, California. Photograph by Lesley Ewing.

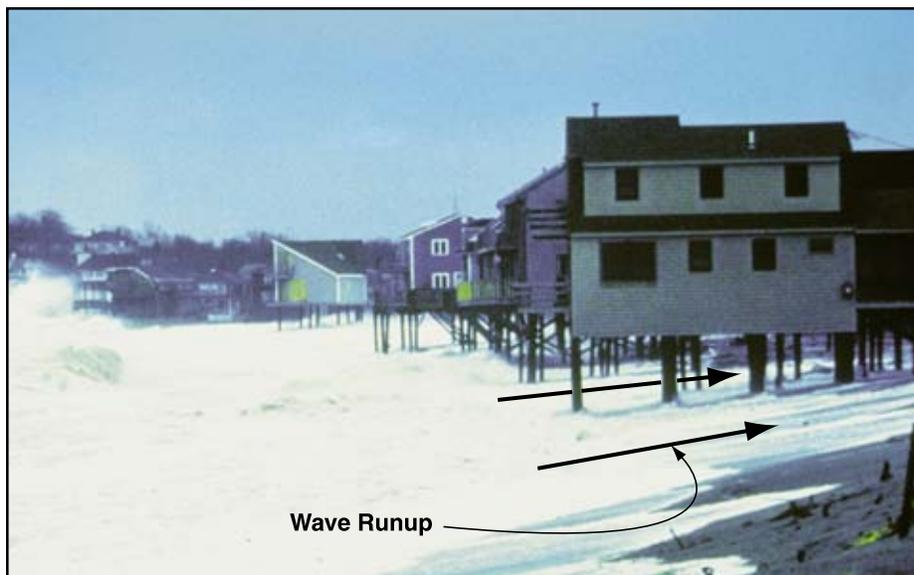
Figure 7-14

Wave runup beneath elevated buildings at Scituate, Massachusetts, during the December 1992 northeast storm. Nine homes in the area were purchased with public funds and demolished following the storm. Photograph by Jim O'Connell.

Wave runup occurs as waves break and run up beaches, sloping surfaces, and vertical surfaces. Wave runup (see Figure 7-14) can drive large volumes of water against or around coastal buildings, inducing fluid impact forces (albeit smaller than breaking wave forces), current drag forces, and localized erosion and scour. Wave runup against a vertical wall will generally extend to a higher elevation than runup on a sloping surface and will be capable of destroying overhanging decks and porches. Figure 7-15 shows the effects of wave runup and breaking against a vertical wall and adjacent building. *Wave reflection or deflection* from adjacent structures or objects can produce forces on a building similar to those caused by wave runup.

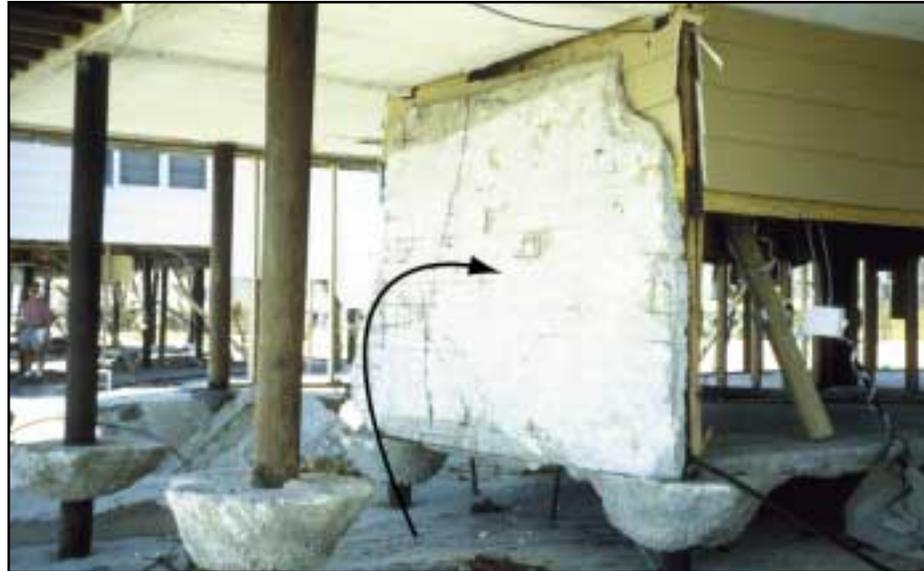
Figure 7-16
Hurricane Fran (1996).
Concrete slab-on-grade
flipped up by wave action
came to rest against two
foundation members,
generating large
unanticipated loads on the
foundation.

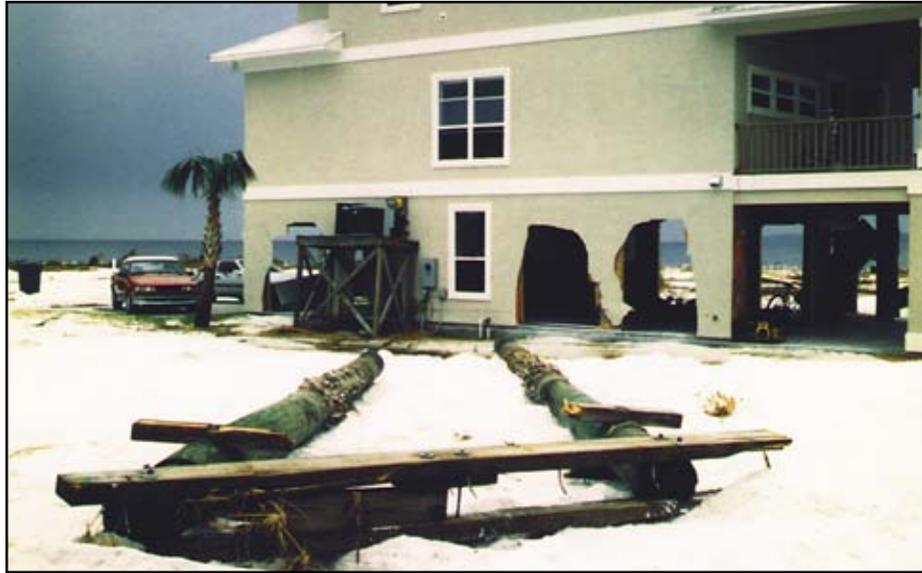
Hurricane Opal (1995). Pier pilings were carried over 2 miles by storm surge and waves before they came to rest against this elevated house in Pensacola Beach, Florida.

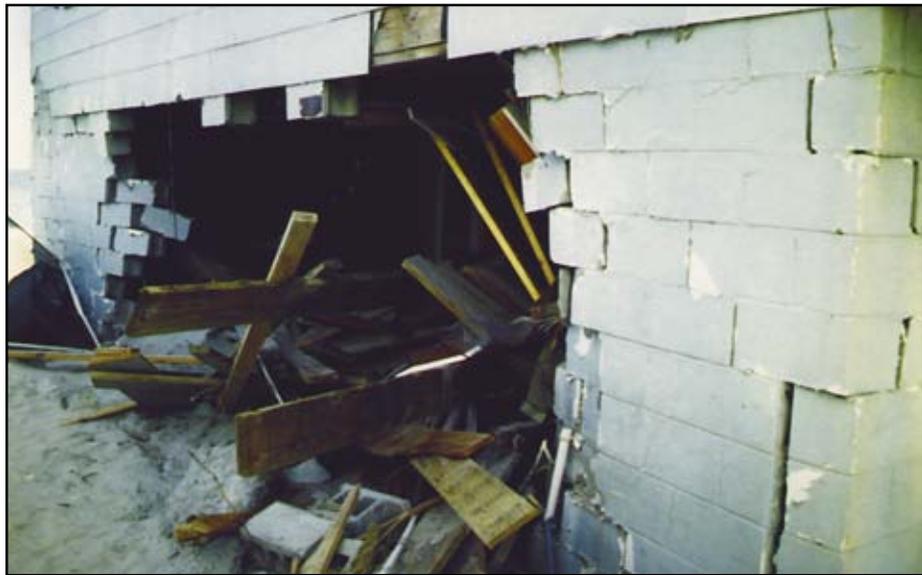
**Figure 7-19**

Hurricane Fran (1996). Debris lodged beneath a Topsail Island, North Carolina, house elevated on unreinforced masonry walls. The wall damage could have resulted from flood and wave forces, debris loads, or both.

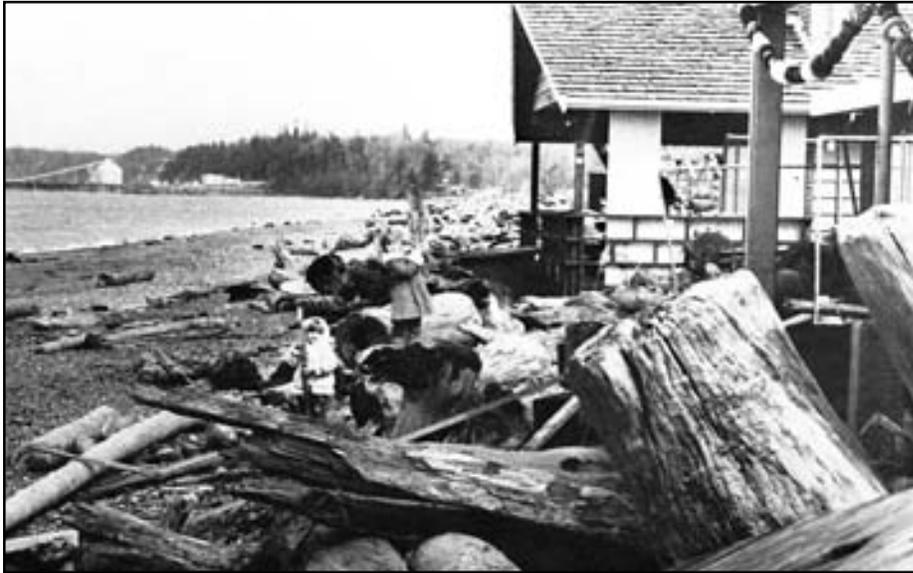
Figure 7-20
March 1975 storm. Drift logs driven into coastal houses at Sandy Point, Washington (from Knowles and Terich [1977]). Courtesy of *Shore and Beach*.

Floodborne debris produced by coastal flood events and storms typically includes decks, steps, ramps, breakaway wall panels, portions of or entire houses (see Figure 7-17), heating oil and propane tanks, vehicles, boats, decks and pilings from piers (see Figure 7-18), fences, destroyed erosion control structures, and a variety of smaller objects. Floodborne debris is often capable of destroying unreinforced masonry walls (see Figure 7-19), light wood-frame construction, and small-diameter posts and piles (and the components of structures they support). Debris trapped by cross bracing, closely spaced pilings, grade beams, or other components or obstructions below the Base Flood Elevation (BFE) is also capable of transferring flood and wave loads to the foundation of an elevated structure. Parts of the country are exposed to more massive debris, such as the drift logs shown in Figure 7-20.

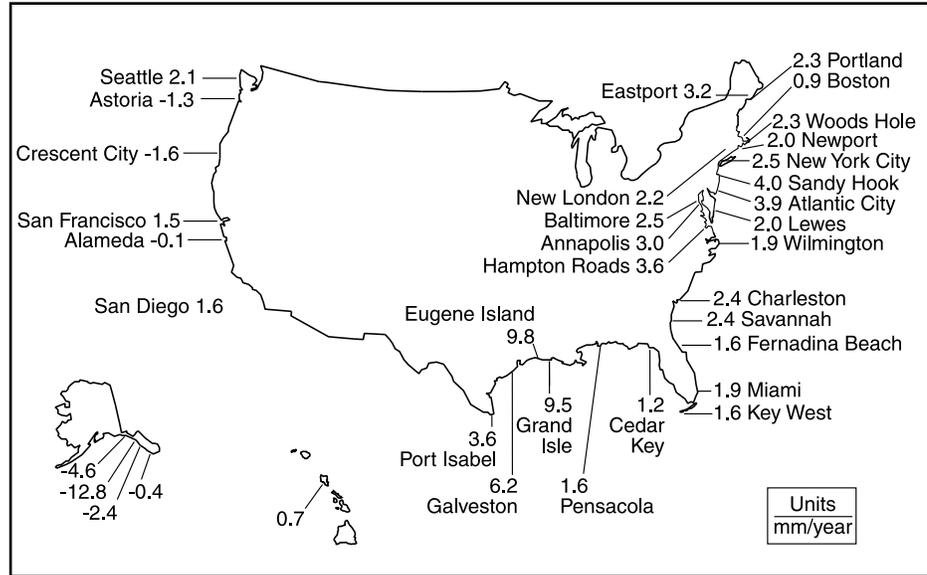
Figure 7-21
 Estimates of relative sea level rise along the continental United States in millimeters per year. Negative values indicate falling relative sea levels (from National Research Council 1987).

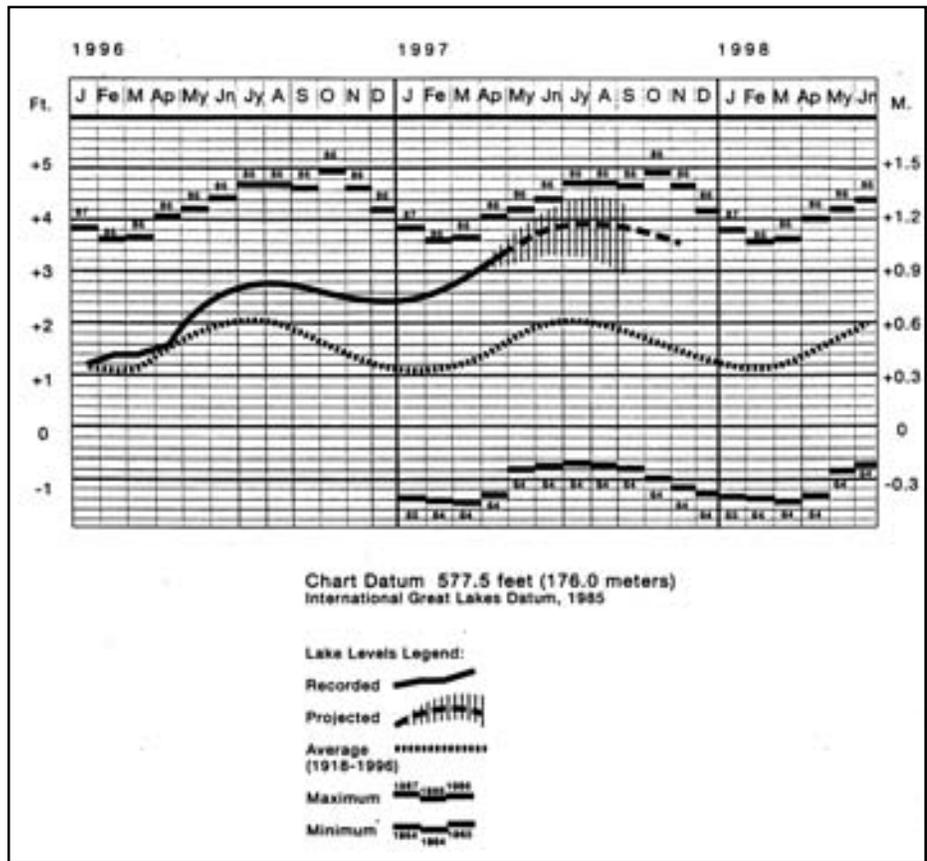
Figure 7-22
 Monthly bulletin of lake levels for Lakes Michigan and Huron. Courtesy of USACE, Detroit District.

Keillor (1998) discusses the implications of both high and low lake levels on Great Lakes shorelines. In general, beach and bluff erosion rates tend to increase as long-term water levels rise. As water levels fall, erosion rates diminish. Low lake levels lead to generally stable shorelines and bluffs, but make navigation through harbor entrances difficult.

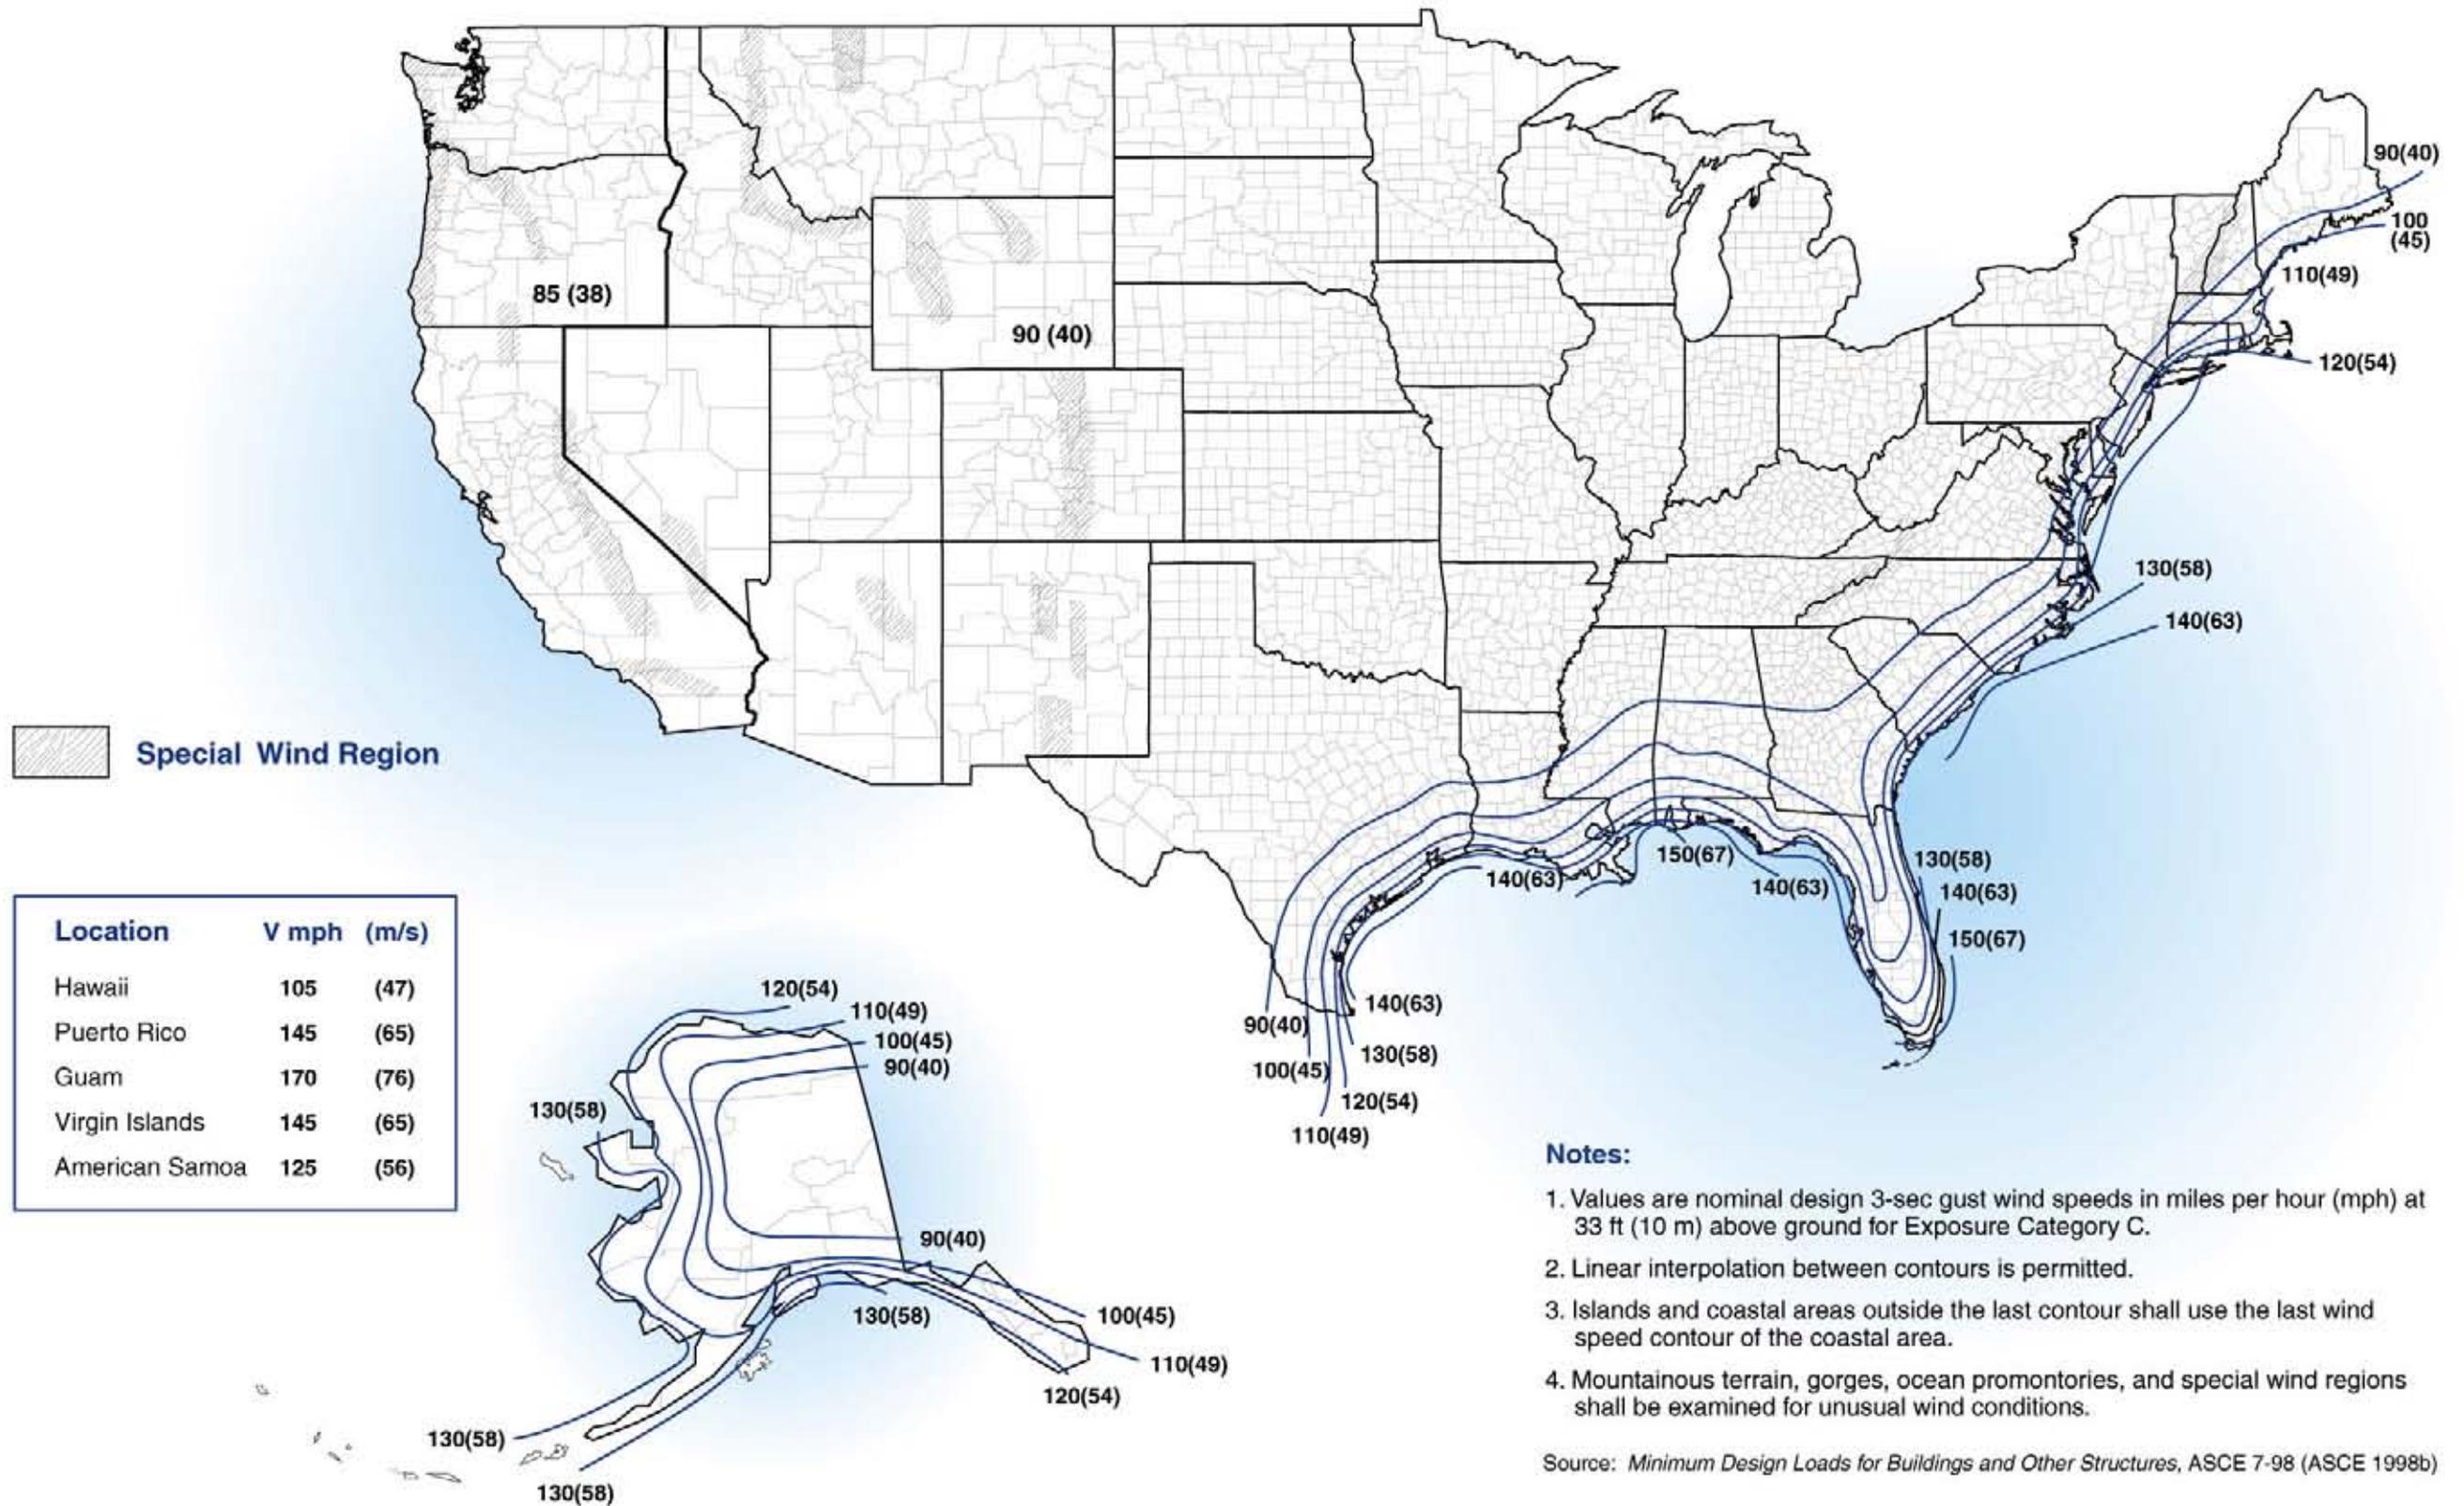
Figure 7-23 ASCE 7-98 wind speed map (ASCE 1998).

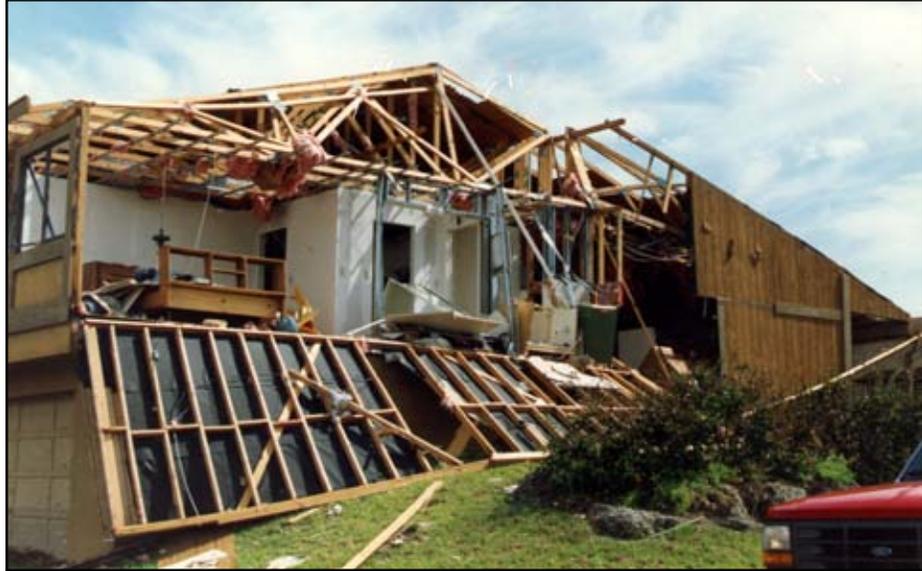
Figure 7-24
Hurricane Andrew (1992).
End-wall failure of typical
first-floor masonry/second-
floor wood-frame building in
Dade County, Florida.

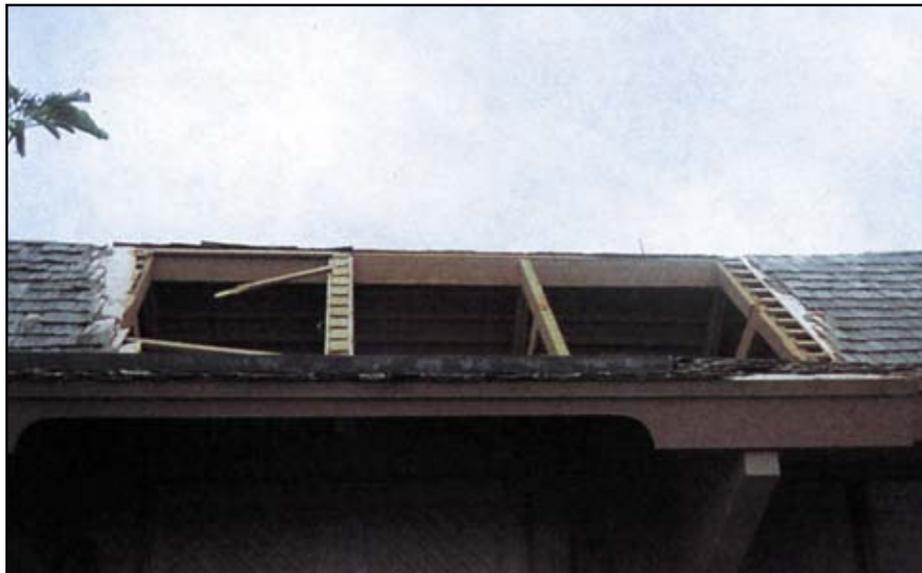
Figure 7-25
Hurricane Iniki (1992), Kauai
County, Hawaii. Loss of roof
sheathing due to improper
nailing design and schedule.

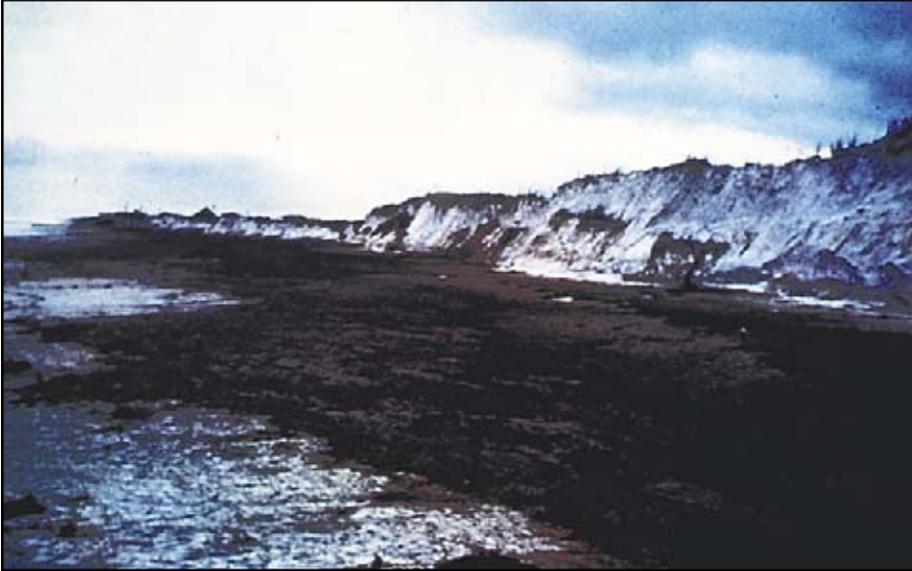
Figure 7-26
Dune erosion in Walton County, Florida, caused by Hurricane Eloise, 1975.

- destroying dunes or other natural protective features, (see Figure 7-26)
- destroying erosion control devices (see Figures 7-27 and 7-28)
- lowering ground elevations, undermining shallow foundations, and reducing penetration of deep foundations such as piles (see Figures 7-29 and 7-30)

Erosion during storms can be dramatic and damaging. Although storm-induced erosion is usually short-lived (usually occurring over a few hours in the case of hurricanes and typhoons, or over a few tidal cycles or days in the case of northeasters and other coastal storms), the resulting erosion can be equivalent to decades of long-term erosion. During severe storms or coastal flood events, it is not uncommon for large dunes to be eroded 25–75 feet or more (see Figure 7-26) and for small dunes to be completely destroyed.

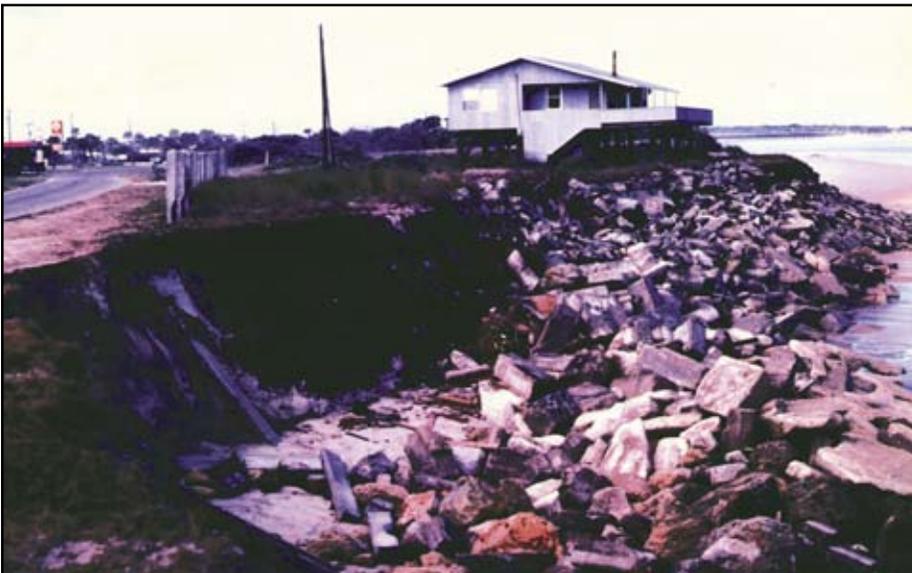
Figure 7-27
Erosion and revetment damage in St. Johns County, Florida, caused by the November 1984 northeast storm.

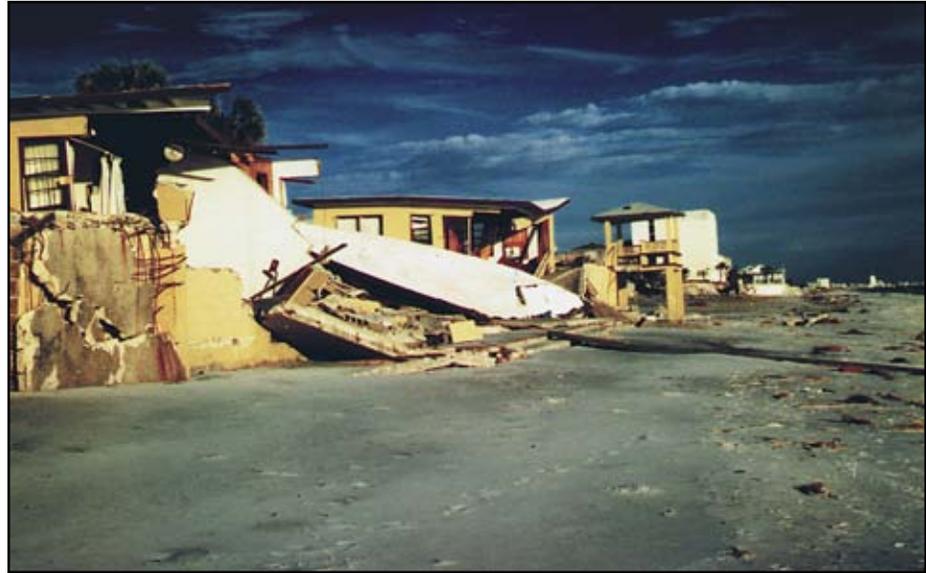
Figure 7-28
Hurricane Opal (1995).
Failure of seawall in Bay
County, Florida, led to
undermining and collapse
of the building behind the wall.

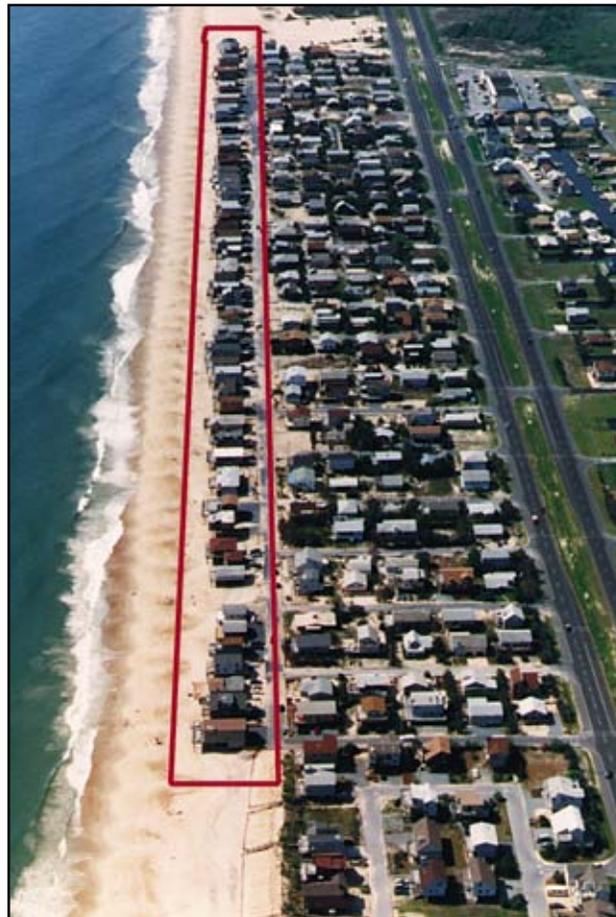
Figure 7-29
Long-term erosion at South
Bethany Beach, Delaware,
has lowered ground
elevations beneath buildings
and left them more
vulnerable to storm damage.
1992 photograph.

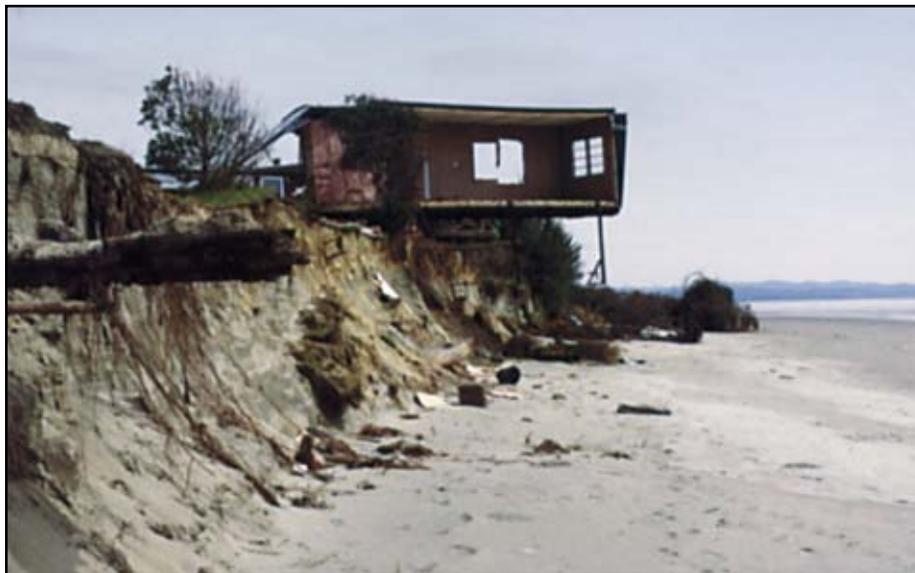
Figure 7-30
Erosion undermining a coastal residence at Cape Shoalwater, Washington. 1992 photograph by Washington Department of Ecology.
