PDHonline Course C220 (6 PDH)

Assessing the Vulnerability at Coastal Sites

Chapter 7: Identifying Hazards

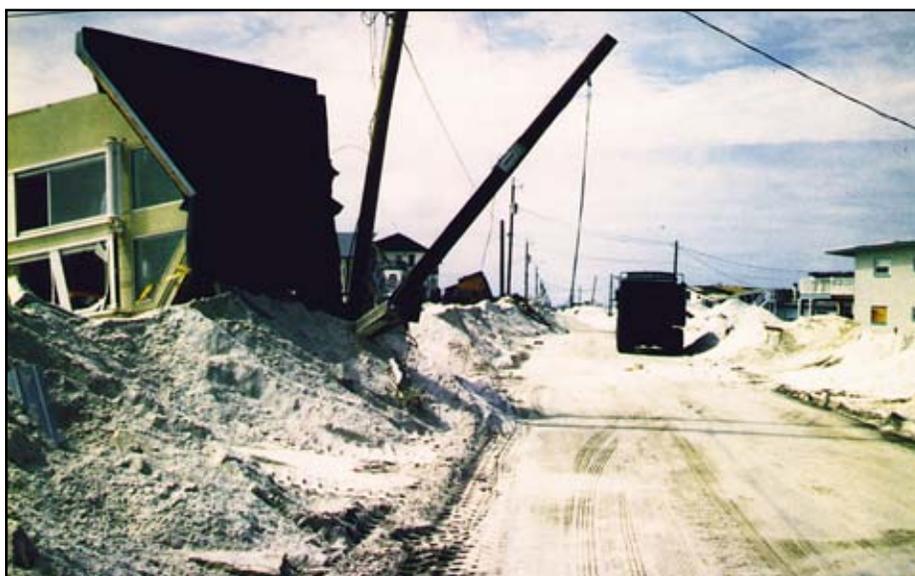
Figure 7-31
Removal of Hurricane Opal overwash from road at Pensacola Beach, Florida. Sand washed landward from the beach buried the road, adjacent lots, and some at-grade buildings to a depth of 3–4 feet.

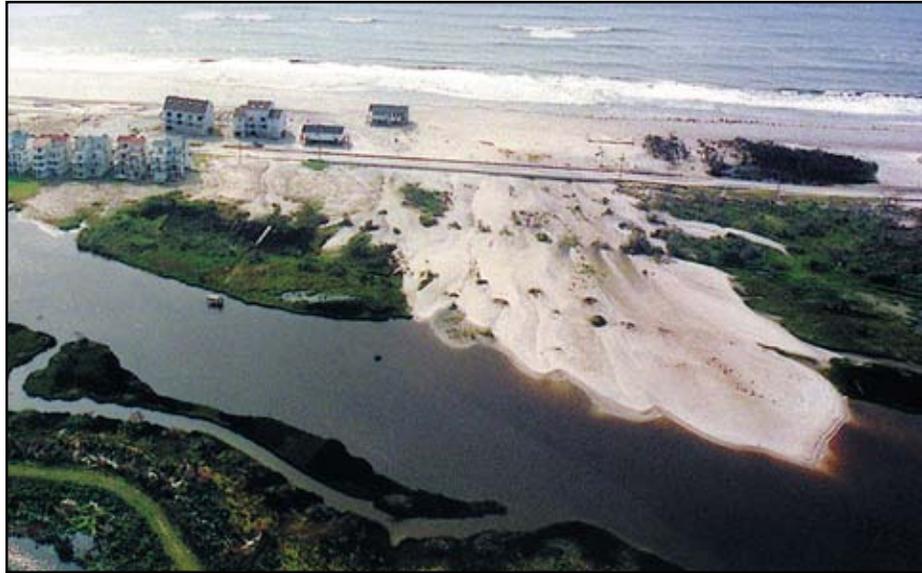
Figure 7-32
Hurricane Bonnie (1998).
Overwash on Topsail Island,
North Carolina. Photograph
by Jamie Moncrief,
Wilmington Morning Star.
Copyright 1998, Wilmington
Star-News, Inc.

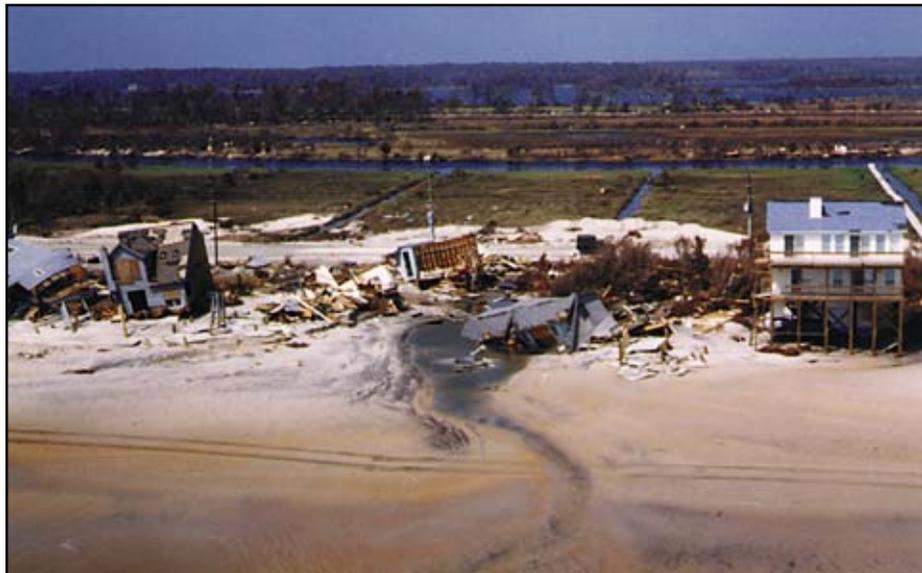
Figure 7-33
Hurricane Fran (1996).
Breach and building damage
at North Topsail Beach, North
Carolina.

Narrow sand spits and low-lying coastal lands can be breached by tidal channels and inlets—often originating from the buildup of water on the back side (see Figure 7-33)—or washed away entirely (see Figures 7-36 and 7-37). Storm-induced erosion damage to unconsolidated cliffs and bluffs typically takes the form of large-scale collapse, slumping, and landslides, with concurrent recession of the top of the bluff (see Figure 2-23, in Chapter 2).

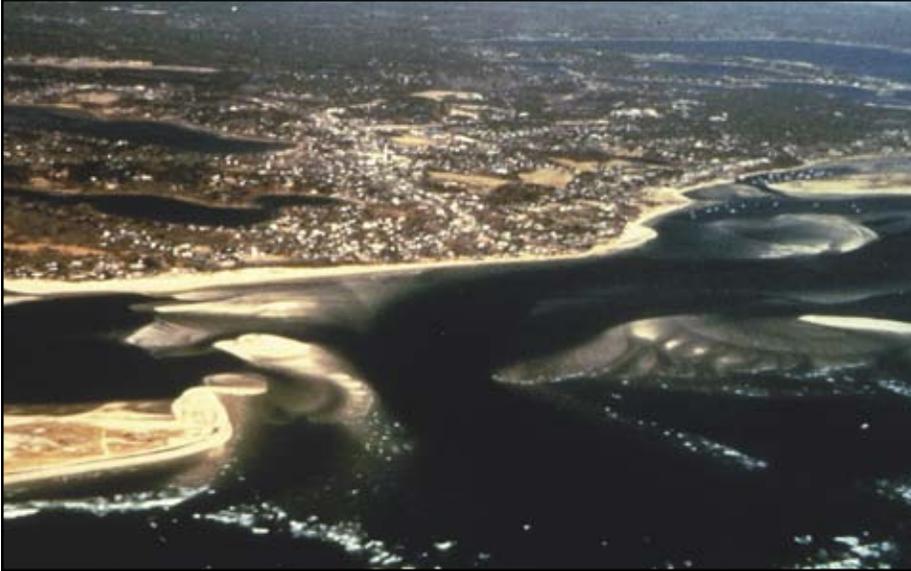
**Figure 7-34**

A breach was cut across Nauset Spit on Cape Cod, Massachusetts, by a January 1987 northeaster. The breach grew from an initial width of approximately 20 feet to over a mile within 2 years, exposing the previously sheltered shoreline of Chatham to ocean waves and erosion. Photograph by Jim O'Connell.

- breaching low-lying coastal barrier islands, destroying structures at the site of the breach (see Figure 7-33), and sometimes exposing structures on the mainland to increased flood and wave effects (see Figures 7-34 and 7-35)

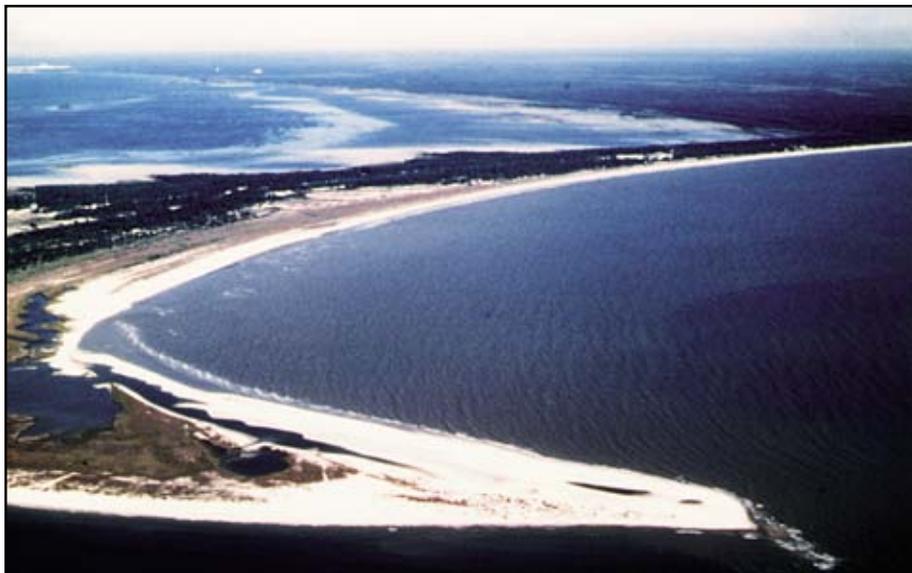
Figure 7-36
Cape San Blas, Gulf County,
Florida, in November 1984,
before Hurricane Elena.

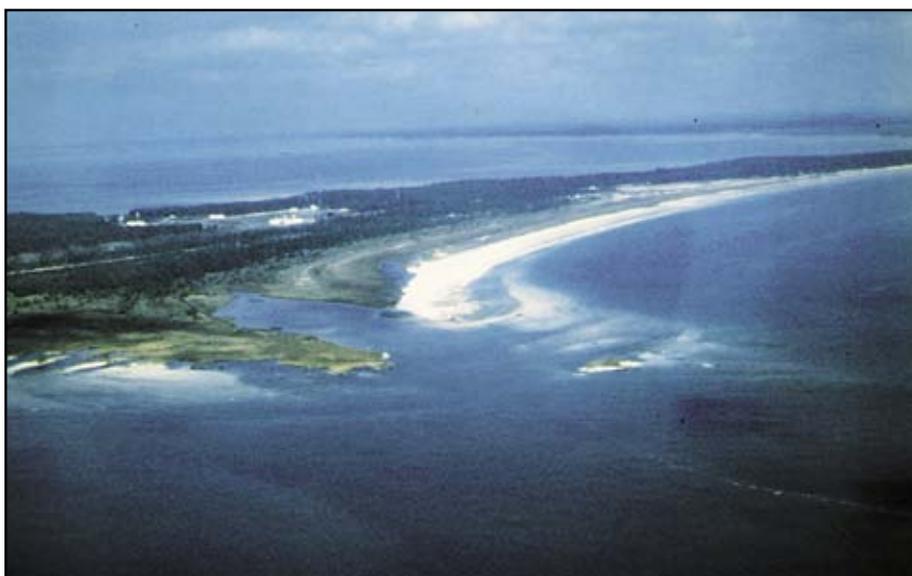
Figure 7-37
Cape San Blas, Gulf County,
Florida, in November 1985,
after Hurricane Elena.

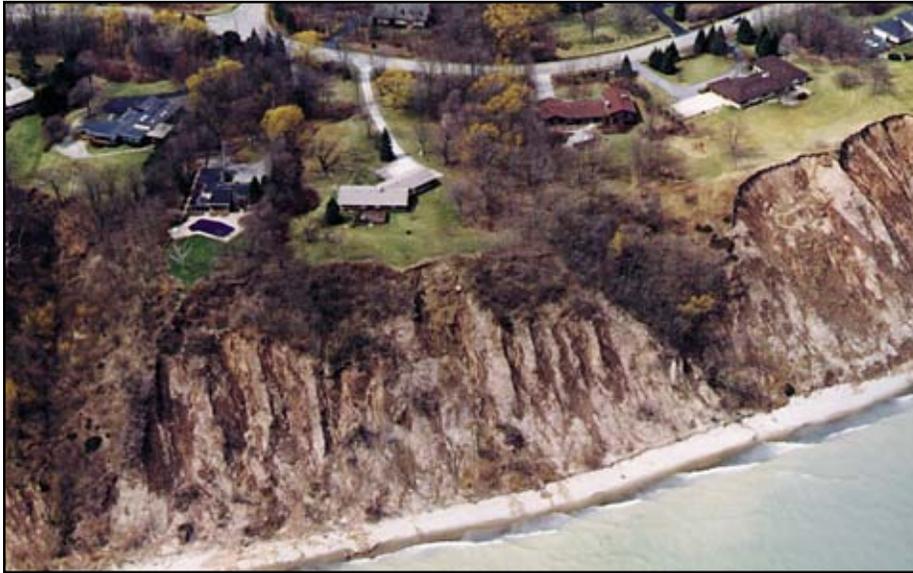
Figure 7-38
Long-term erosion along the Lake Michigan shoreline in Ozaukee County, Wisconsin, increases the threat to residential buildings outside the floodplain. 1996 photograph.

- washing away low-lying coastal landforms (see Figures 7-36 and 7-37)
- eroding coastal bluffs that provide support to buildings outside the floodplain itself (see Figure 7-38 and 7-39)

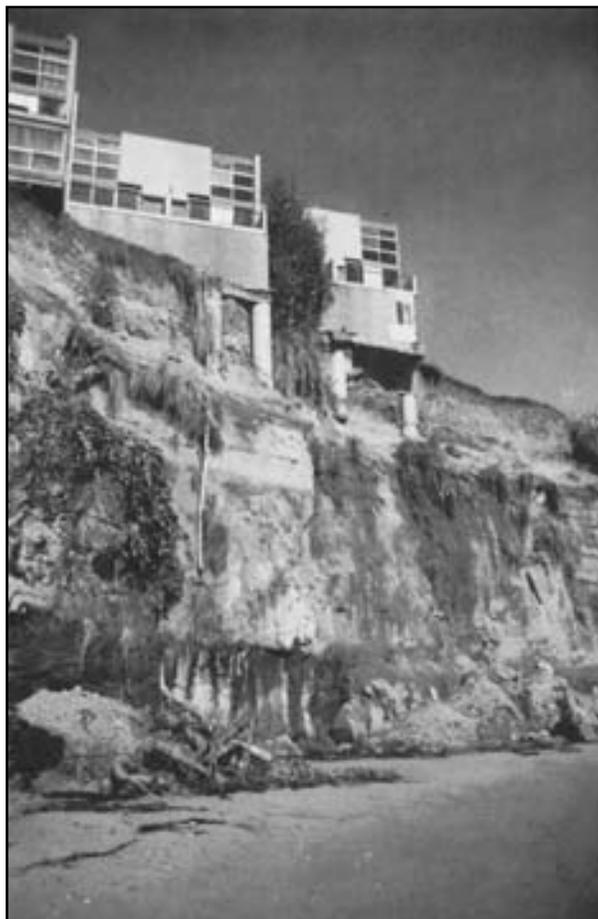
Figure 7-39
Bluff failure by a combination of marine, terrestrial, and seismic processes led to progressive undercutting of blufftop apartments at Capitola, California. Six of the units were demolished after the 1989 Loma Prieta earthquake. 1989 photograph from Griggs (1994), courtesy of Journal of Coastal Resources.

Finally, coastal bluff failures can be induced by seismic activity. Griggs and Scholar (1997) detail bluff failures and damage to residential buildings resulting from the several earthquakes, including the March 1964 Alaska earthquake and the October 1989 Loma Prieta earthquake (see Figure 7-39). Coastal bluff failures were documented as much as 50 miles from the Loma Prieta epicenter and 125 miles from the Alaska earthquake epicenter. In both instances, houses and infrastructure were damaged and destroyed as a result of these failures. Buildings at the top and base of the bluffs were vulnerable to damage.

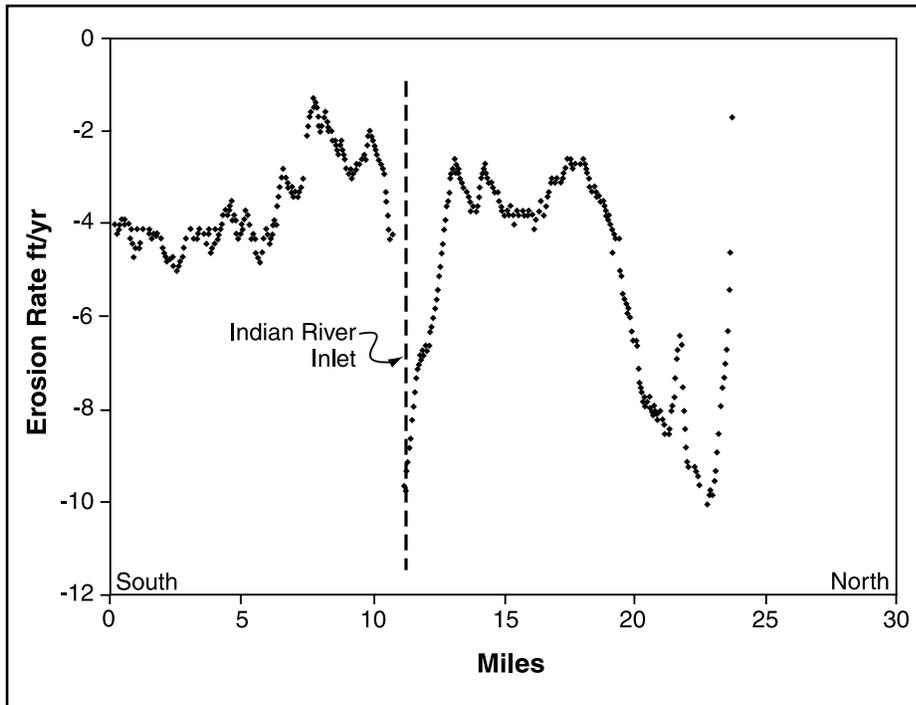
Figure 7-40
Longshore variation in long-term erosion rates, Delaware Atlantic shoreline (from Douglas et al. 1998).

Shoreline erosion rates are usually computed and cited as long-term, average annual rates. However, erosion rates are *not* uniform in time or space. Erosion rates can vary substantially from one location along the shoreline to another, even when the two locations are only a short distance apart. Figure 7-40 (Douglas et al. 1998) illustrates this point for the Delaware coastline: long-term, average annual shoreline change rates for the period 1845-1993 vary from approximately -1 foot/year to -10 feet/year, over a distance of less than 5 miles.

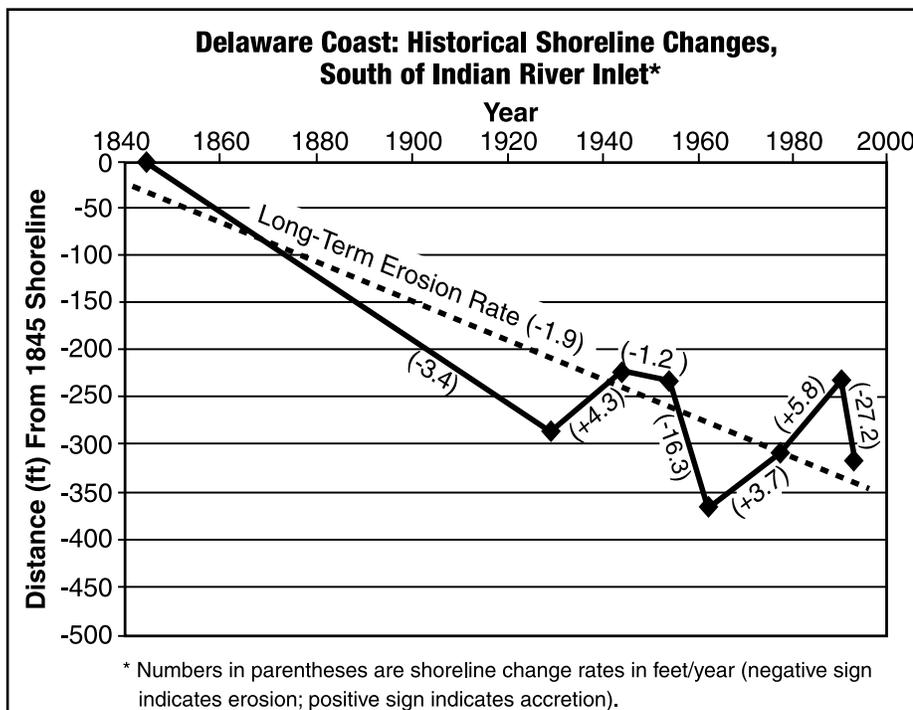
Figure 7-41
Shoreline changes through time at a location approximately 1.5 miles south of Indian River Inlet, Delaware.

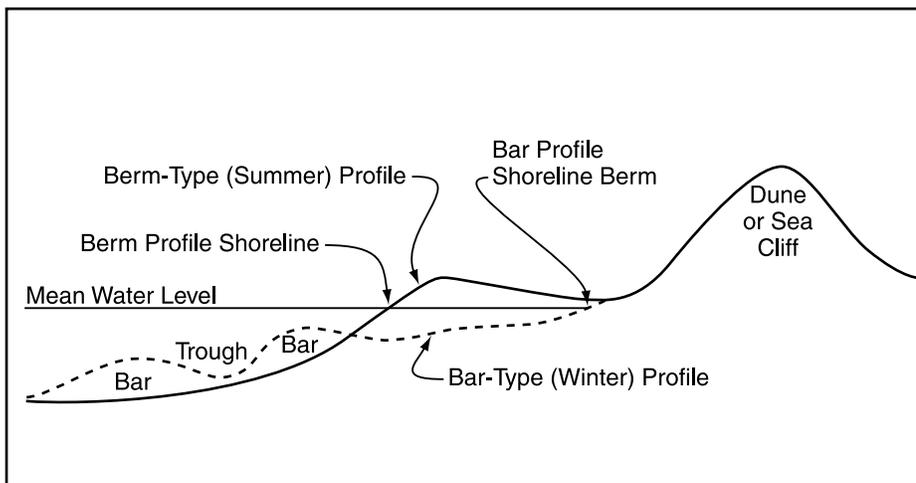
Figure 7-42
Seasonal fluctuations in beach width and elevation.

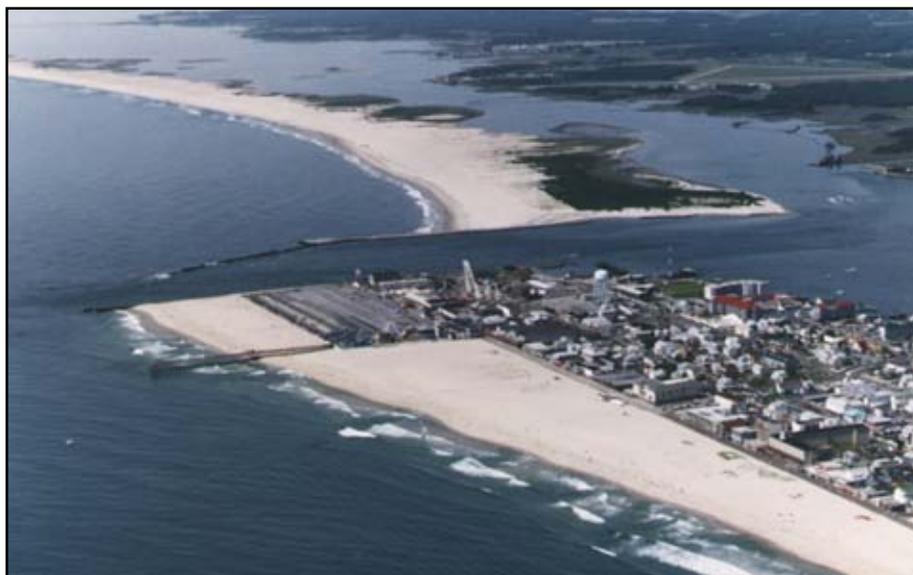
Figure 7-45
Ocean City Inlet, Maryland, was opened by a hurricane in 1933 and stabilized by jetties in 1934–35. Note extreme shoreline offset and downdrift erosion resulting from inlet stabilization. 1992 photograph.

Construction of jetties or similar structures at a tidal inlet or a bay, harbor, or river entrance often results in accretion on one side and erosion on the other, with a substantial shoreline offset. This offset results from the jetties trapping the *littoral drift* (wave-driven sediment moving along the shoreline) and preventing it from moving to the downdrift side. Figure 7-45 shows such a situation at Ocean City Inlet, Maryland, where formation of the inlet in 1933 by a hurricane and construction of inlet jetties in 1934-1935 have led to approximately 800 feet of accretion against the north jetty at Ocean City and approximately 1,700 feet of erosion on the south side of the inlet along Assateague Island (Dean and Perlin 1977). The downdrift erosion is ongoing. Stauble and Cialone (1966) report that post-inlet shoreline change rates on Assateague Island have been documented between -30 feet/year and -40 feet/year (pre-inlet shoreline change rates were approximately -4 feet/year).

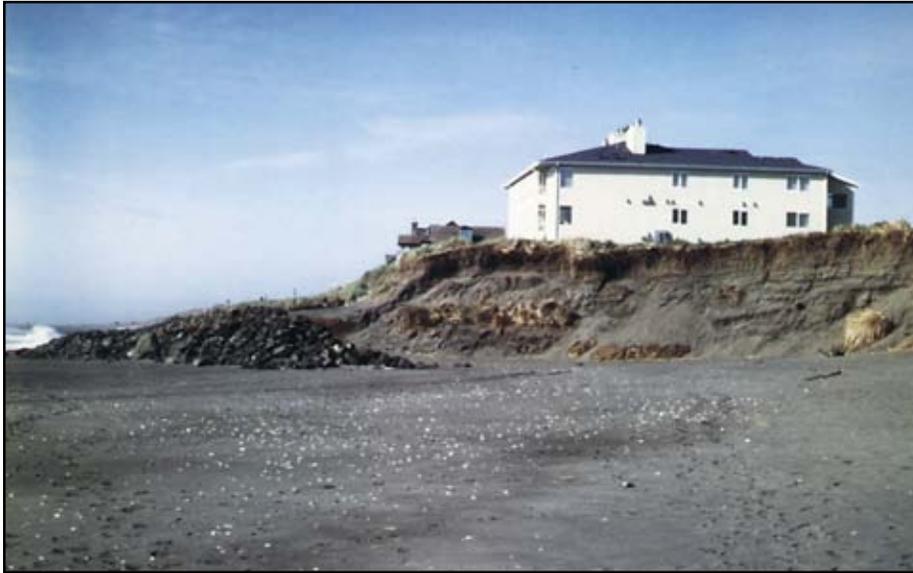
Figure 7-46
Buildings threatened by erosion at Ocean Shores, Washington. The rock revetments were built in response to shoreline erosion along an area adjacent to a jetty and thought to be accretional. 1998 photograph.

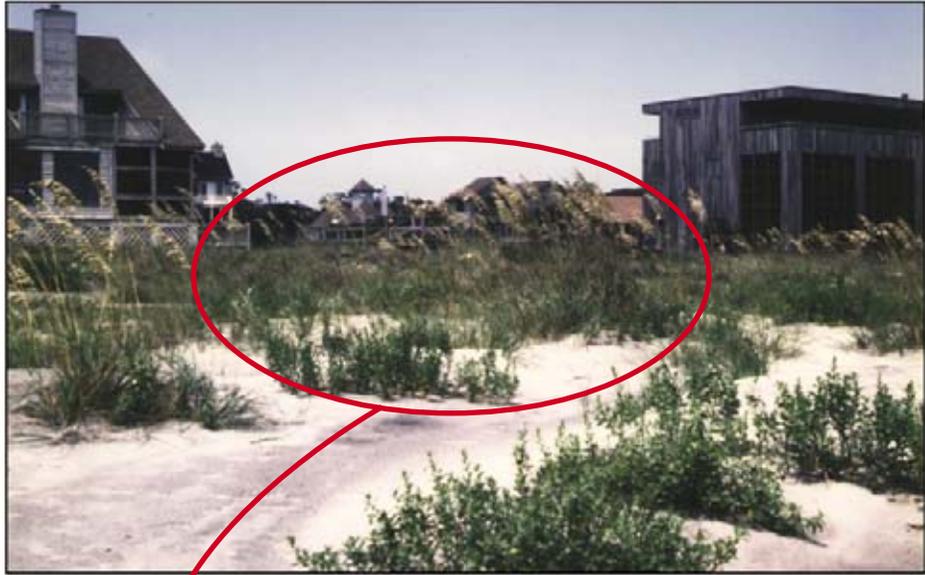
July 1989 photograph of vacant lot owned by Lucas, Isle of Palms, South Carolina.

Shoreline changes in the vicinity of one of the more notable regulatory takings cases illustrate this point. Figure 7-47 is a 1989 photograph of one of the two vacant lots owned by David Lucas, which became the subject of the case *Lucas vs. South Carolina Coastal Council* (Lucas challenged the state's prohibition of construction on the lots – the state law has since been changed to allow residential construction in similar circumstances). By December 1997, the case had been decided in favor of Lucas, the State of South Carolina had purchased the lots from Lucas, the State had resold the lots, and a home had been constructed on one of the lots (Jones et al. 1998). Figure 7-48 shows a December 1997 photograph of the same area, with erosion undermining the home built on the former Lucas lot (left side of photo) and an adjacent house (also present in 1989 in Figure 7-47). Comparison of historical shorelines in the vicinity (see Figure 7-49) indicates such an occurrence should not be surprising – changes in inlet sand bars and channels at a nearby unstabilized inlet have caused the shoreline throughout the area to advance and recede approximately 300 feet to 400 feet in just a few years.

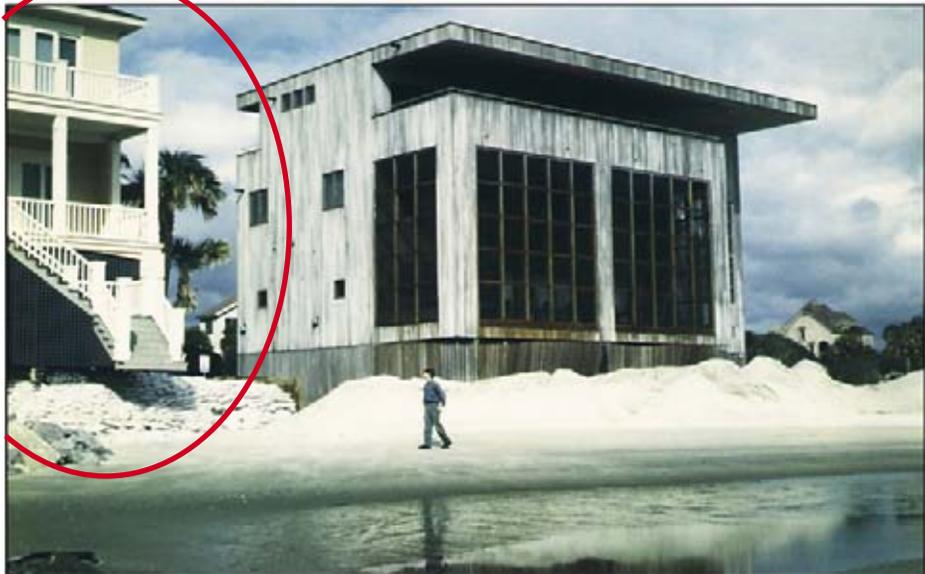
**Figure 7-48**

December 1997 photograph taken in the same area as Figure 7-47. Erosion and undermining of the houses is a result of shoreline changes associated with changes in inlet sand bars and wave patterns. Note that this area is approximately 0.5 mile from the houses shown in Figure 4-2.

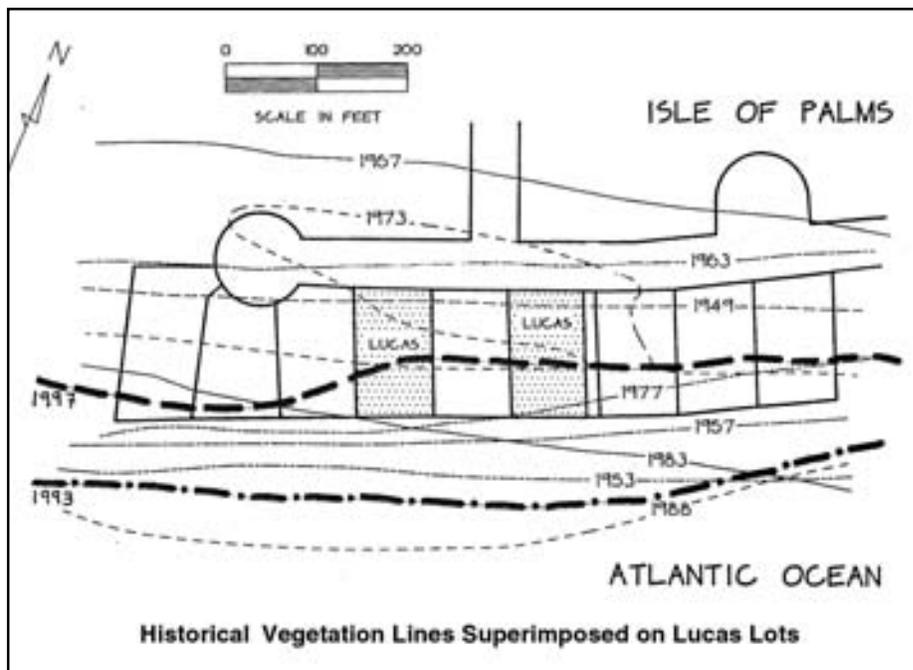
Figure 7-49
Historical shoreline changes
in the vicinity of Lucas lots.

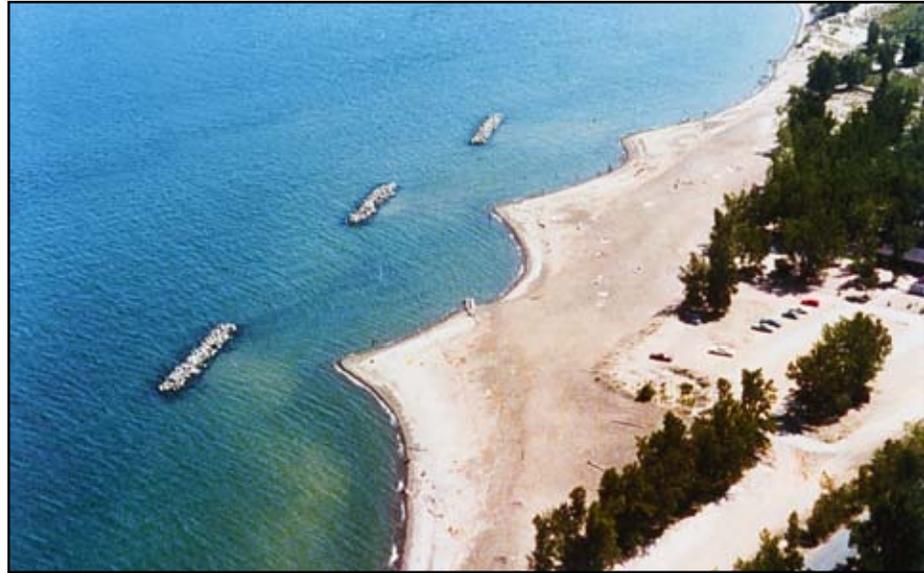
Figure 7-50
Trapping of littoral sediments
behind offshore breakwaters,
Presque Isle, Pennsylvania.
Photograph courtesy of
USACE.

Likewise, *offshore breakwaters* (see Figure 7-50) can trap available littoral sediments and reduce the sediment supply to nearby beaches. This adverse effect should be mitigated by combining breakwater construction with beach nourishment – in fact, current design guidance for offshore breakwater projects calls for the inclusion of beach nourishment (Chasten et al. 1993).

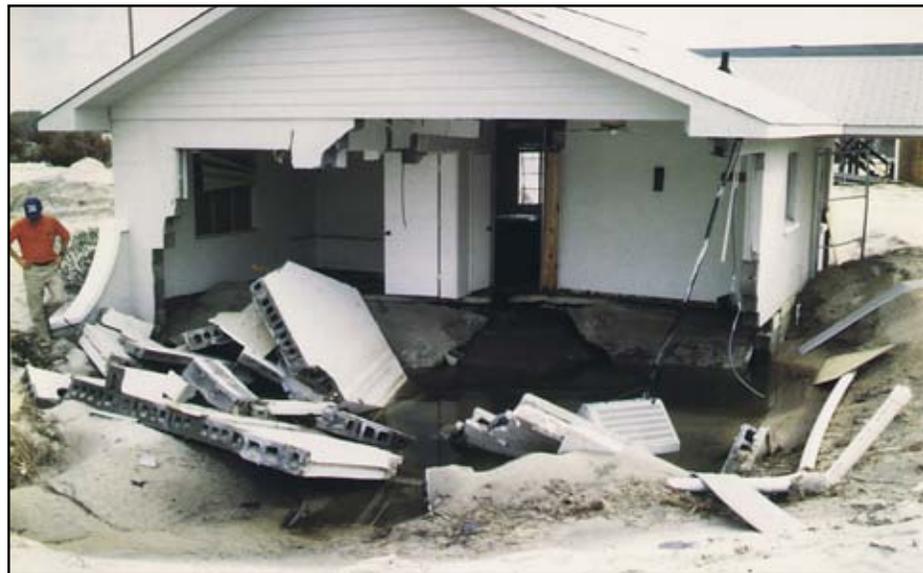
Figure 7-52
Hurricane Fran (1996).
Extreme case of localized scour undermining a slab-on-grade house on Topsail Island, North Carolina. The lot was several hundred feet from the shoreline and mapped as an A zone on the FIRM prior to the storm. This case provides one argument for the treatment of these areas as coastal A zones.

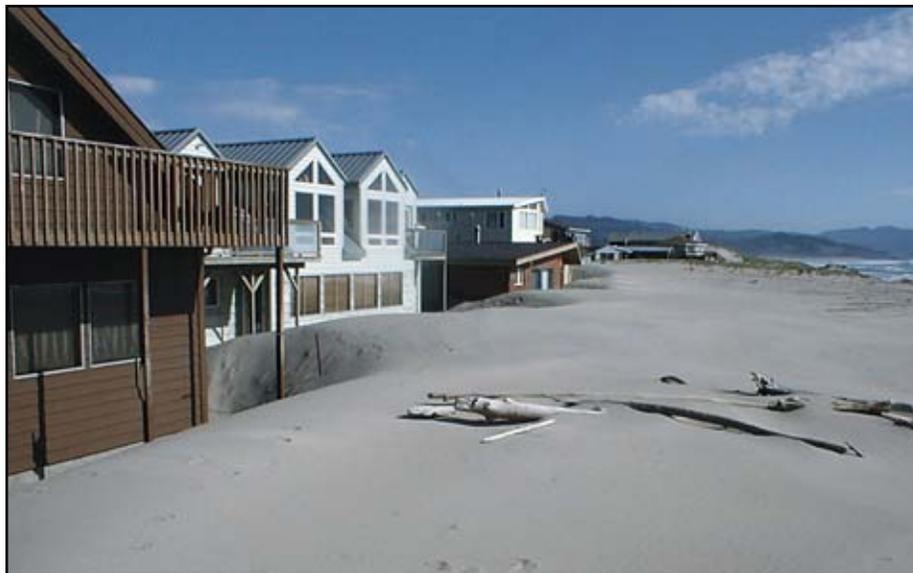
Figure 7-53
Windblown sand drifting
against coastal residences in
Pacific City, Oregon.
Photograph by Jim Good.

Some coastal areas suffer from an excess of sand rather than from erosion. The excess usually translates into accretion of the shoreline and/or significant quantities of windblown sand. Unless this windblown sediment is stabilized by vegetation or other means, it will likely be blown inland by coastal winds, where it can bury non-elevated coastal residential buildings and at-grade infrastructure—such as drainage structures and ground-mounted electrical and telephone equipment—and drift across roads (see Figure 7-53).

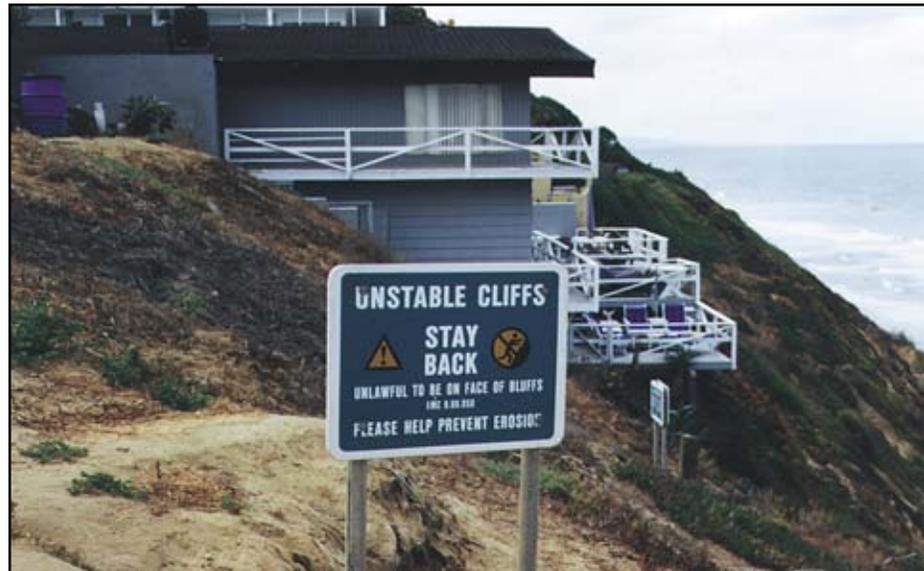
Figure 7-56
Unstable coastal bluff at
Beacon's Beach, San Diego,
California. Photograph by
Lesley Ewing.

floods, or heavy rains, but can be worsened by human actions such as destruction of vegetation or uncontrolled pedestrian access on steep slopes (see Figure 7-56). An extreme example is Hurricane Mitch in 1998, where heavy rainfall led to flash flooding, numerous landslides, and an estimated 10,000 deaths in Nicaragua.

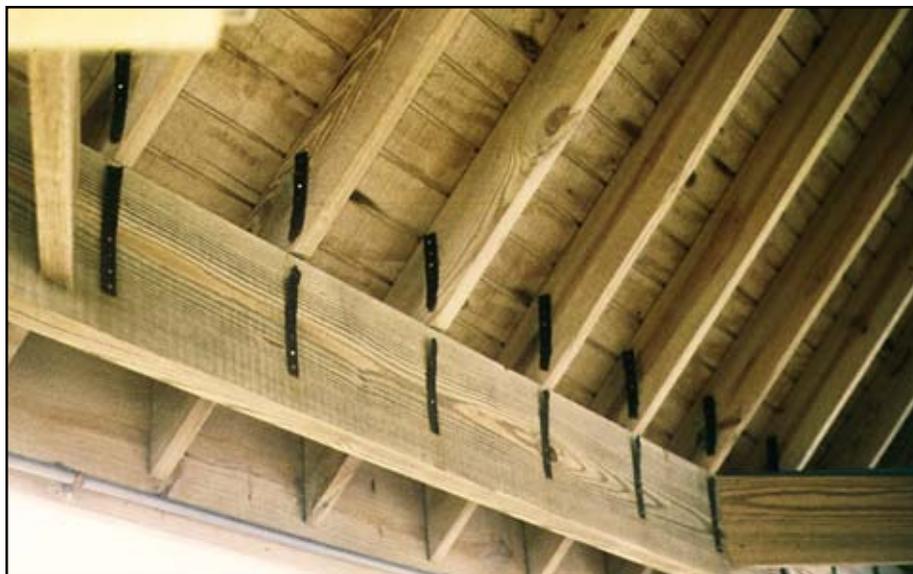
Figure 7-58

Example of corrosion, and resulting failure, of metal connectors. Photograph by Spencer Rogers.

For example, metal connectors, straps, and clips used to improve a building's resistance to high winds and earthquakes will often show signs of corrosion (see Figure 7-58). Corrosion is affected by many factors, but the primary difference between coastal and inland areas is the presence of salt spray, tossed into the air by breaking waves and blown onto land by onshore winds. Salt spray accumulates on metal surfaces, accelerating the electrochemical processes that cause rusting and other forms of corrosion, particularly in the humid conditions common along the coast.

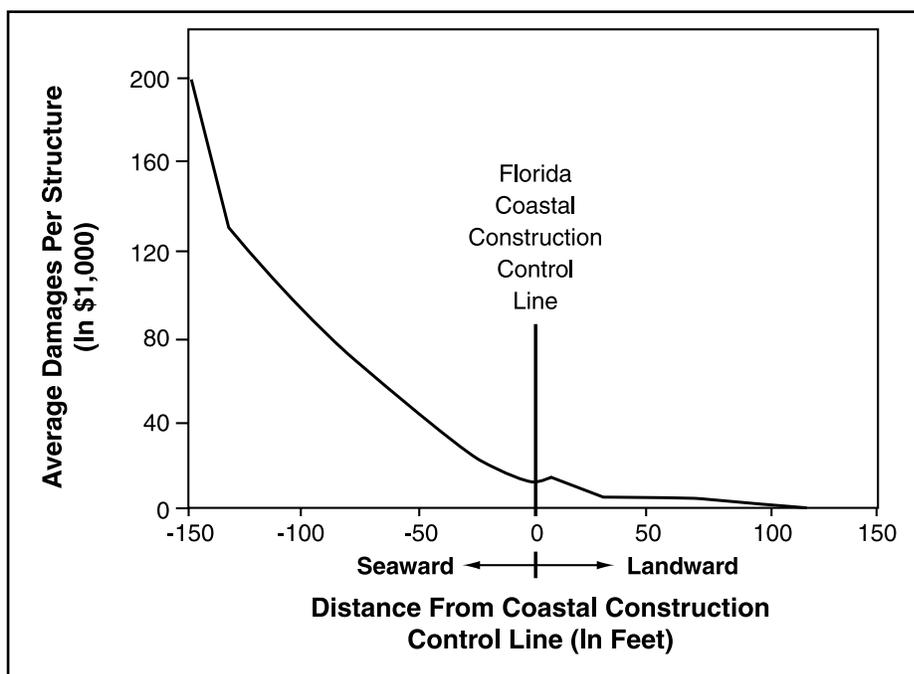
Figure 7-59
Hurricane Eloise, Bay County, Florida. Average damage per structure (in thousands of 1975 dollars) vs. distance from the Florida Coastal Construction Control Line (from Shows 1978).

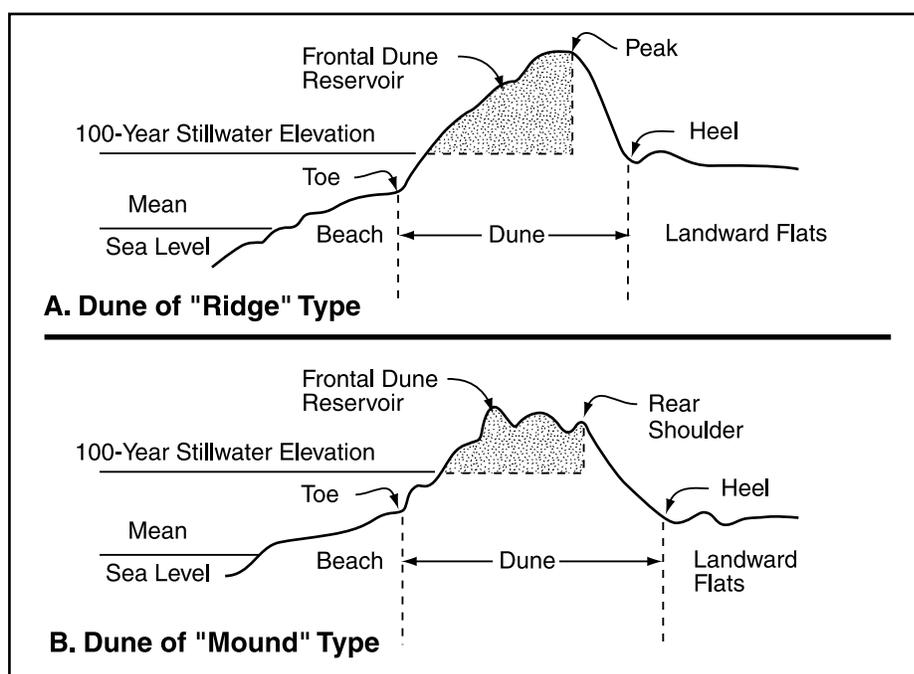
Figure 7-62
Definition sketch for frontal dune reservoir (from FEMA 1995)

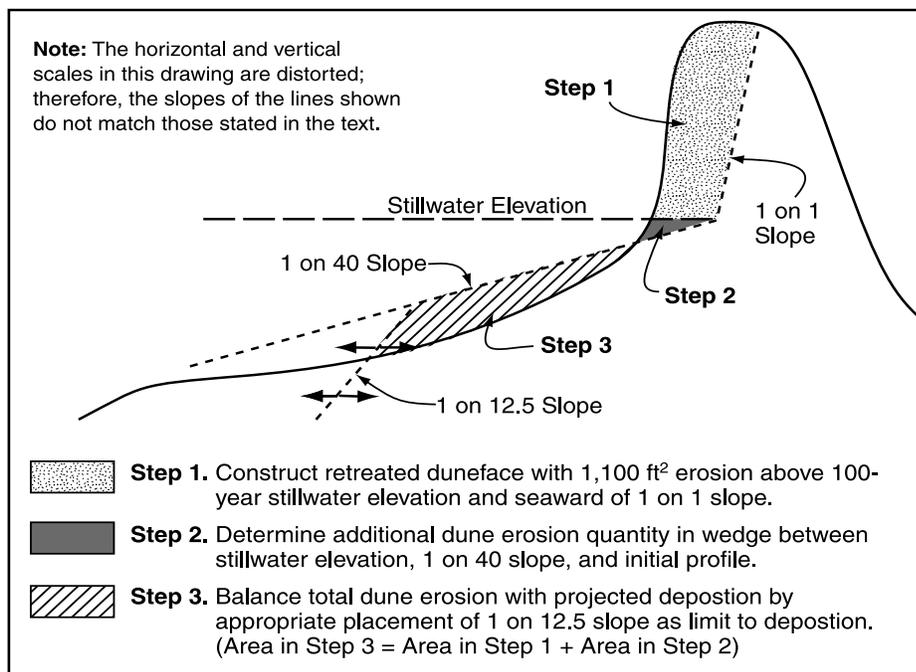
Figure 7-64
Procedure recommended by this manual for calculating dune retreat profile (modified from FEMA 1995).

This manual recommends that the size of the frontal dune reservoir used by designers to prevent dune removal during a 100-year storm be increased to 1,100 ft² (see Figure 7-64). This recommendation is made for three reasons: (1) FEMA's 540 ft² rule reflects dune size at the time of mapping and does not account for future conditions, when beaches and dunes may be compromised by long-term erosion, (2) FEMA's 540 ft² rule does not account for the cumulative effects of multiple storms that may occur within short periods of time, such as occurred in 1996, when Hurricanes Bertha and Fran struck the North Carolina coast within 2 months of each other (see Figure 5-5 in Chapter 5), and (3) even absent long-term erosion and multiple storms, use of the median frontal dune reservoir will underestimate dune erosion 50 percent of the time.
