**FHWA Bridge Inspector's Manual  
Sections 8.1-2 Steel Superstructures**

SECTION 8: Inspection and Evaluation of Common Steel Superstructures  
TOPIC 8.1: Fatigue and Fracture in Steel Bridges

### Topic 8.1 Fatigue and Fracture in Steel Bridges

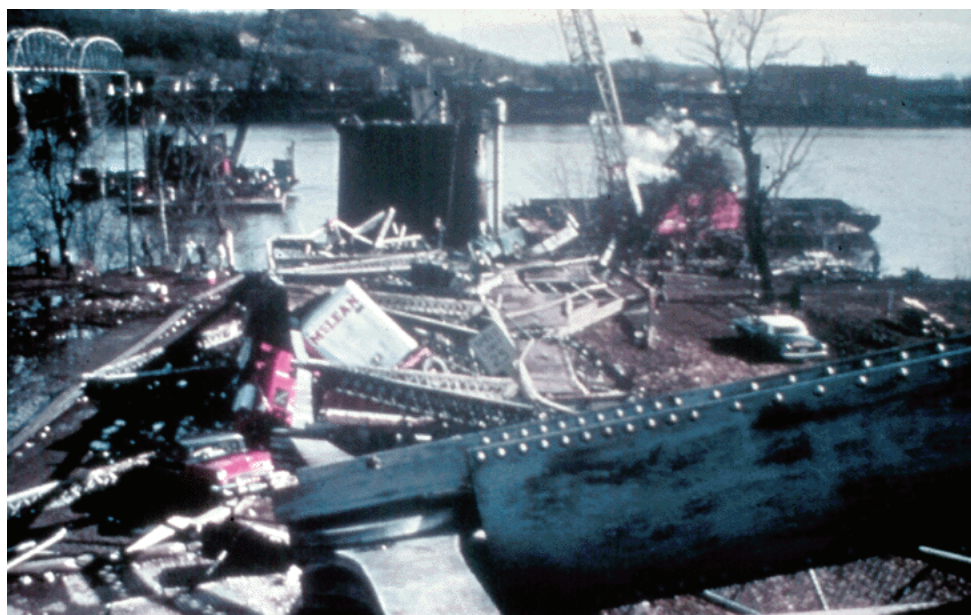
The first collapse was the Silver Bridge over the Ohio River at Point Pleasant, West Virginia on December 15, 1967. This structure was an eyebar chain suspension bridge with a 213 m (700-foot) main span that collapsed without warning and forty-six people died (see Figure 8.1.1). The collapse was due to stress corrosion and corrosion fatigue that allowed a minute crack, formed during casting of an eye-bar, to grow. The two contributing factors, over the years continued to weaken the eye-bar. Stress corrosion cracking is the formation of brittle cracks in a normally sound material through the simultaneous action of a tensile stress and a corrosive environment. Corrosion fatigue occurs as a result of the combined action of a cyclic stress and a corrosive environment. The bridge's eye-bars were linked together in pairs like a chain. A huge pin passed through the eye and linked each piece to the next. The heat-treated carbon steel eye-bar broke, placing undue stress on the other members of the bridge. The remaining steel frame buckled and fell due to the newly concentrated stresses.

Figure 8.1.1 Silver Bridge Collapse

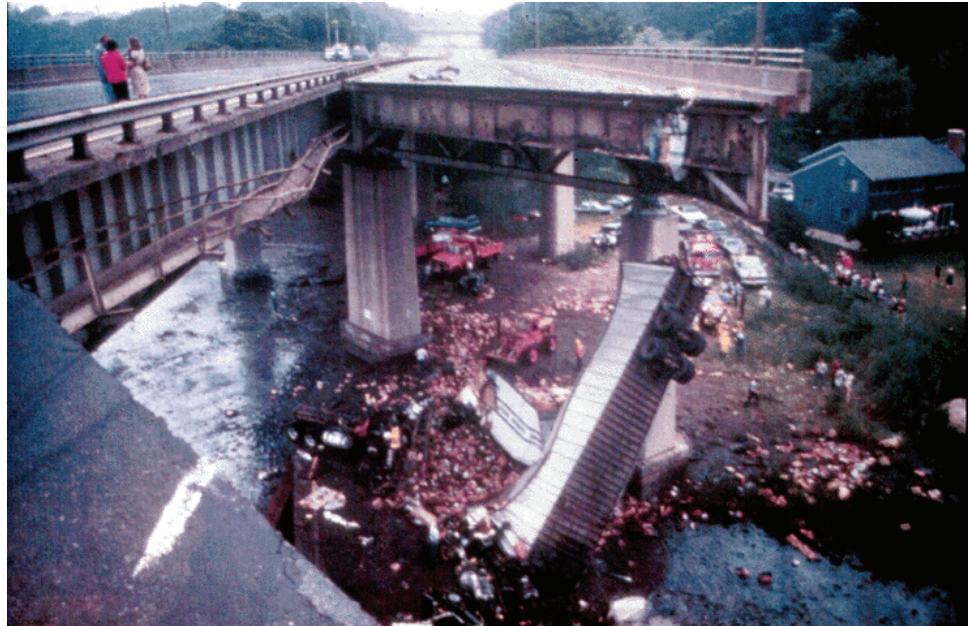
The second collapse occurred on June 28, 1983, when a suspended two-girder span carrying I-95 across the Mianus River in Greenwich, Connecticut failed (see Figure 8.1.2).

**Figure 8.1.2** Mianus River Bridge Failure

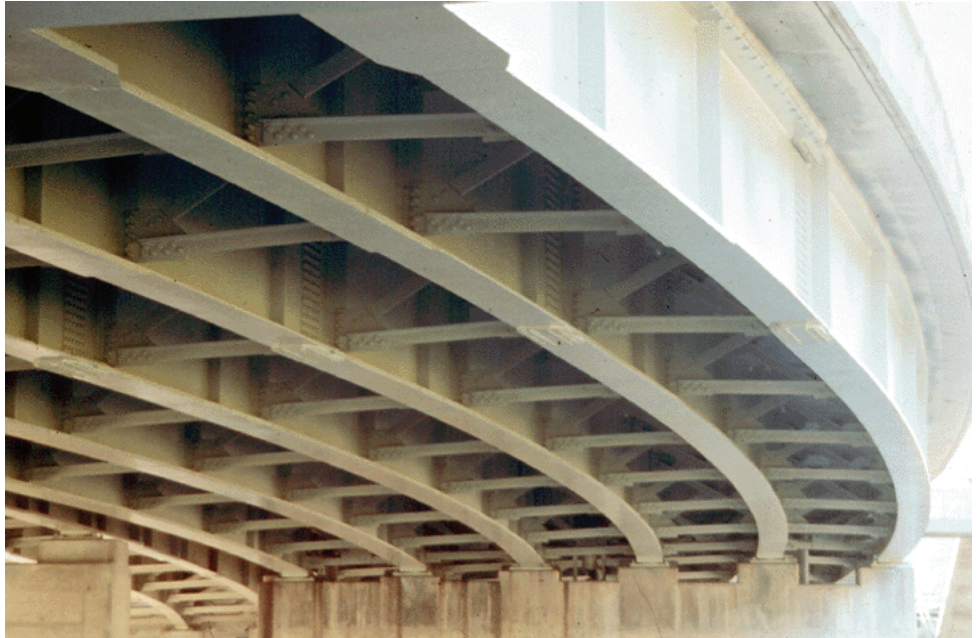
Bridge designs that have three or more main load-carrying members or load paths between supports are considered load path redundant. If one member were to fail, the bridge load would likely be redistributed to the other members, and bridge failure may not occur. An example of load path redundancy is a multi-girder bridge (see Figure 8.1.3).

**Figure 8.1.3** Load Path Redundant Multi-Girder Bridge

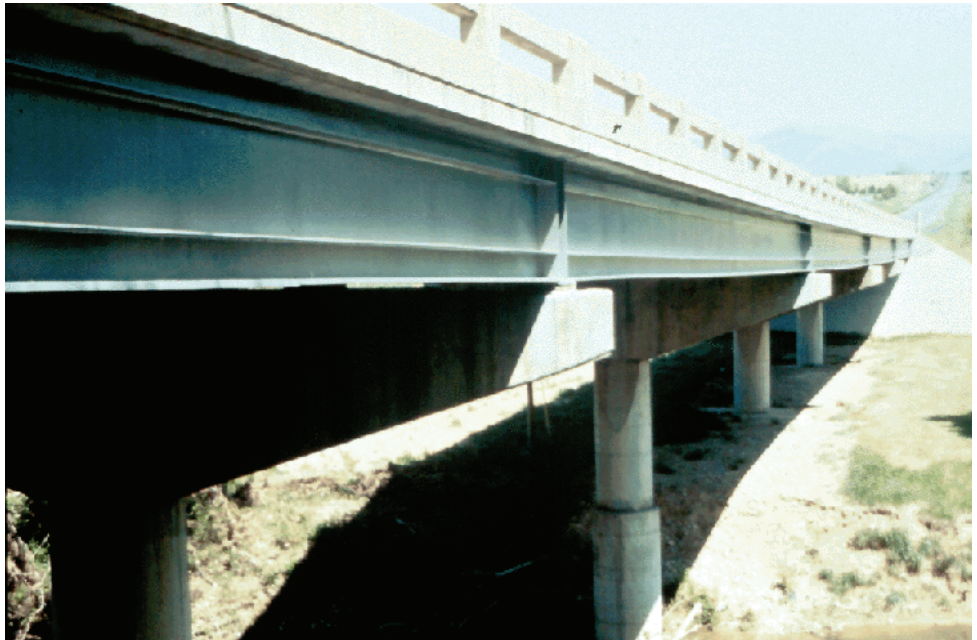
Bridge designs which provide continuity of load path from span to span are referred to as structurally redundant. Continuous span arrangements consisting of three or more spans are considered structurally redundant (see Figure 8.1.4). In the event of an interior member failure, loading from that span can be redistributed to the adjacent spans, and bridge failure may not occur.

**Figure 8.1.4** Structurally Redundant Continuous Span Bridge

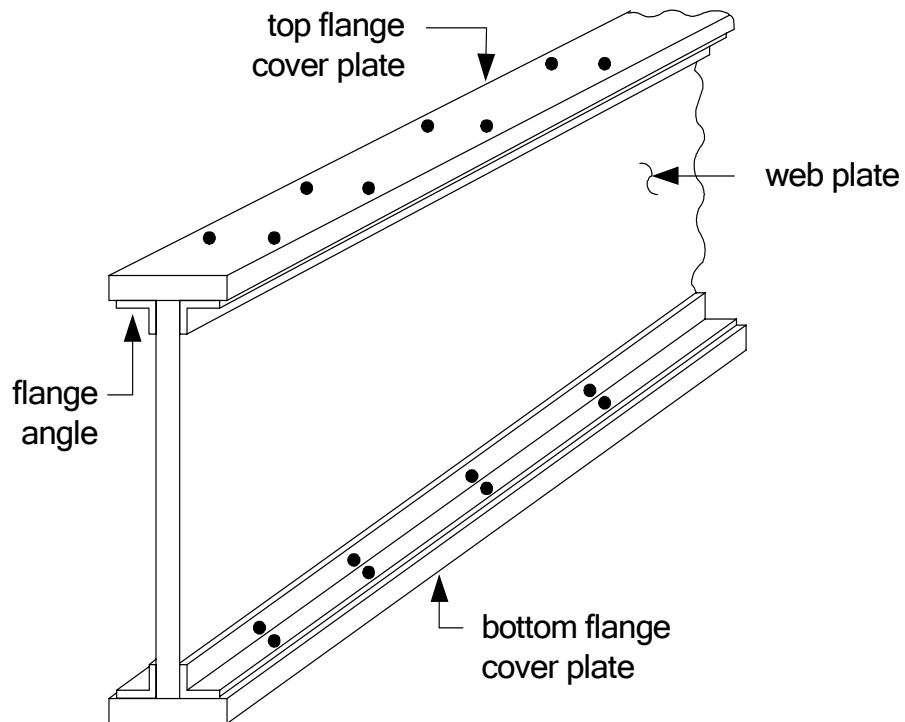
Internal or member redundancy exists when a bridge member contains three or more elements that are mechanically fastened together so that multiple independent load paths are formed. Failure of one member element might not cause total failure of the member. Examples of internally redundant members are shown in Figures 8.1.5 and 8.1.6.

**Figure 8.1.5** Internally Redundant Riveted I-Beam

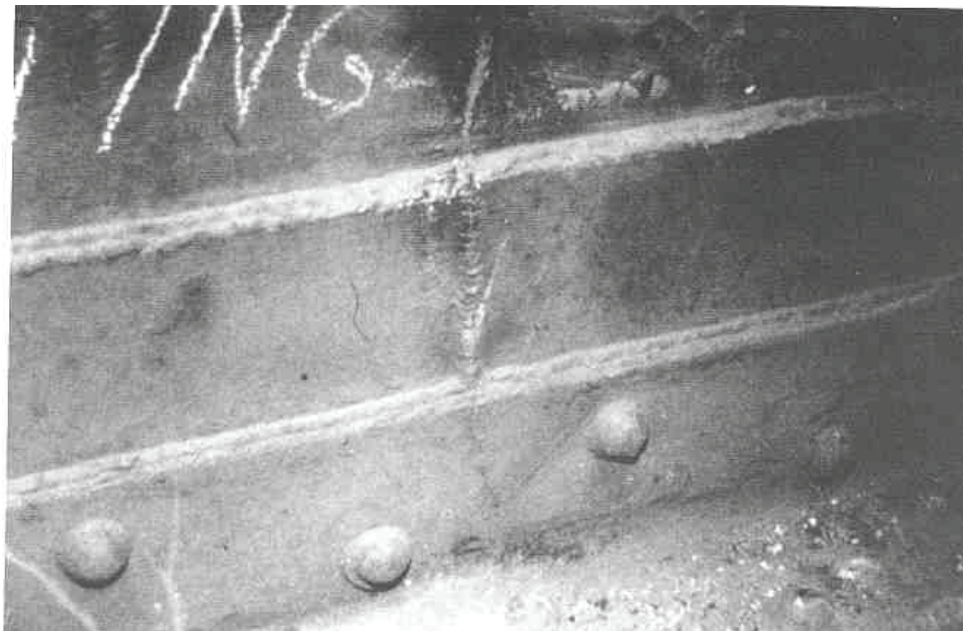
Internal redundancy of a member can be decreased or eliminated by repairs that involve welding. The welds provide paths for cracks to travel from one element to another (see Figure 8.1.7).

**Figure 8.1.7** Patch Plate on Girder Web along Flange Angle

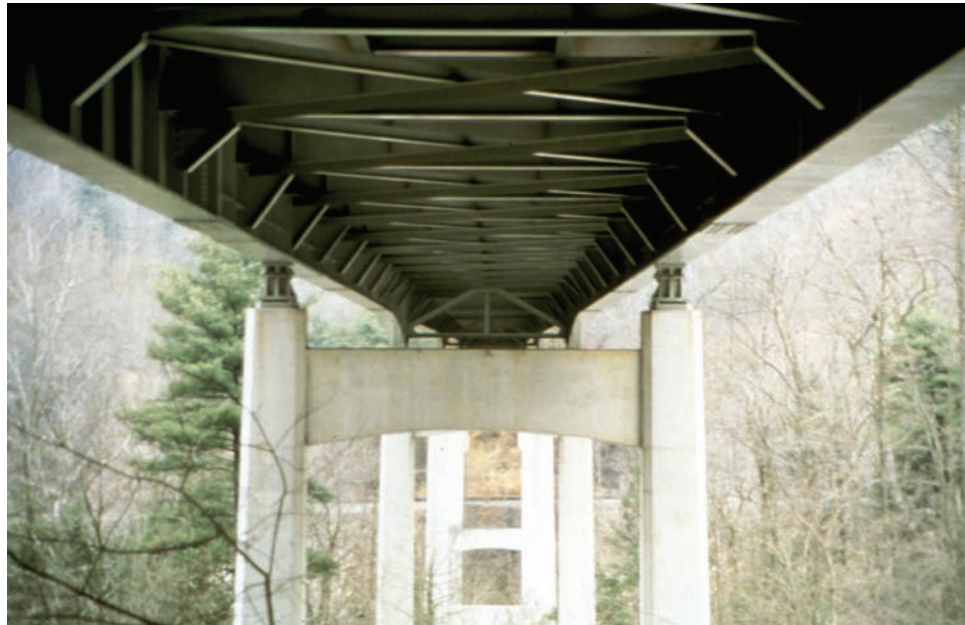
Bridge inspectors are concerned primarily with load path redundancy. The inspector should neglect structural and internal redundancy and classify all bridges with less than three load paths as nonredundant (see Figure 8.1.8). Nonredundant bridge configurations in tension contain fracture critical members.

**Figure 8.1.8** Nonredundant Two-Girder

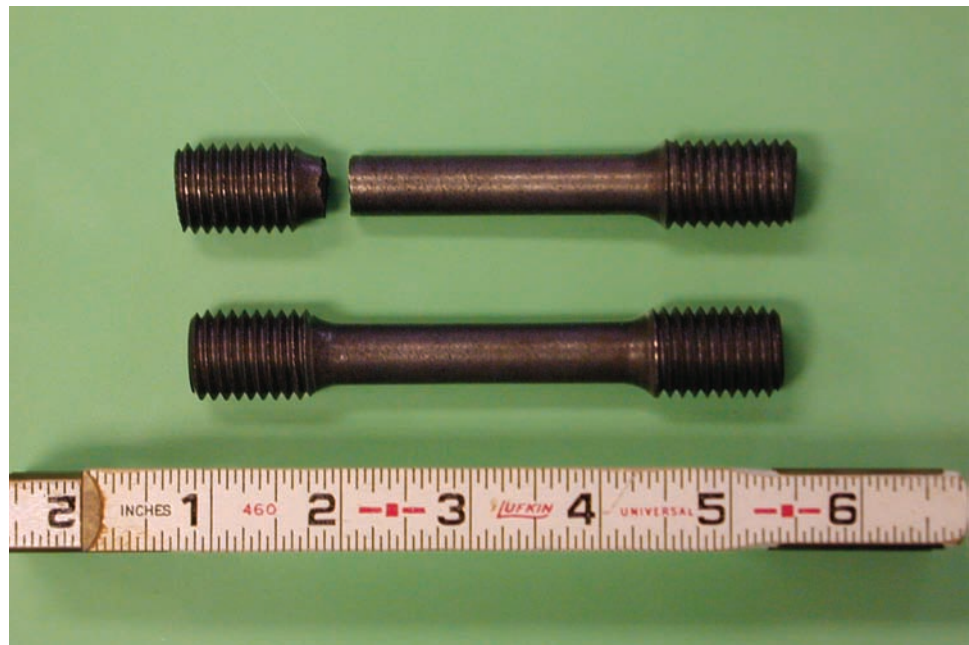
- Brittle Fracture - Occurs with no warning and without prior plastic deformation (see Figure 8.1.9).
- Ductile Fracture - Generally preceded by local plastic deformation of the net uncracked section. This plastic deformation results in distortion of the member, providing some visual warning of the impending failure (see Figure 8.1.10).

**Figure 8.1.9** Brittle Fracture of Cast Iron Specimen

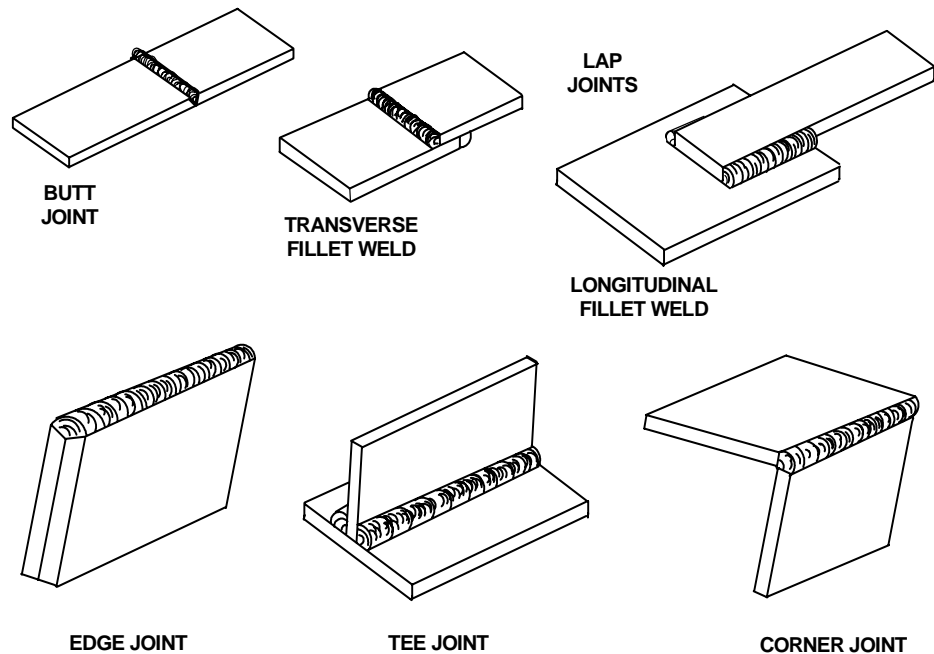
- Butt
- Lap
- Tee
- Edge
- Corner

**Figure 8.1.16** Types of Welded Joints

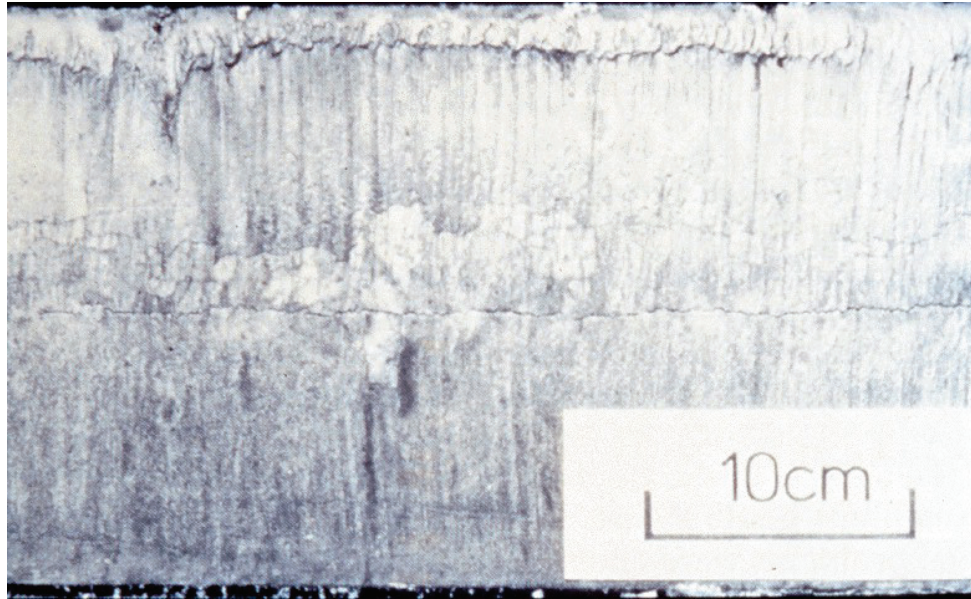
**Figure 8.1.17** Centerline Crack in Steel Slab

The centerline crack in Figure 8.1.17 may have resulted from a shrinkage cavity like that shown in Figure 8.1.18 which was not forged and melded completely in the hot rolling process.

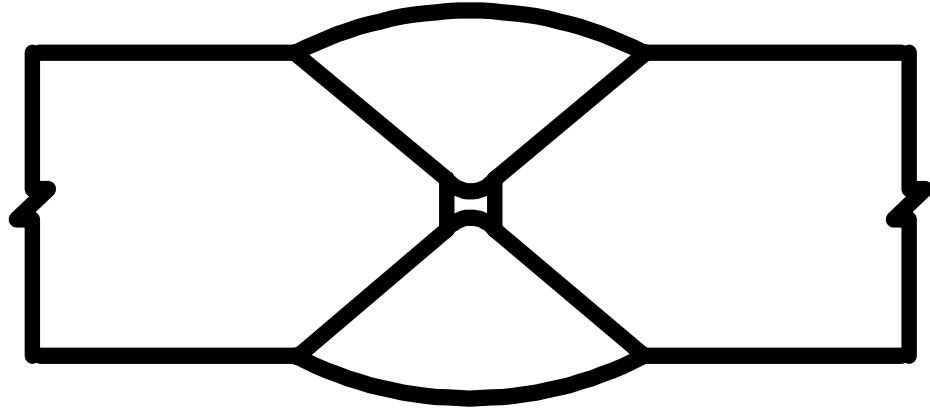
**Figure 8.1.19** Incomplete Penetration of a Double V-Groove Weld

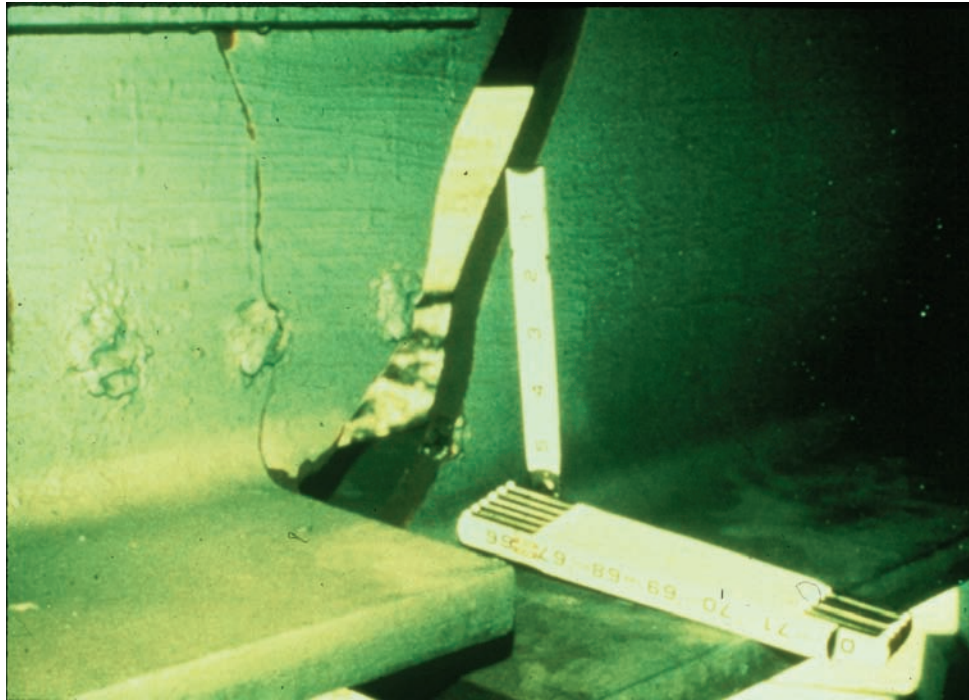
Plug welds are sometimes found in bridge members. In most cases, they were made to fill mislocated bolt holes. Such welds are highly restrained and often will contain incomplete penetration, lack of fusion, slag inclusions, and porosity. There have been many instances where a crack and fracture have occurred because of a plug weld (see Figure 8.1.23).

**Figure 8.1.23** Crack Resulting from Plug Welded Holes

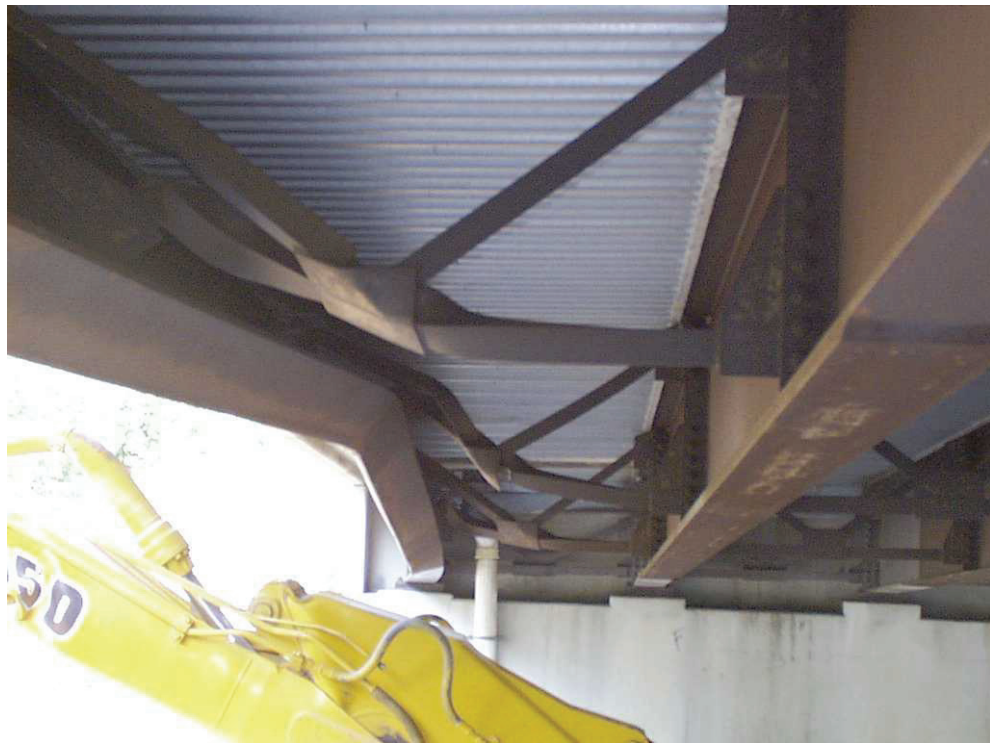
Once the structure is placed in service, some members may be prone to collision damage by errant vehicles which may nick, tear, and excessively stress the steel (see Figure 8.1.28). Improper heat straightening may damage the steel. Deep corrosion pits can develop in structures that are improperly detailed for corrosion control, poorly maintained, or left unpainted. Also, any indiscriminate welding of conduit supports, lighting attachments, and ladder brackets to steel members can cause stress risers in the base metal.

**Figure 8.1.28** Severe Collision Damage on a Fascia Girder

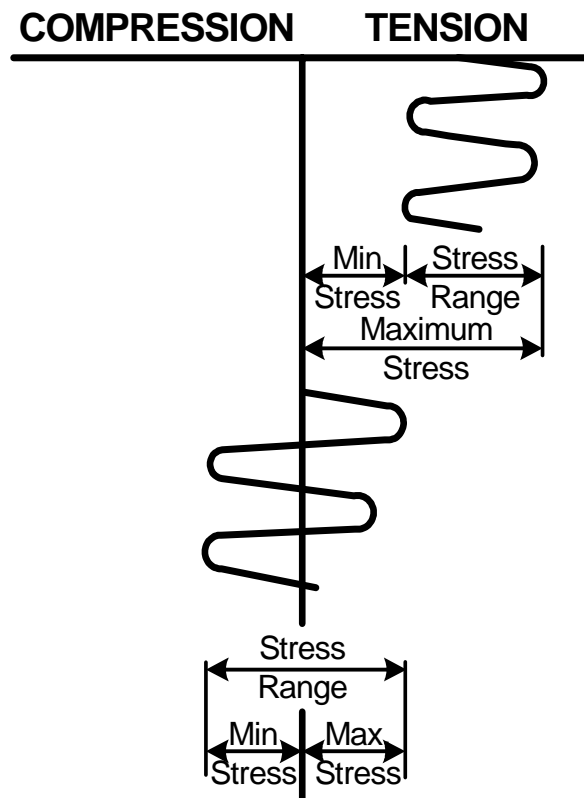
The stress range is defined as the algebraic difference between the maximum stress and the minimum stress calculated at the detail under consideration. In other words, it is the value of the cyclic stress caused by a truck crossing the bridge (see Figure 8.1.29). The weight of the bridge produces a constant stress instead of a cyclic stress. Therefore, it does not affect the crack propagation life. Only stress ranges in tension or stress reversal can drive fatigue cracks to failure. Stress ranges in compression may cause cracks to grow to some extent at weldments where there are high residual tensile stresses. However, these "compression" cracks eventually arrest, and they do not induce fracture of the member.

**Figure 8.1.29** Applied Tensile and Compressive Stress Cycles

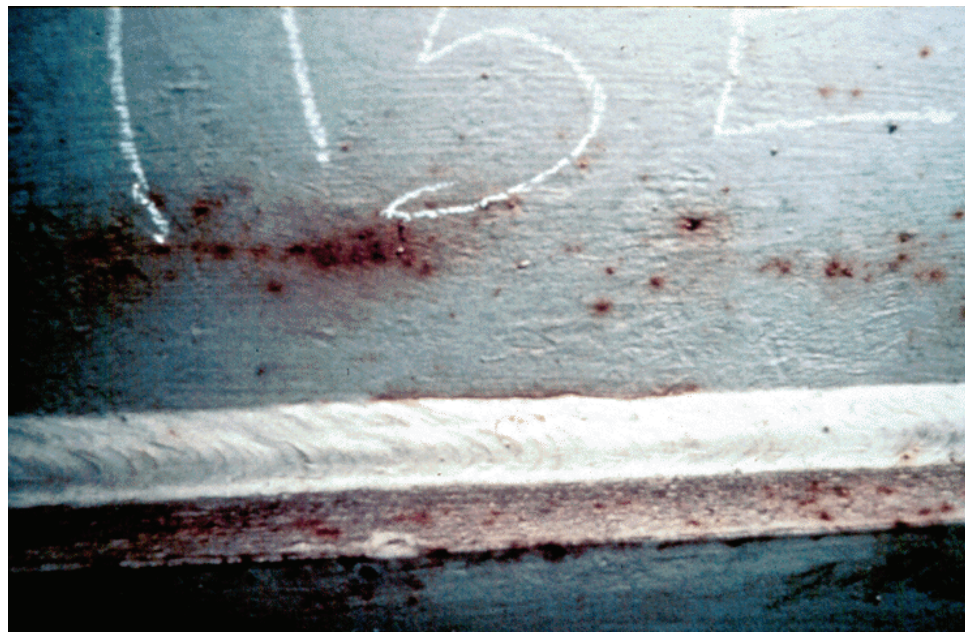
One or more cracks can initiate from microscopic flaws or defects at the weld toe of the transverse end weld (see Figure 8.1.31). Such cracking may then advance in three stages:

**Figure 8.1.31** Part-Through Crack at a Cover Plated Flange

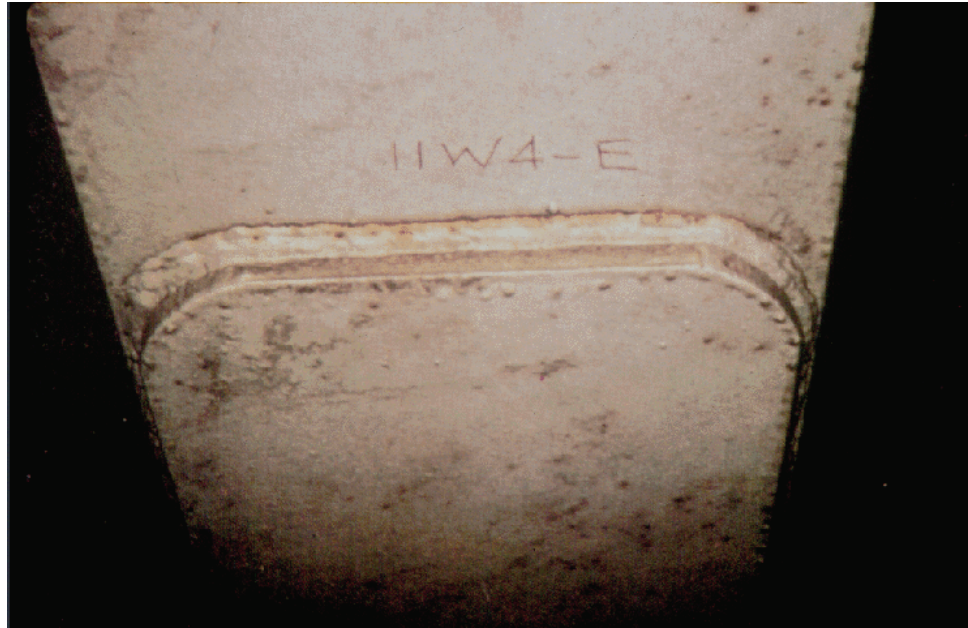
In the first stage, a part-through surface crack is only barely visible as a hairline on the bottom of the flange at the toe of weld. As stress is applied, the small cracks that have initiated join each other and begin to form a larger part-through surface crack (see Figure 8.1.32).

**Figure 8.1.32** Part-Through Crack Growth at Cover Plate Welded to Flange

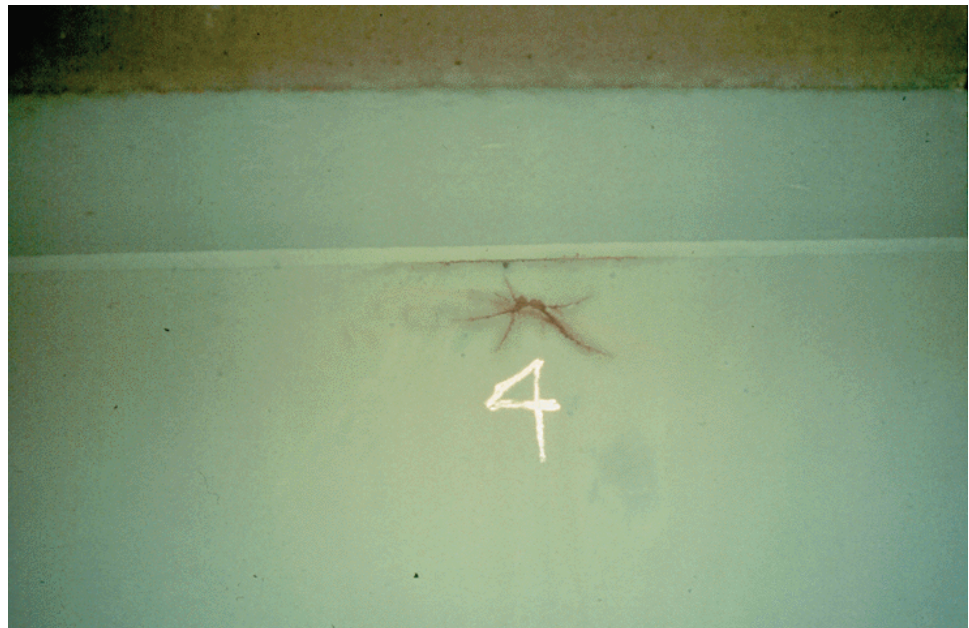
After it breaks through the web, the shape changes into a two-ended (or more) through crack which propagates up and down the web (see Figure 8.1.39). The through crack can be readily seen on both sides of the web. The stiffener crack expends about 5% of the fatigue life propagating in Stage 2.

**Figure 8.1.39** Through Crack in the Web

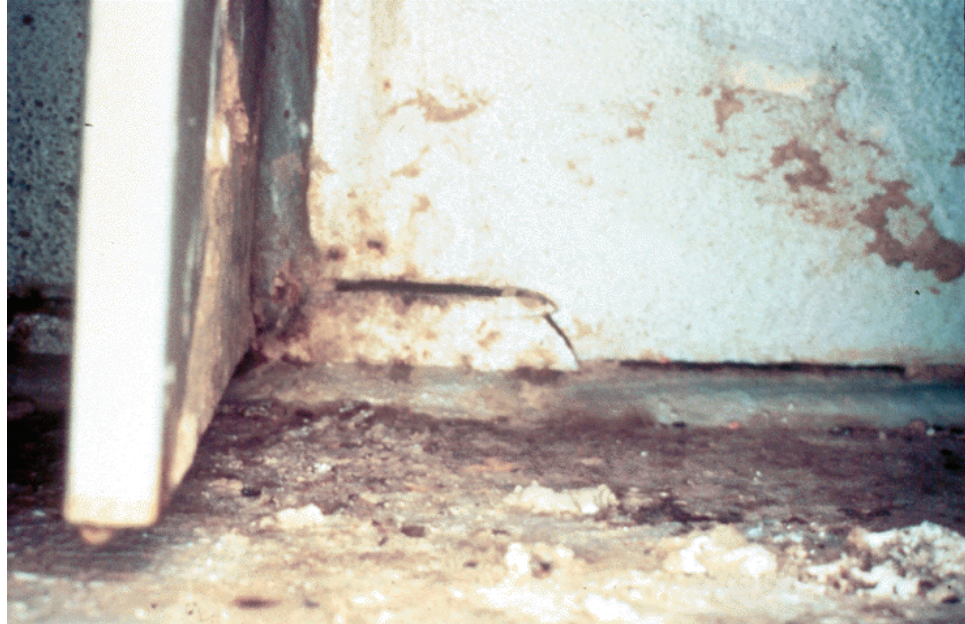
Eventually, the lower crack front will reach the bottom flange, and the three-ended crack will then propagate with two fronts moving across the flange and one front moving farther up the web, until the member fractures (see Figure 8.1.40).

**Figure 8.1.40** Through-Crack Ready to Propagate into the Flange

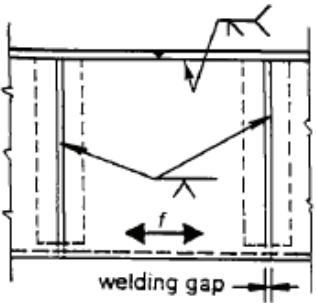
<p>Welded rib "window" field splice</p> <p>Single groove butt weld</p>	<p>(7) Permanent backing bar for rib splice</p> <p>Welding gap &gt; rib wall thickness</p> <p><math>f</math> = axial stress range in bottom of rib</p>	<p>D</p>

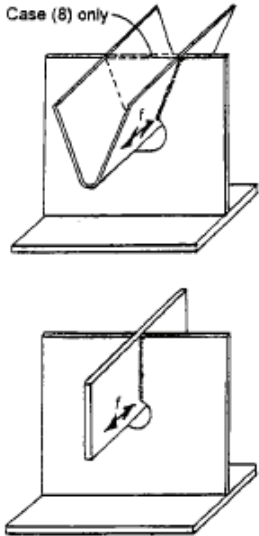
<p>Rib wall at rib/floorbeam intersection</p> <p>Fillet welds between rib and floorbeam web</p>	<p>(8) Closed rib with internal diaphragm inside the rib or open rib</p> <p><math>f</math> = axial stress range in rib wall at the lower end of rib/floorbeam weld</p> <p>(9) Closed rib, no internal diaphragm inside of rib</p> <p><math>f = f_1 + f_2</math></p> <p><math>f_1</math> = axial stress range in rib wall</p> <p><math>f_2</math> = local bending stress range in rib wall due to out-of-plane bending caused by rib-floorbeam interaction, obtained from a rational analysis</p>	<p>C</p> <p>C</p>

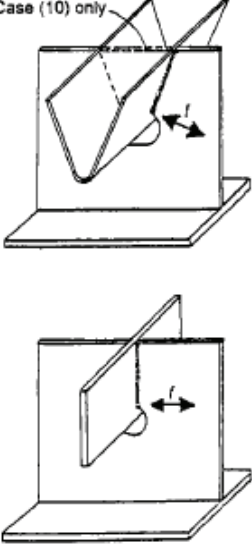
<p>Case (10) only</p>	<p>Floorbeam web at rib/floorbeam intersection</p> <p>Fillet welds between rib and floorbeam web and between rib and internal diaphragm</p>	<p>(10) With internal diaphragm inside of closed rib, or open rib</p> <p><math>f</math> = axial stress range component in floorbeam web perpendicular to weld = <math>f_1 + f_2</math></p> <p><math>f_1</math> = axial stress range in web</p> <p><math>f_2</math> = bending stress range in web due to out-of-plane bending caused by rib rotation at support</p> <p>Both stresses <math>f_1</math> and <math>f_2</math> to be obtained from a rational analysis</p>	<p>Lesser of C or Eq.6.6.1.2.5-3</p> <p>C for combination fillet-groove welds</p>
		<p>(11) No internal diaphragm inside of closed rib</p> <p><math>f = f_1 + f_2</math></p> <p><math>f</math> = interaction stress range between the "tooth" of the floorbeam web and the rib wall obtained from a rational analysis</p> <p><math>f_2</math> as defined for (10)</p>	<p>C</p>

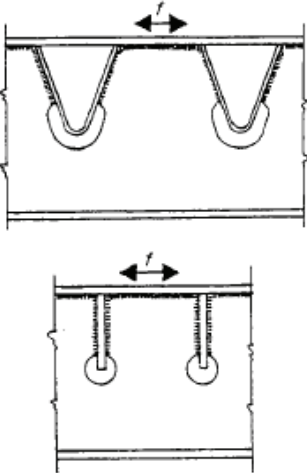
<p>Deck plate at the connection to floorbeam web</p>	<p>(12) <math>f</math> = axial stress range in the deck plate at the deck/floorbeam weld</p>	<p>E</p>

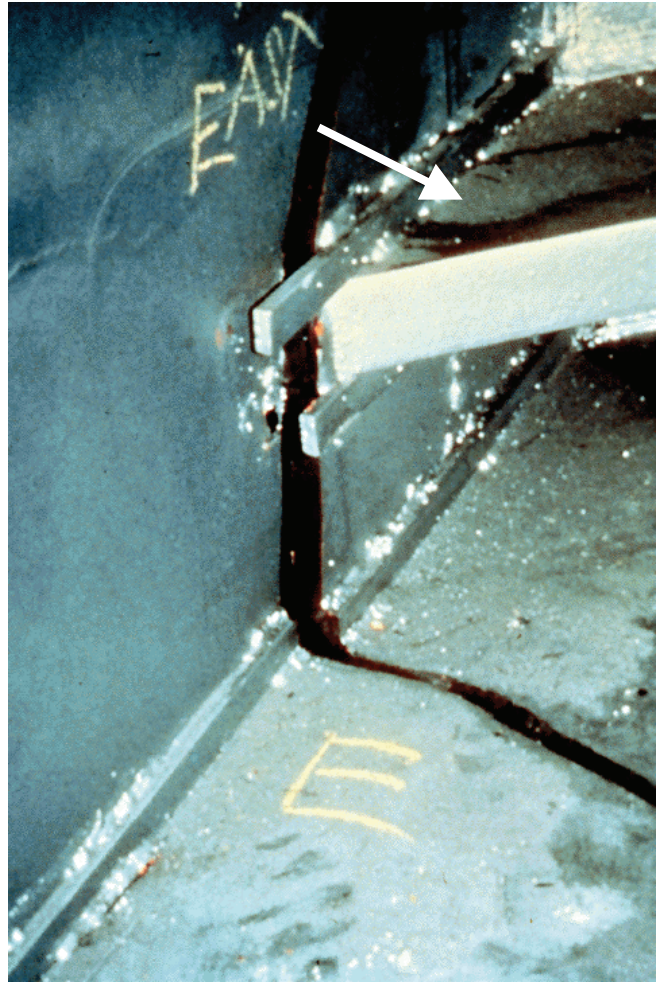
**Figure 8.1.43** Poor Quality Welds Inside Cross Girder

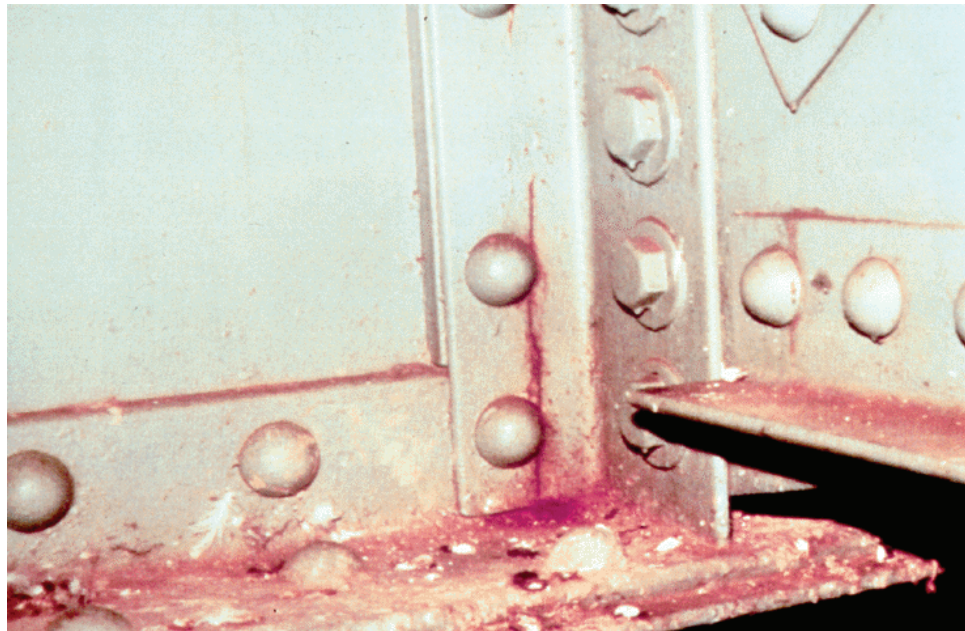
**Figure 8.1.49** Cracked Stringer to Floorbeam Connection Angle

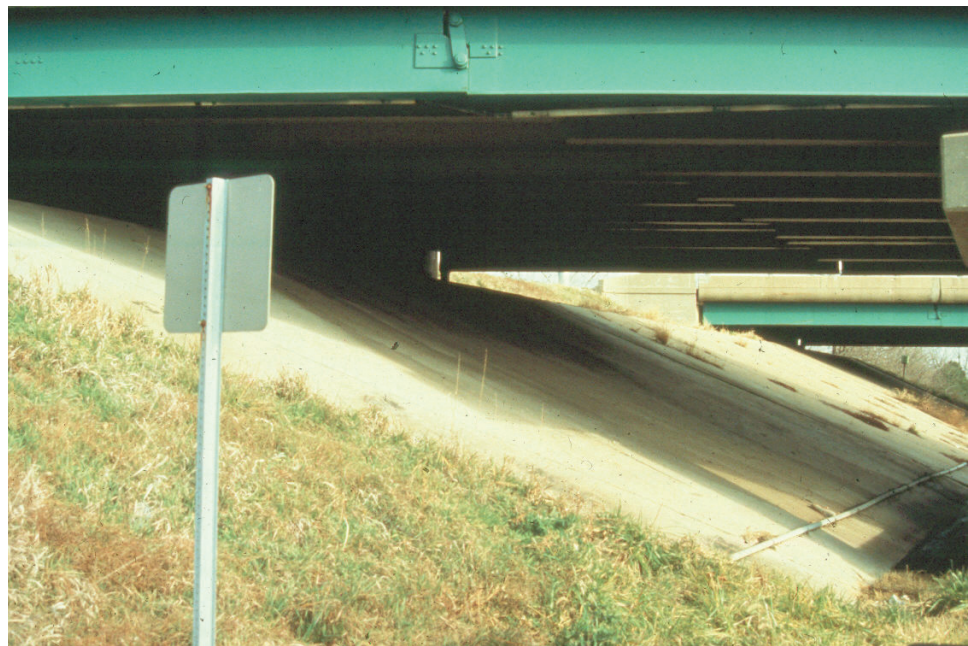
**Figure 8.2.2** Continuous Span Rolled Multi-beam Bridge with Pin & Hanger

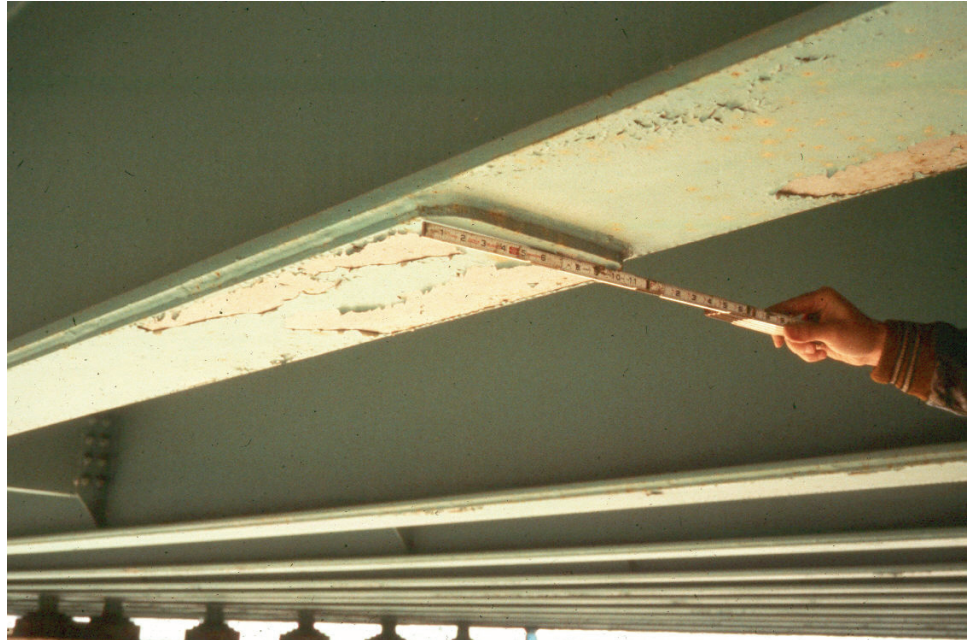
**Figure 8.2.3** Rolled Multi-beam Bridge with a Cover Plate

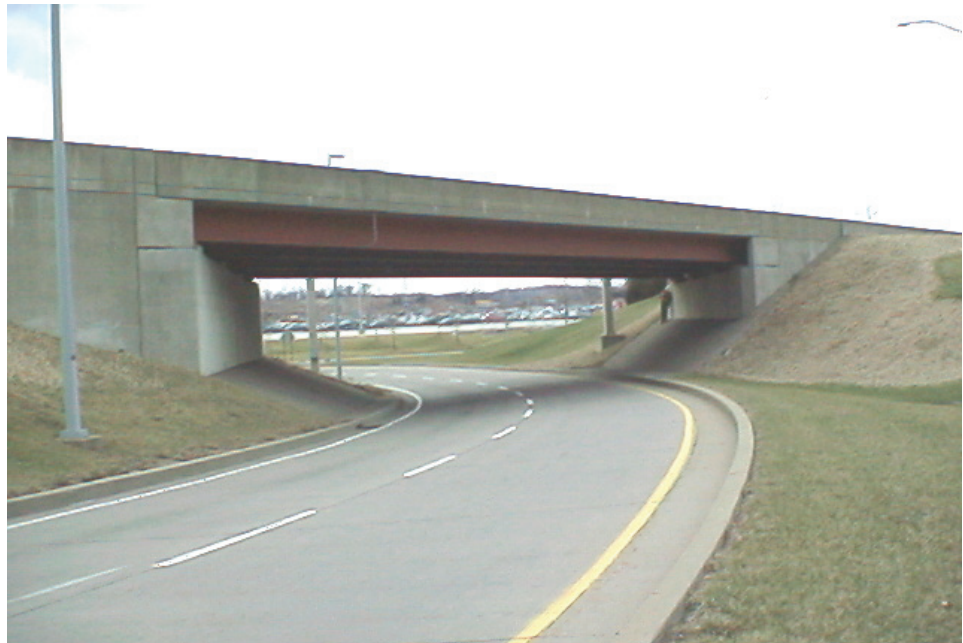
**Figure 8.2.6** Single Span Fabricated Multi-girder Bridge

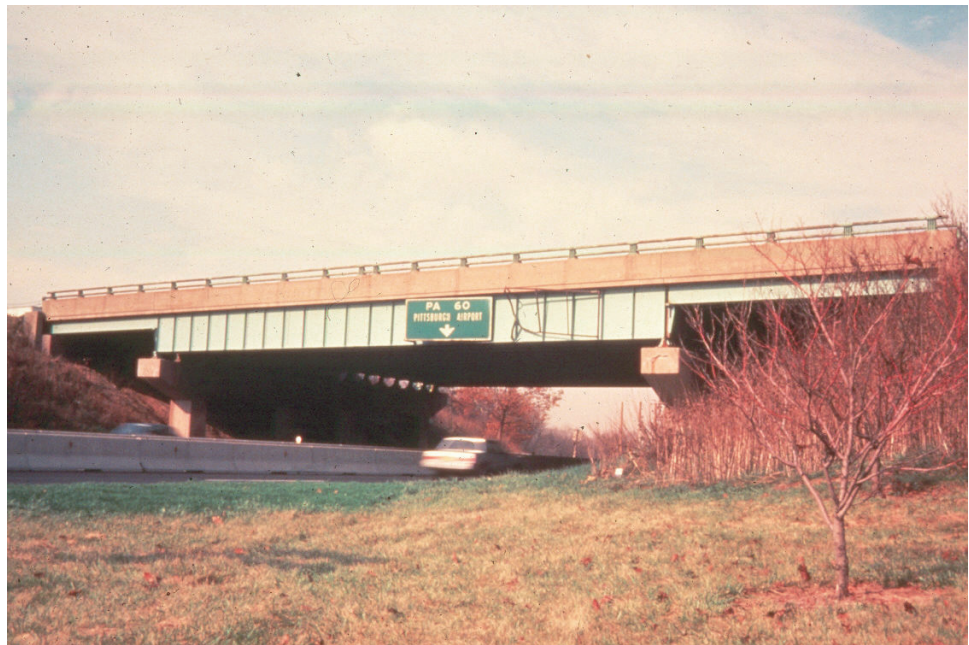
**Figure 8.2.10** Combination Rolled Beams and Fabricated Girders

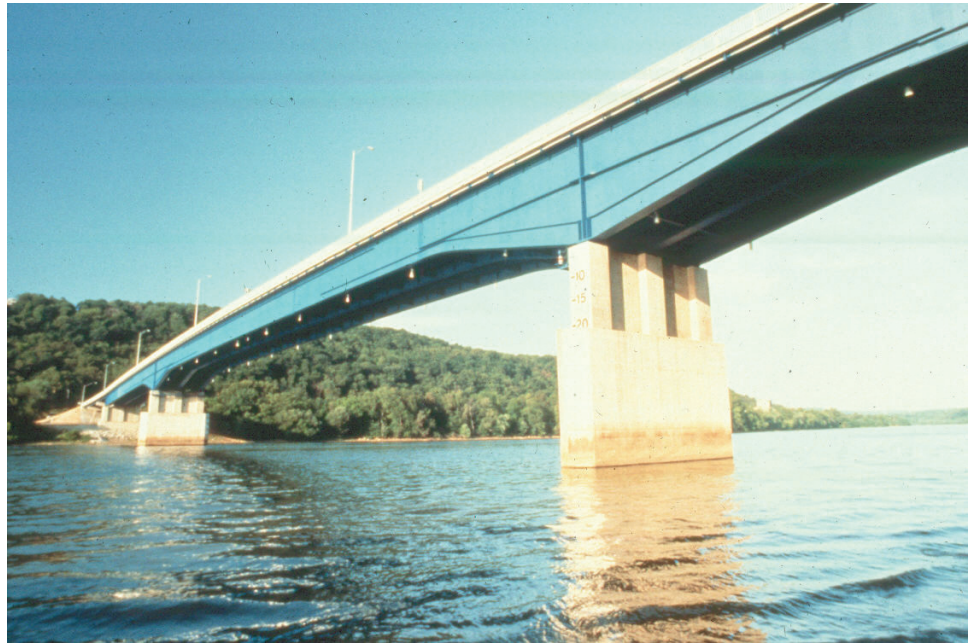
**Figure 8.2.12** Fabricated Variable Depth Girder Bridge

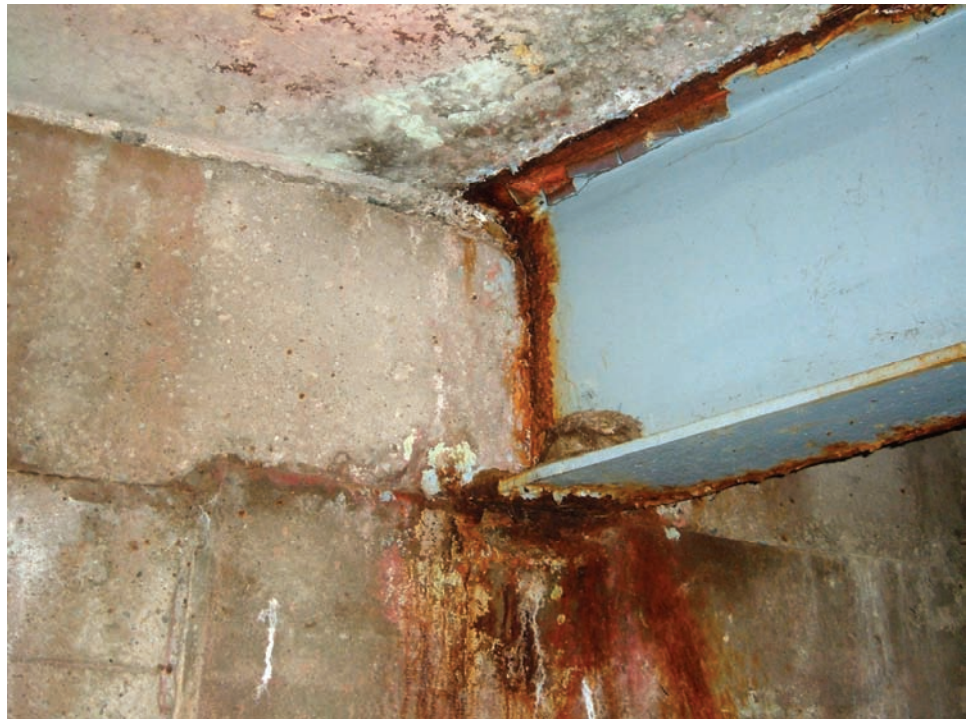
**Figure 8.2.16** Corroded Shear Zone on a Rolled Multi-beam Bridge

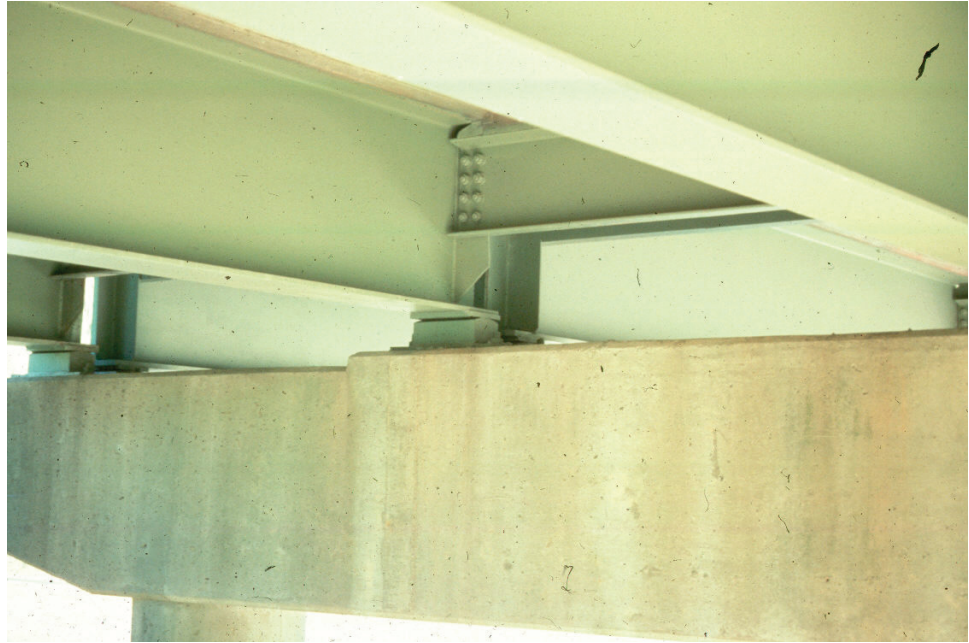
**Figure 8.2.21** End Diaphragm

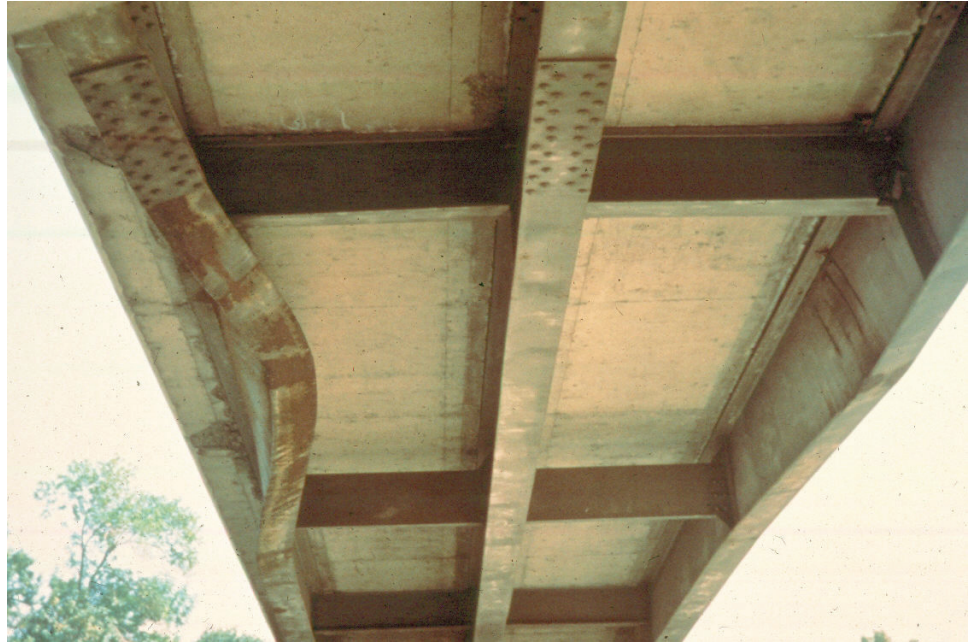
**Figure 8.2.24** Collision Damage on a Fabricated Multi-girder Bridge

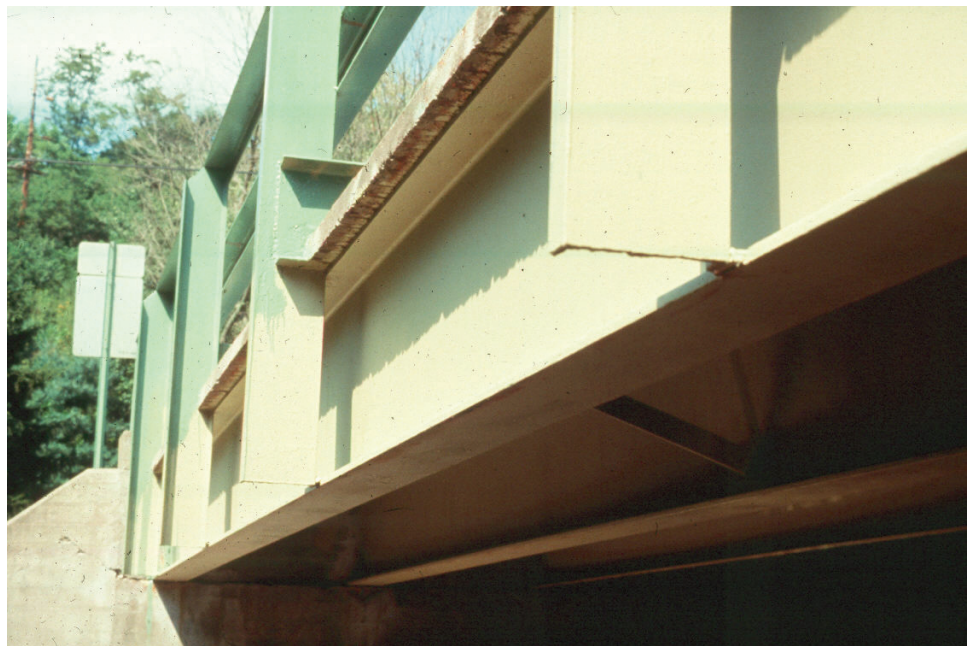
**Figure 8.2.26** Welded Attachment in Tension Zone of a Beam

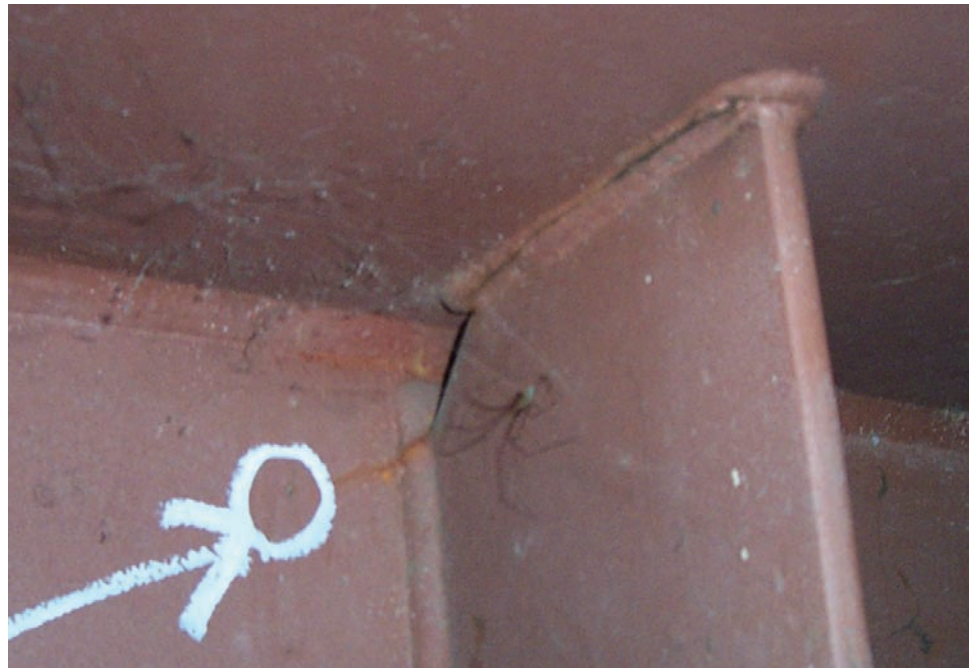
**Figure 8.2.28** Web Crack due to Out-of-plane Distortion at Top Flange

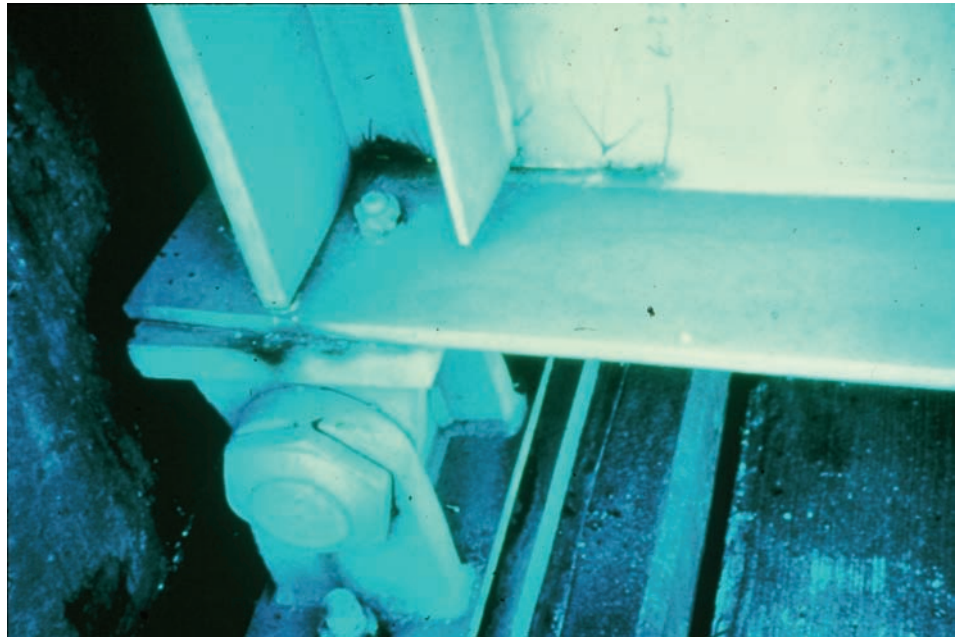
**Figure 8.2.29** Web Crack due to Out-of-plane Distortion at Bottom Flange
