PDHonline Course C558 (2 PDH)

Diamond Grinding & Grooving

Instructor: John Huang, Ph.D., PE and John Poullain, PE

CHAPTER 5 DIAMOND GRINDING AND GROOVING

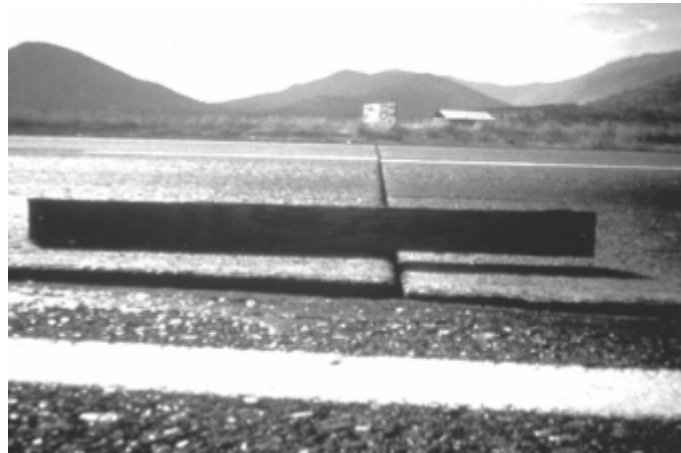
Figure 5-3 Faulting at a joint (FHWA, 2006)

The most common reason for diamond grinding is to remove roughness caused by excessive faulting of pavement joints. However, if load transfer at the joints and cracks is not restored, faulting will most likely re-occur. Faulting at a joint is illustrated in Figure 5-3. A straightedge is used to measure the difference in elevation between the two adjacent slabs. In such cases diamond grinding can still be used as a short-term solution.

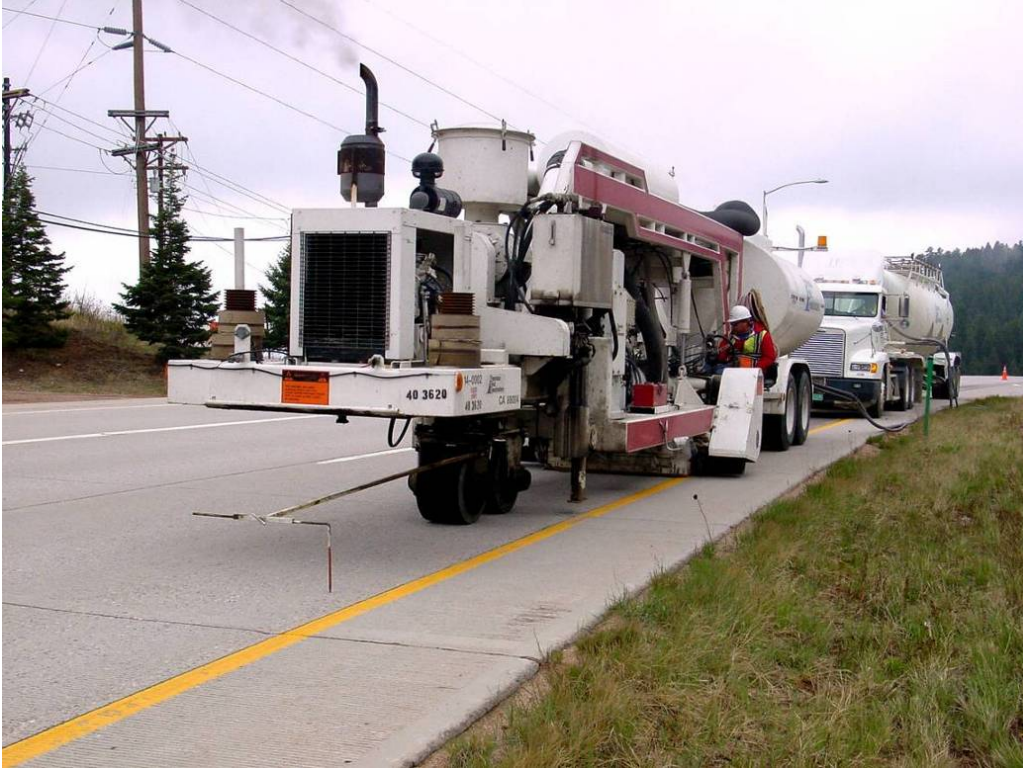
Figure 5-8 Typical grinding machine, front view (Courtesy of Caltrans)

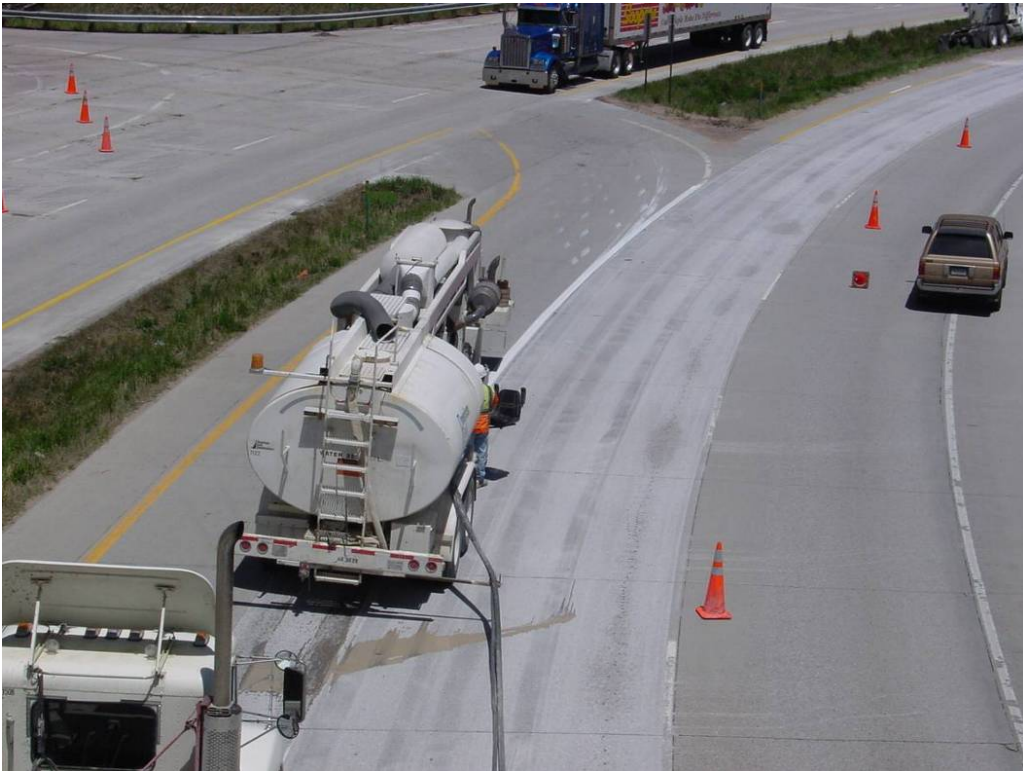
Figure 5-9 Grinding process (Courtesy of Caltrans)

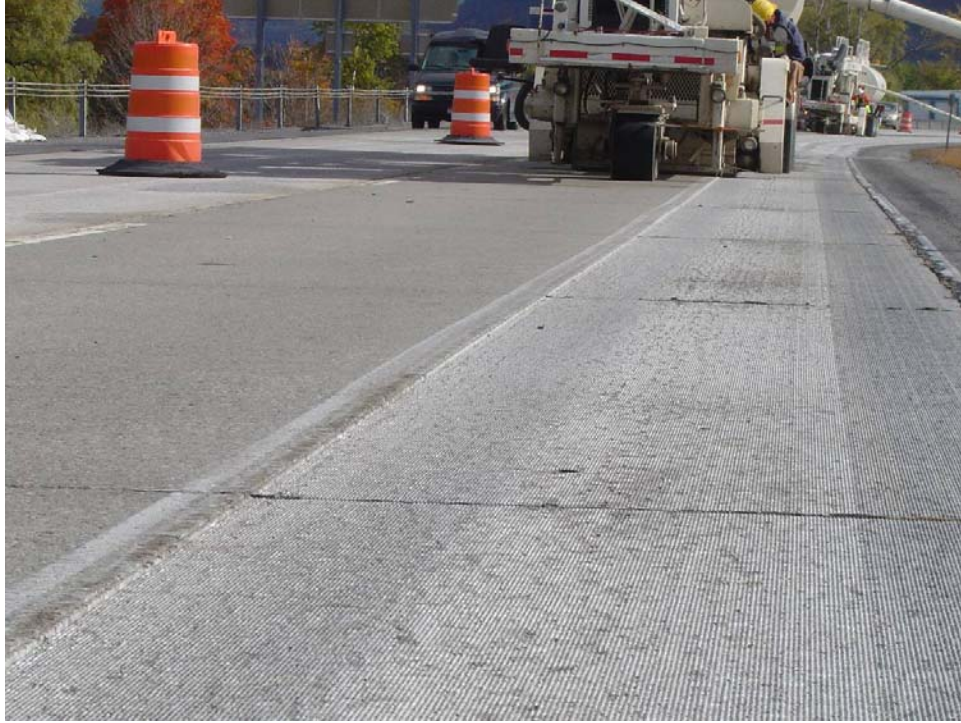
Figure 5-12 Pavement surface after diamond grinding (Courtesy of IGGA)

In general, three or four passes of one or more grinding machines are necessary to cover the entire width of a lane. The desired texture is produced using a spacing of 50 to 60 blades per foot (165 to 200 blades per meter). The texture of the pavement surface after diamond grinding is shown in Figures 5-12 and 5-13.

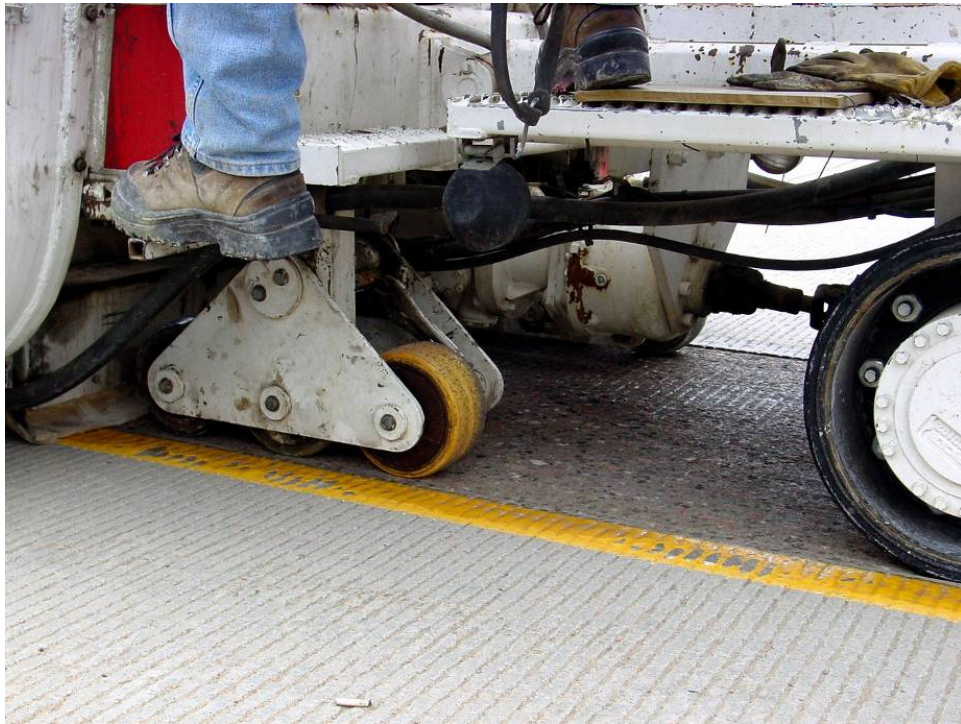
Figure 5-13 Pavement surface texture behind grinding head (Courtesy of Caltrans)
