Common ADA Errors in Facilities Design

Common ADA Errors and Omissions in New Construction and Alterations

Common ADA Problems at Newly Constructed Lodging Facilities

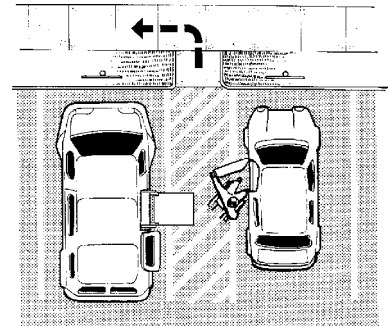
There is no accessible route from accessible parking to an accessible entrance.

4.6.3* Parking Spaces. ...Parking access aisles shall be part of an accessible route to the building or facility entrance and shall comply with 4.3.

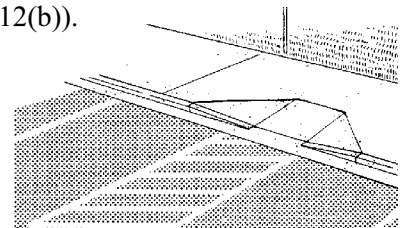
Curb ramp that is located across a circulation path has steep unprotected side flares.

4.7.5 Sides of Curb Ramps. If a curb ramp is located where pedestrians must walk across the ramp, or where it is not protected by handrails or guardrails, it shall have flared sides; the maximum slope of the flare shall be 1:10 (see Fig. 12(a)). Curb ramps with returned curbs may be used where pedestrians would not normally walk across the ramp (see Fig. 12(b)).

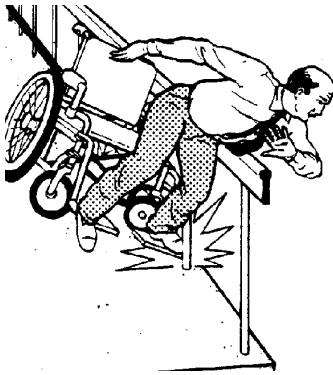
Parts of an accessible route with slopes that exceed 1:20 lack required features including handrails and edge protection.

4.8.1* General. Any part of an accessible route with a slope greater than 1:20 shall be considered a ramp and shall comply with 4.8.

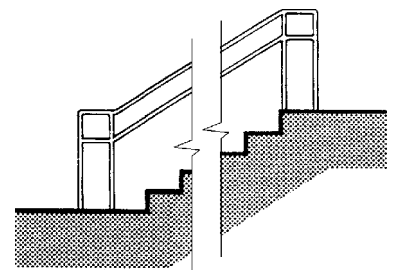
Handrail extensions are not provided at the top and bottom risers.

4.9.4(2) If handrails are not continuous, they shall extend at least 12 in (305 mm) beyond the top riser and at least 12 in (305

mm) plus the width of one tread beyond the bottom riser. At the top, the extension shall be parallel with the floor or ground surface. At the bottom, the handrail shall continue to slope for a distance of the width of one tread from the bottom riser; the remainder of the extension shall be horizontal (see Fig. 19(c) and (d)). Handrail extensions shall comply with 4.4.

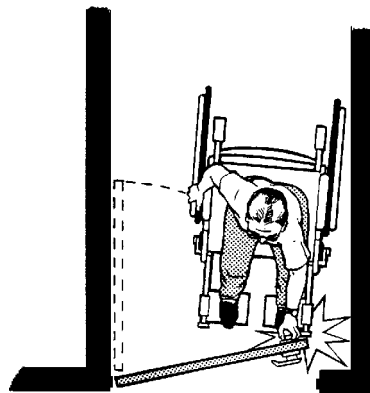
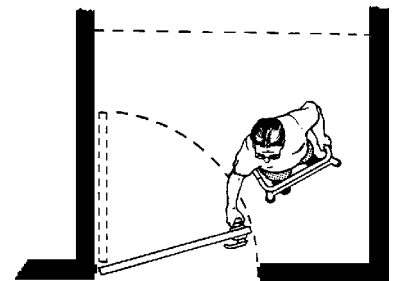
Adequate maneuvering clearance is not provided at doors, including doors to accessible toilet stalls.

4.13.6 Maneuvering Clearances at Doors. Minimum maneuvering clearances at doors that are not automatic or power-assisted shall be as shown in Fig. 25. The floor or ground area within the required clearances shall be level and clear.

4.17.5* Doors. Toilet stall doors, including door hardware, shall comply with 4.13. If toilet stall approach is from the latch side of the stall door, clearance between the door side of the stall and any obstruction may be reduced to a minimum of 42 in (1065 mm) (Fig. 30).

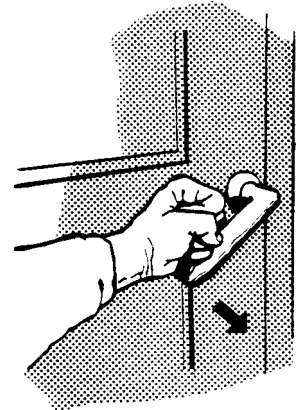
The shape of the door hardware requires tight grasping, pinching, and twisting of the wrist to use.

4.13.9* Door Hardware. Handles, pulls, latches, locks, and other operating devices on accessible doors shall have a shape that is easy to grasp with one hand and does not require tight grasping, tight pinching, or twisting of the

wrist to operate. Lever-operated mechanisms, push-type mechanisms, and U-shaped handles are acceptable designs. When sliding doors are fully open, operating hardware shall be exposed and usable from both sides. Hardware required for accessible door passage shall be mounted no higher than 48 in (1220 mm) above finished floor.

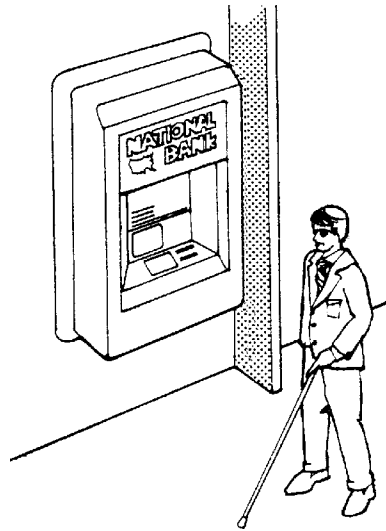
Objects protrude into circulation paths from the side or from posts.

Objects that overhang circulation paths do not provide clear headroom.

4.4.1* General. Objects projecting from walls (for example, telephones) with their leading edges between 27 in and 80 in (685mm and 2030 mm) above the finished floor shall protrude no more than 4 in (100 mm) into walks, halls, corridors, passageways, or aisles (see Fig. 8(a)). Objects mounted with their leading edges at or below 27 in (685 mm) above the finished floor may protrude any amount (see Fig. 8(a) and (b)). Free-standing objects mounted on posts or pylons may overhang 12 in (305 mm) maximum from 27 in to 80 in (685 mm to 2030 mm) above the ground or finished floor (see Fig. 8(c) and (d)). Protruding objects shall not reduce the clear width of an accessible route or maneuvering space (see Fig.8(e)).

4.4.2 Head Room. Walks, halls, corridors, passageways, aisles, or other circulation spaces shall have 80 in (2030 mm) minimum clear head room (see Fig. 8(a)). If vertical clearance of an area adjoining an accessible route is reduced to less than 80 in (nominal dimension), a barrier to warn blind or visually-impaired persons shall be provided (see Fig. 8(c-1)).

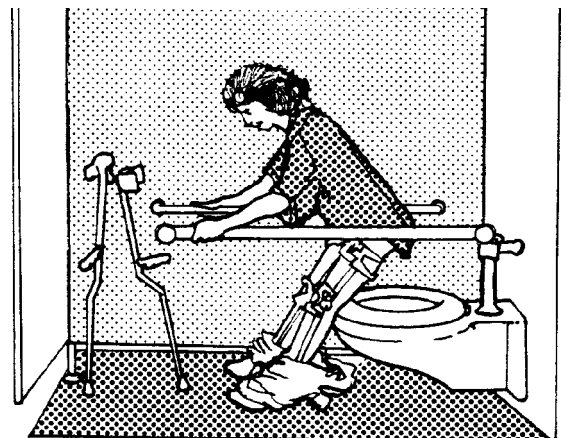
Toilet rooms with 6 or more toilet stalls lack a 36" wide "ambulatory" toilet stall.

4.22.4, 4.23.4 Water Closets. If toilet stalls are provided, then at least one shall be a standard toilet stall complying with 4.17; where 6 or more stalls are provided, in addition to the stall complying with 4.17.3, at least one stall 36 in (915 mm) wide with an outward swinging, self-closing door and parallel grab bars complying with Fig. 30(d) and 4.26 shall be provided. Water closets in such stalls shall comply with 4.16. If water closets are not in stalls, then at least one shall comply with 4.16.

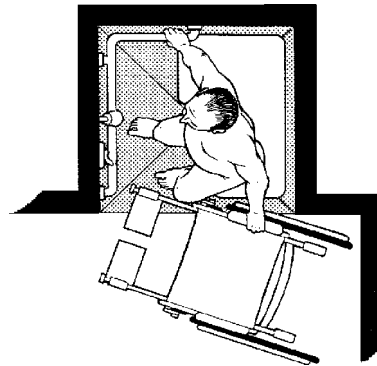
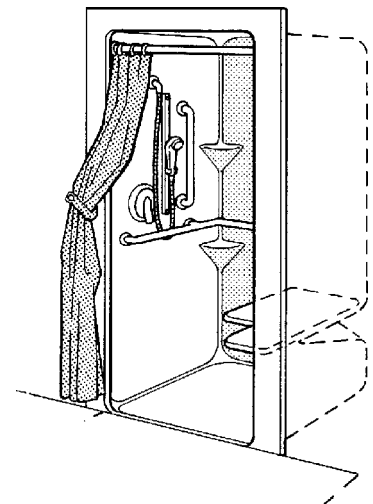
When a transfer shower is used, it is often larger than the required 36" x 36" size.

4.21.2 Size and Clearances. Except as specified in 9.1.2, shower stall size and clear floor space shall comply with Fig. 35(a) or (b). The shower stall in Fig. 35(a) shall be 36 in by 36 in (915 mm by 915 mm). Shower stalls required by 9.1.2 shall comply with Fig. 57(a) or (b). The shower stall in Fig. 35(b) will fit into the space required for a bathtub.

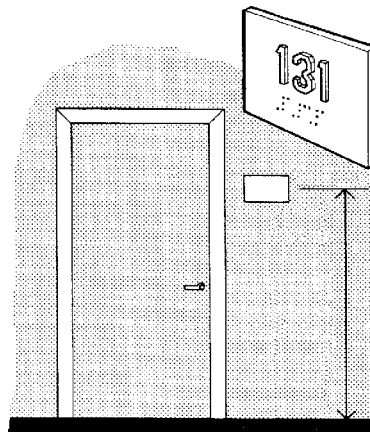
Where permanent room identification signage is provided, it is mounted in the wrong location.

4.30.6 Mounting Location and Height. Where permanent identification is provided for rooms and spaces, signs shall be installed on the wall adjacent to the latch side of the door. Where there is no wall space to the latch side of the door, including at double leaf doors, signs shall be placed on the nearest adjacent wall. Mounting height shall be 60 in (1525 mm) above the finish floor to the centerline of the sign. Mounting location for such signage shall be so that a person may approach within 3 in (76 mm) of signage without encountering protruding objects or standing within the swing of a door.

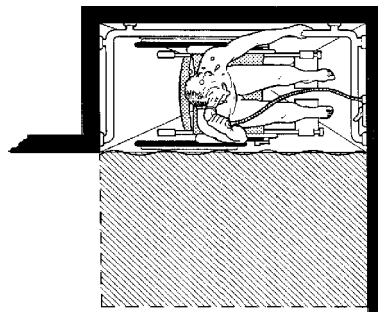
In hotels, motels, or other lodging facilities of 50 or more sleeping rooms, no rooms with roll-in showers are provided, or the roll-in showers that are provided lack a fold-down seat.

9.1.2 Accessible Units, Sleeping Rooms, and Suites. Accessible sleeping rooms or suites that comply with the requirements of 9.2 (Requirements for Accessible Units, Sleeping Rooms, and Suites) shall be provided in conformance with the table below. In addition, in hotels, of 50 or more sleeping rooms or suites, additional accessible sleeping rooms or suites that include a roll-in shower shall also be provided in conformance with the table below. Such accommodations shall comply with the requirements of 9.2, 4.21, and Figure 57(a) or (b).

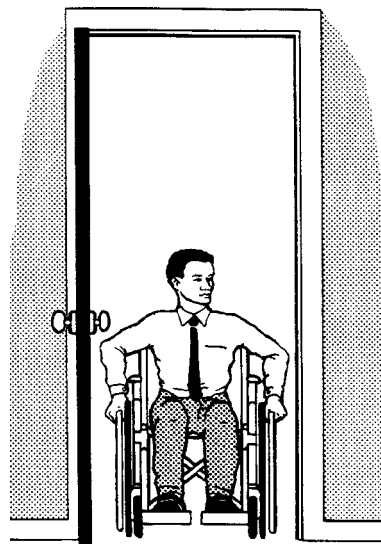
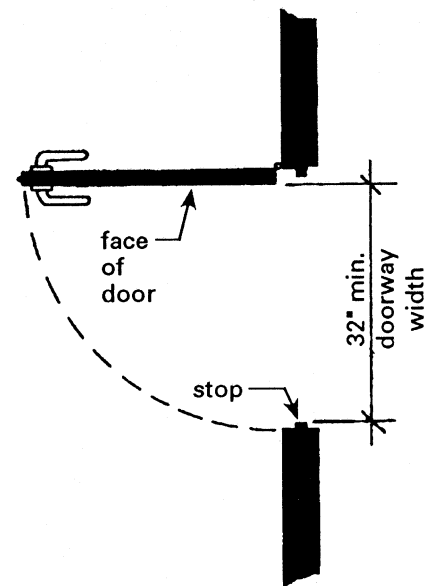
Measuring Clear Width

All doors and doorways (except shallow closets) into and within all guestrooms and suites (including guestroom bathrooms, kitchens, and connecting room doors) shall provide 32 inches of clear opening width measured when a hinged door is open 90 degrees or a sliding door is fully opened.

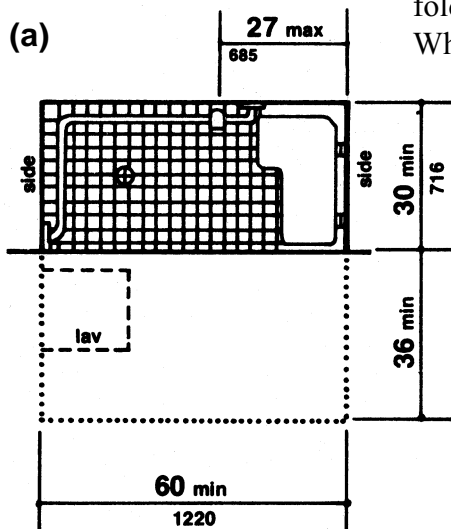
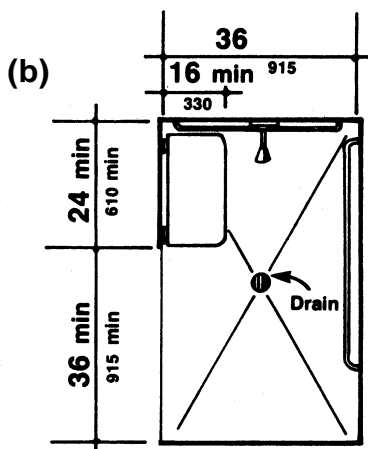
Fig. 57
Roll-in Shower
with Folding Seat

Lodging facilities must provide a specific number of accessible guest rooms based on the table provided below. Bathing facilities in these rooms must comply with the Standards. In addition, in lodging facilities with more than 50 guestrooms or suites, the facility must provide a specified number of accessible guestrooms that have a roll-in shower with a permanently attached fold-down seat. The roll-in shower in these rooms must comply with specific requirements contained in Figure 57 of the Standards, shown on this page.

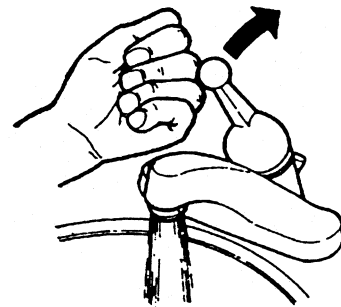
Handles, pulls, latches, locks, and other operating devices on accessible doors; faucets; fixed lamps; and drapery, heating, and air conditioning controls shall have a shape that is easy to grasp with one hand and does not require tight grasping, tight pinching, or twisting of the wrist to operate. Lever-operated mechanisms, push-type mechanisms, and U-shaped handles are acceptable designs. ADA Standards 4.13.9; 9.2.2(3); 9.2.2(5).

single-lever handle that is easy to reach and operable with one hand

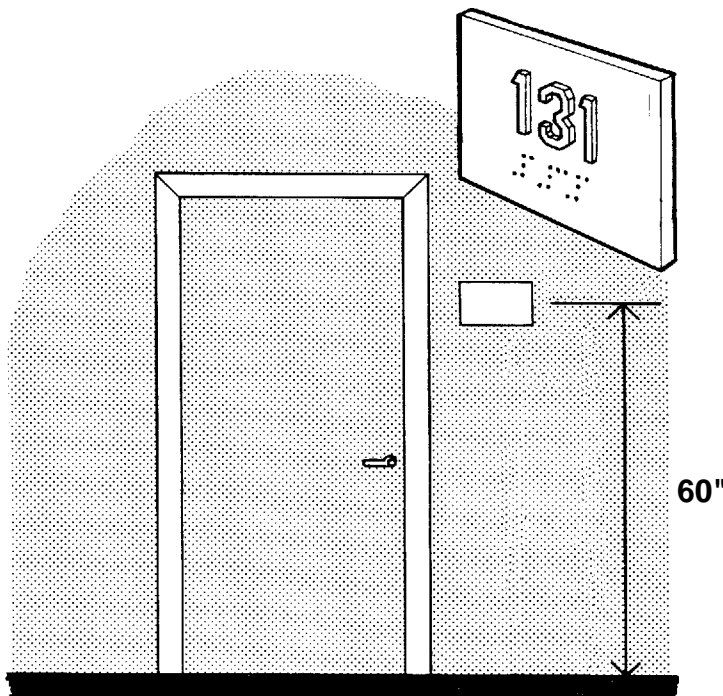
Signs that are provided for all permanent rooms and spaces in the lodging facility must be mounted on the wall (not the door) adjacent to the latch side of the door and centered 60 inches above the floor so that they can be easily located by persons who are blind or who have low vision. Signs must include the same information in Braille, with raised lettering that forms a high contrast with the background of the sign. Signs should not be made of reflective materials such as brass, silver, gold, glass, or mirrored surfaces unless there is an additional properly located sign that complies with the Standards. ADA Standards 4.1.3(16)(a); 4.30.4; 4.30.5.

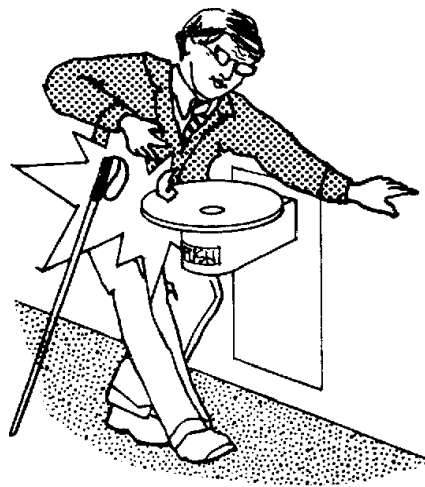
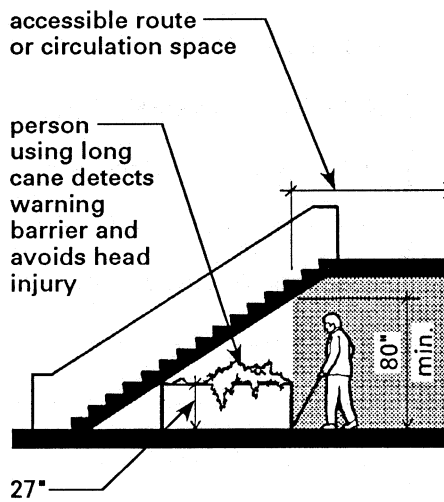
Objects mounted on walls at a height above 27 inches and below 80 inches (e.g., fire extinguishers, telephones) shall protrude no more than 4 inches into walks, halls, corridors, passageways, aisles, or any other areas where a person walks.

Free-standing objects mounted on posts or pylons may not project more than 12 inches into walks, halls, corridors, passageways, aisles, or any other area where a person walks at heights between 27 inches and 80 inches above the ground or finished floor.

Stairways and escalators with undersides that are not enclosed and all objects hanging above walks, hallways, corridors, passageways, aisles, and lobbies cannot hang down below a height of 80 inches above the ground or finished floor, unless there is a cane-detectible barrier that would alert a person who is blind or who has low vision to the hazard.

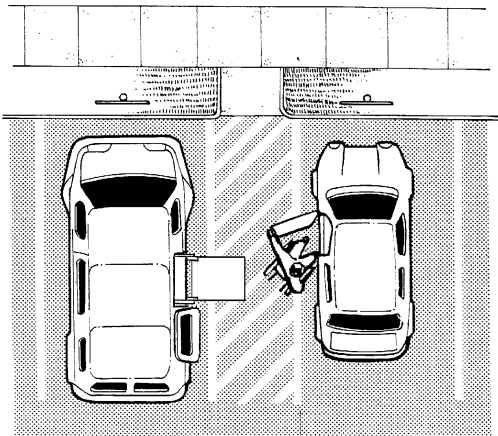
When a lodging facility offers “self-parking,” it must have the proper number of standard accessible parking spaces and van-accessible parking spaces as shown in the table below. Standard accessible parking spaces must be at least 8 feet wide and have or share an access aisle that is at least 5 feet wide. Van-accessible spaces must be at least 8 feet wide and have or share an access aisle that is at least 8 feet wide. The vertical clearance for van accessible parking spaces shall be at least 98 inches. The surface of all standard accessible parking spaces and all van-accessible parking spaces should be level (i.e., no greater than 1:50 or 2%). Accessible parking spaces should be dispersed so that some of those spaces are the nearest to the lobby and others are the nearest spaces to accessible entrances that serve accessible guestrooms. All accessible spaces in a parking garage may be grouped on one level of the structure. All accessible parking spaces must have signs with the international symbol of accessibility that are mounted high enough so that they are not obscured by parked cars. ADA Standards 4.1.2 (5); 4.6.2; 4.6.3; 4.6.4.
