Ethical Issues from the Tacoma Narrows Bridge Collapse (Video Course)

Instructor: J. Paul Guyer, P.E., R.A., Fellow ASCE, Fellow AEI

ETHICAL ISSUES FROM THE TACOMA NARROWS BRIDGE COLLAPSE

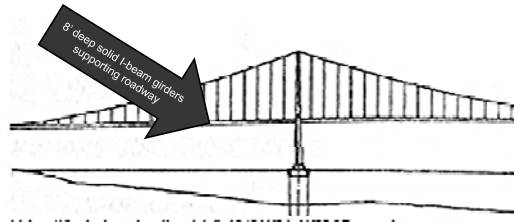
Moisseiff's design, elevation detail, 1940 WSA, WSDOT records

The Moisseiff proposal for a suspension bridge with the roadway supported on 8-foot deep solid I-beam girders

Based upon this theory Moisseiff proposed stiffening the bridge with a set of eight-foot-deep plate girders rather than the 25 feet deep trusses proposed by the Washington Department of Highways. This change contributed substantially to the difference in the estimated cost of the project.

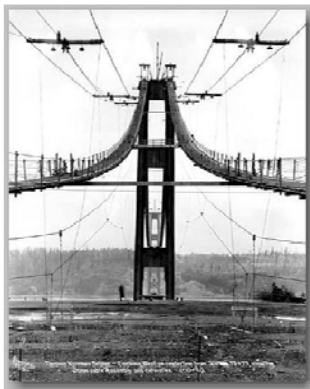
Tacoma Narrows Bridge Under Construction
 (University of Washington Libraries, Special Collections, PH Coll. 11.19)

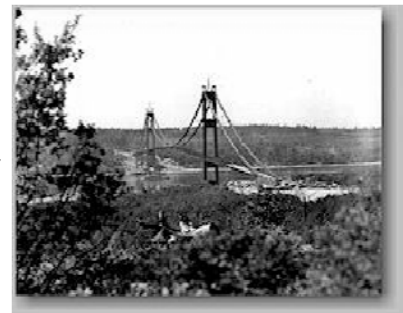
Tacoma Narrows Bridge Under Construction
 (University of Washington Libraries, Special Collections, PI-20789)

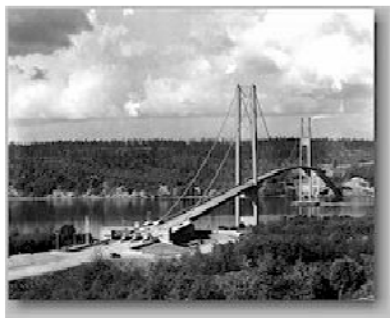
Tacoma Narrows Bridge Completed
 (University of Washington Libraries, Special Collections Division, PH Coll. 290.24)

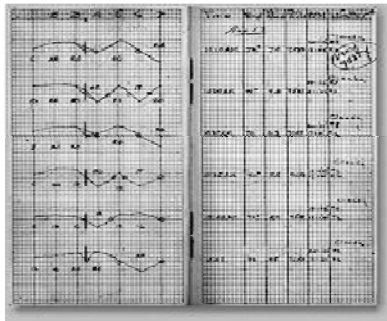
Logbook entry of the motion on the Tacoma Narrows Bridge, recorded by Farquharson on August, 12, 1940. UW Engineering Experiment Station Records, Acc. No. 06-034, Bridge Movement Data Logbooks. University of Washington Libraries, Manuscripts, Special Collections, University Archives Division.

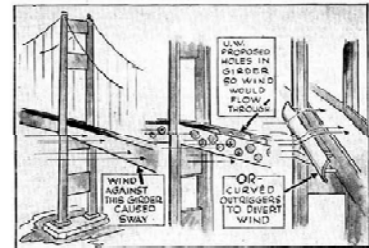
WOULD THIS HAVE SAVED BRIDGE?

University of Washington engineers made a 1:600 scale model of the Tacoma Narrows bridge, attempting to eliminate the dangerous wind waves which finally caused the bridge's collapse on October 28, 1940. The search at left shows the first horizontal girder which allowed resistance to wind, causing the wave. University recommendations were to drill holes with a hole in the girder, permitting the wind to pass through or create an air flow demanding buffer alongside the girder, to divert winds. Their tests showed the latter solution reduced the vibrations, might have saved the bridge.

- To drill holes in the lateral girders and along the deck so that the air flow could circulate through them, thereby reducing lift forces.
- To give a more aerodynamic shape to the transverse section of the deck by adding fairings or deflector vanes along the deck, attached to the girder fascia.

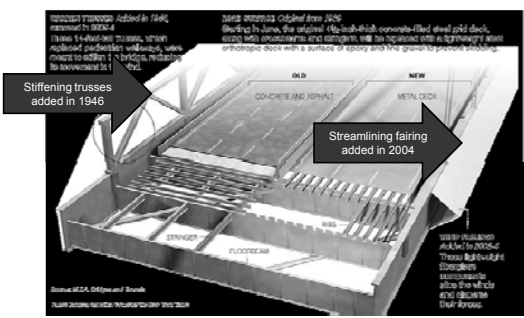
Bronx Whitestone Bridge aerodynamic fairing added in 2004

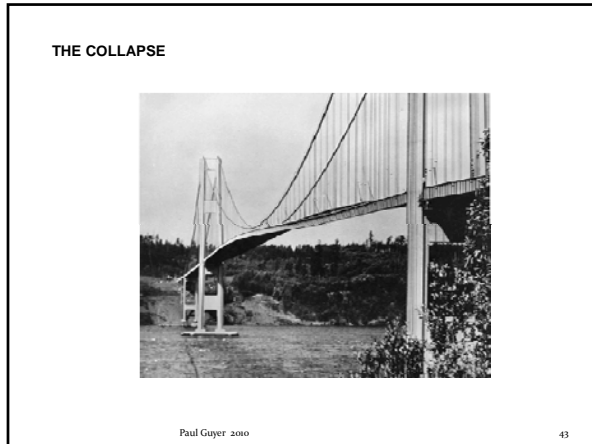
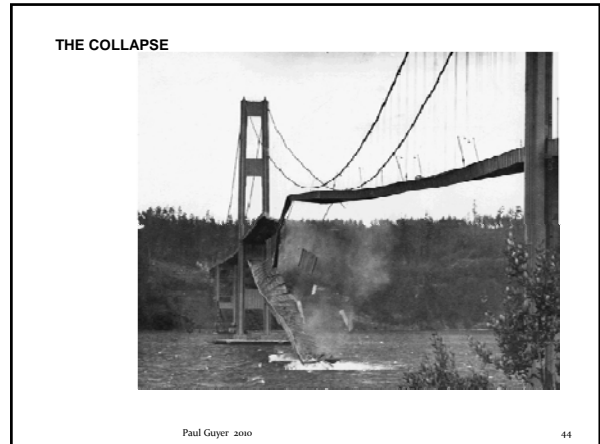
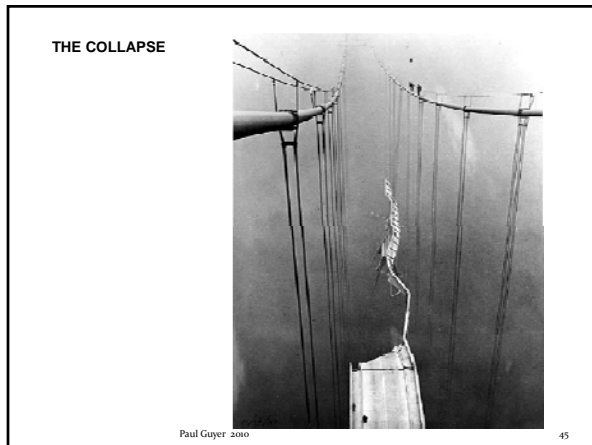
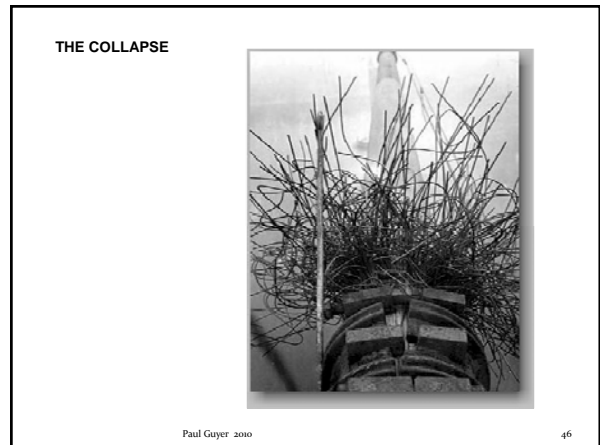
On the morning of November 7, 1940 the wind was blowing through the Narrows at a steady speed of about 42 miles per hour. At 10 AM the bridge began to oscillate severely in the torsional mode and the bridge was closed to traffic. At 11:10 AM the center span collapsed.

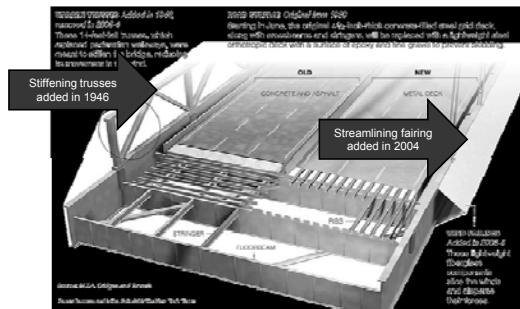
Bronx Whitestone Bridge aerodynamic fairing added in 2004

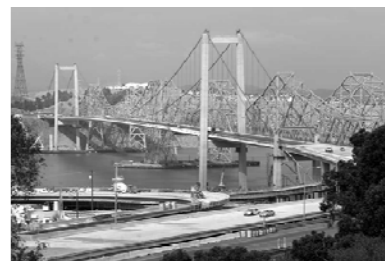
The "third" Carquinez Bridge
(the "first" and "second" bridges are seen beyond; the "first" was subsequently demolished)
(California Department of Transportation)
